Docket No. 272 – Development and Management Plan Inspection

Segment 4a Underground Line

Date: August 23, 2006

Location: Singer Substation to Fairfield/Westport Town Line

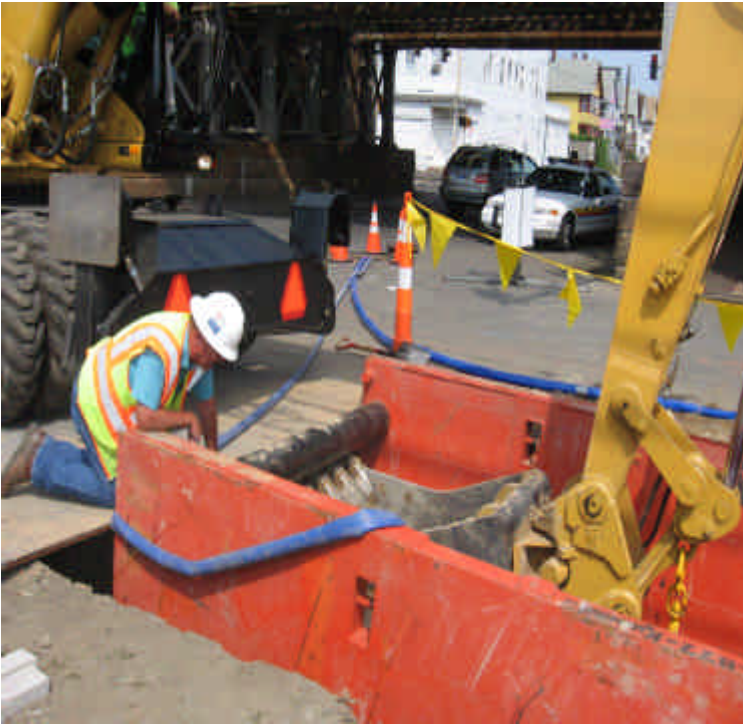
Photo of trenching activities on the shoulder of Railroad Ave. near the intersection with Warden Ave. During excavation, crews encountered an unmapped, brick, sewer conveyance system. Hoses are diverting contents out of work area to the City's sewer system.

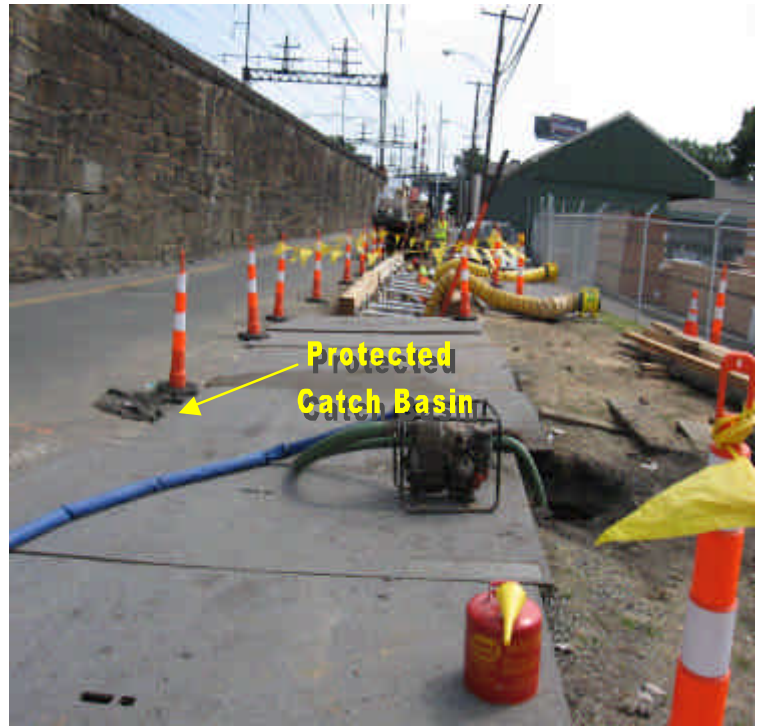
Photo of work along Railroad Ave. between Warden Ave. and Iranistan Ave. Catch basins in the area are protected.

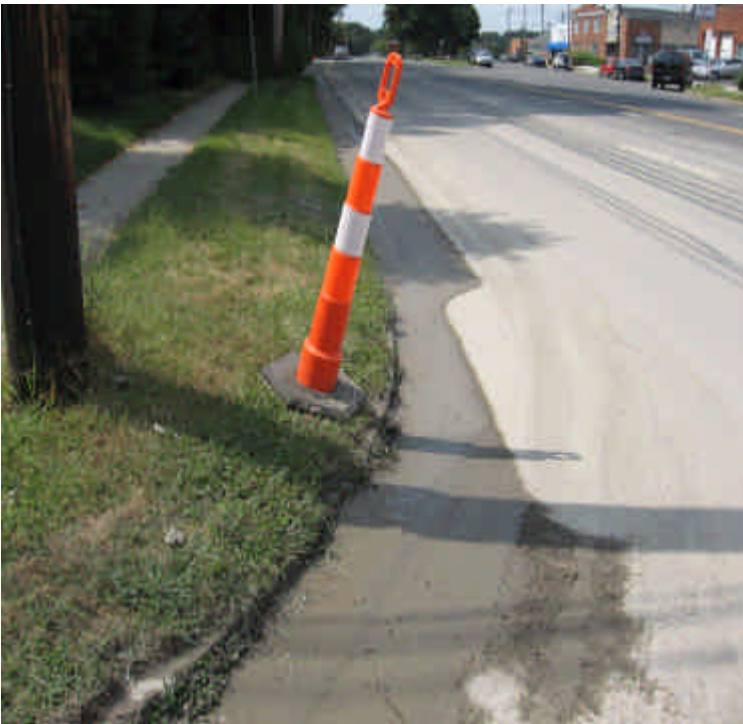
Photo taken at the intersection of Rt. 130 (Post Road) and Shoreham Village Dr. looking southwest at Rt. 130. Saw-cutting in the roadway during nightwork created a slurry of fine sediments that has accumulated along the edge of Rt. 130. (Fairfield)

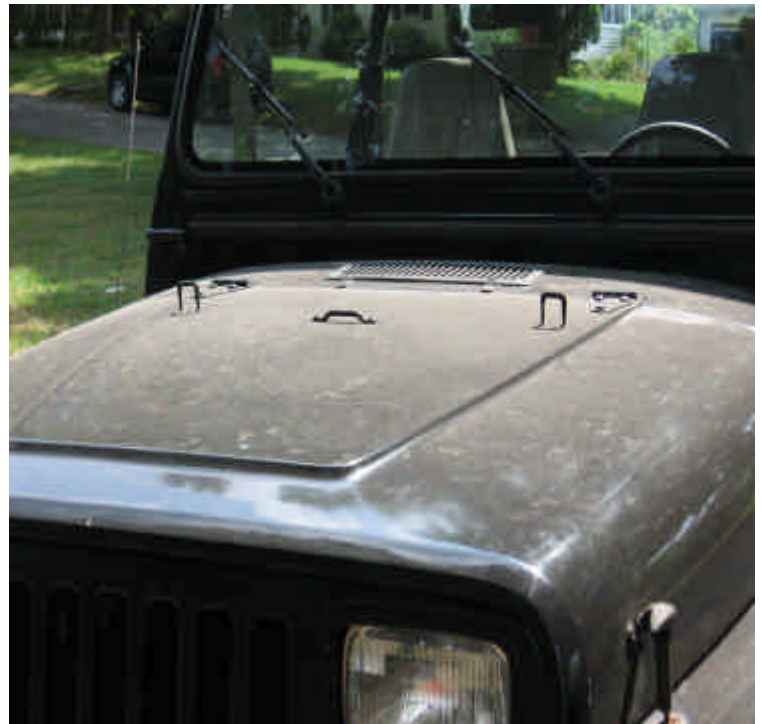
Photograph of parked vehicle on Shoreham Village Dr. that has been affected by dust migration from saw cutting activities. (Fairfield)

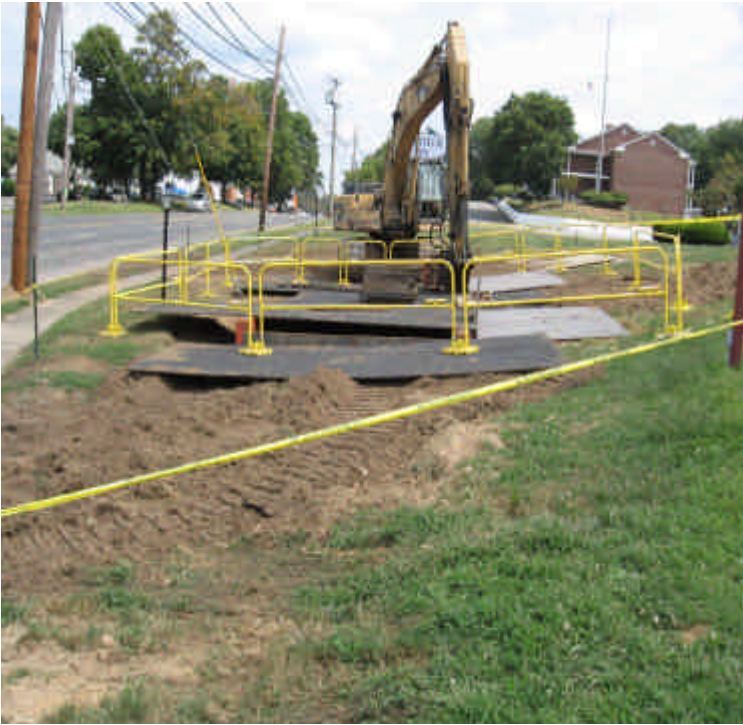
Photo of the construction activities associated with the installation of Vault 7537 adjacent to Rt. 130. (Fairfield)

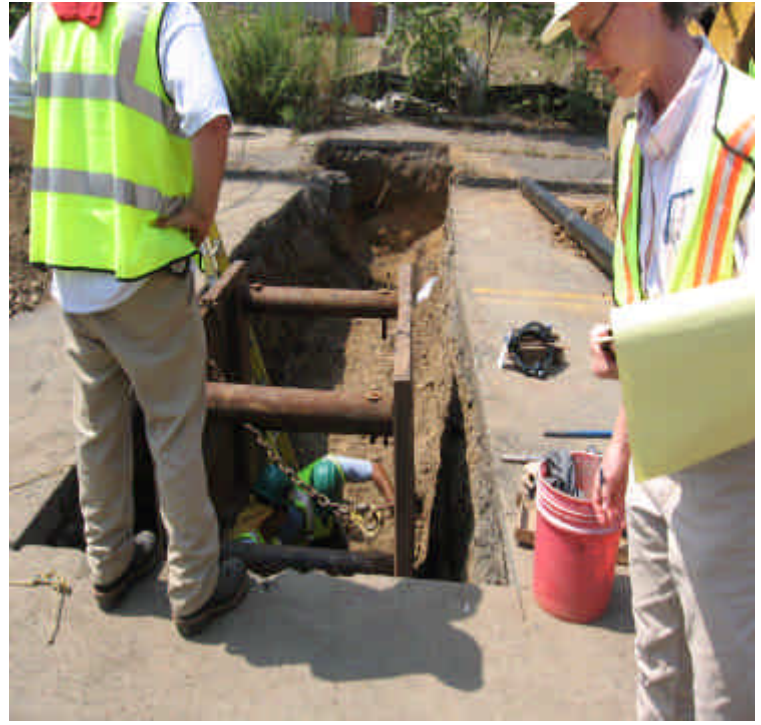
Utility relocation construction activities near the intersection of Broad St. and Cottage St.

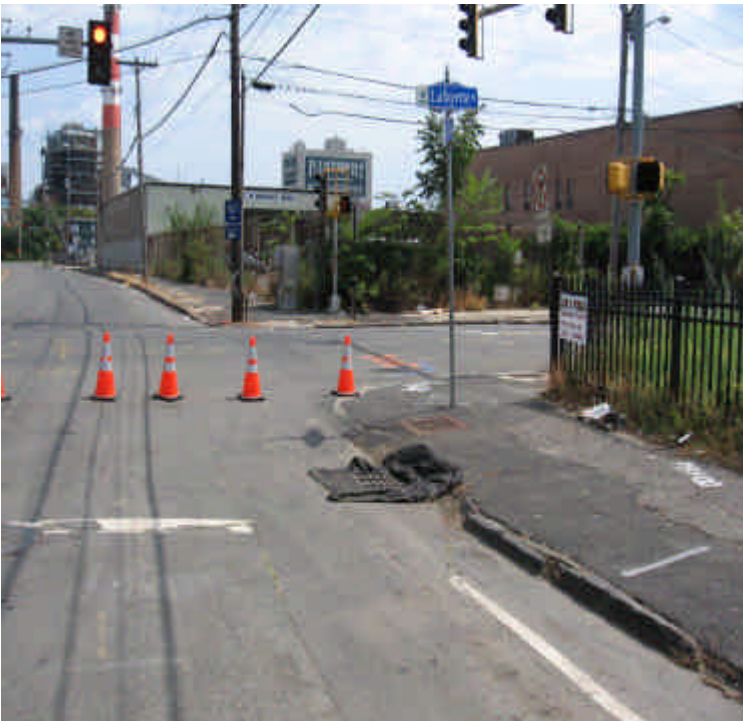
Photo taken from Railroad Ave. facing east looking at the intersection with Lafayette St. Catch basins are being protected.

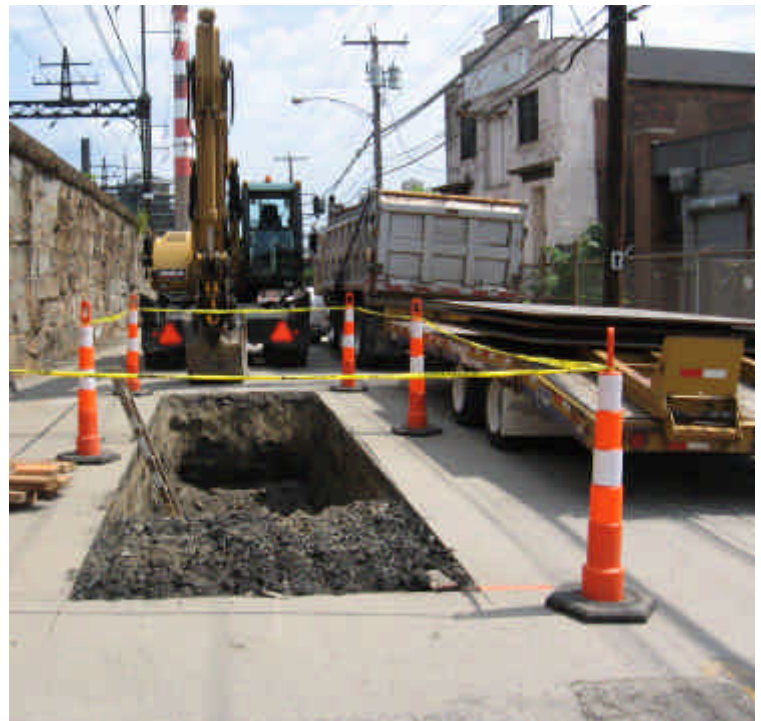
Trench excavation activities on Railroad Ave. between Lafayette St. and Warren St.
