Docket No. 272 – Development and Management Plan Inspection

Segment 4a Underground Line

Date: September 6, 2006

Location: Singer Substation to Fairfield/Westport Town Line

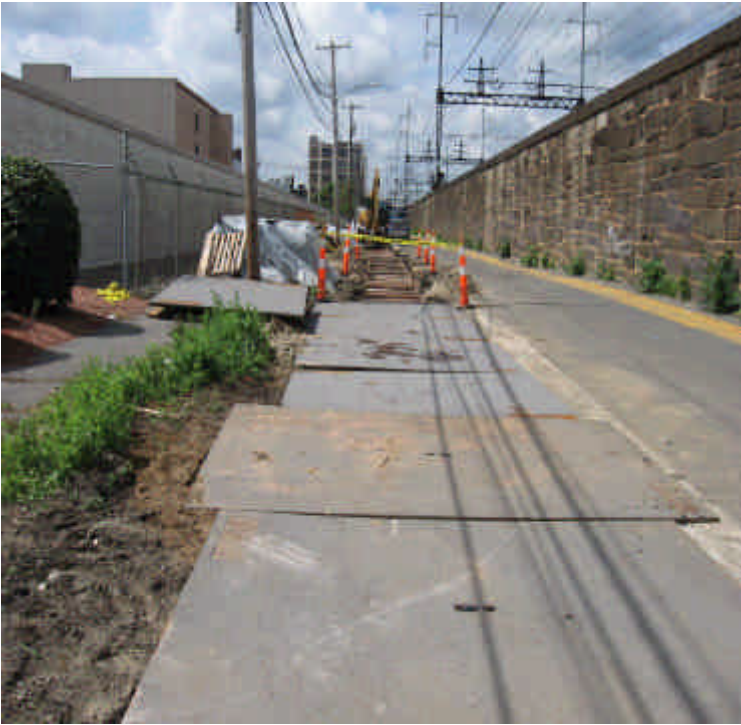
Photograph taken on Railroad Ave. looking towards Wordin Ave. of trench excavating activities.

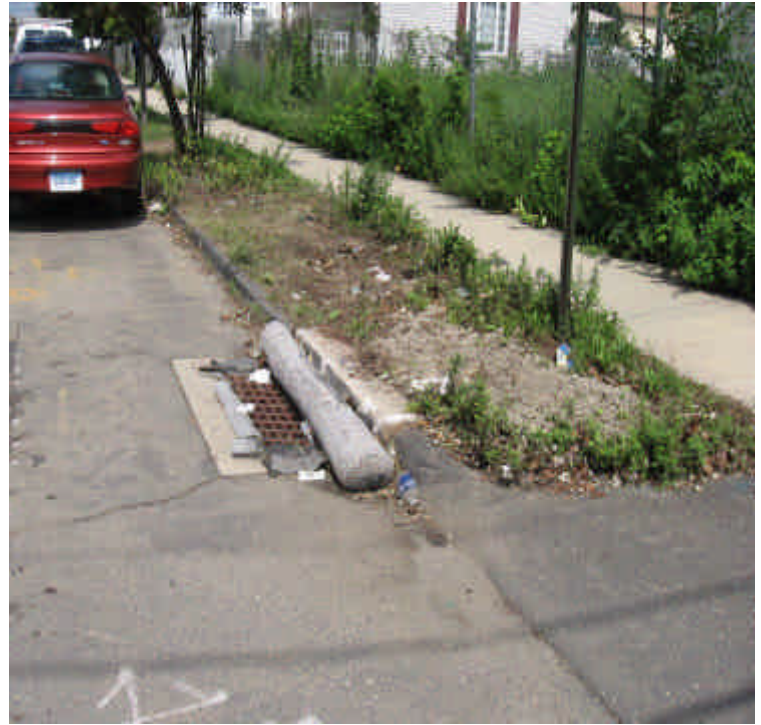
Example of appropriate catch basin protection associated with the utility work on and in the vicinity of Atlantic Ave and Broad Street.

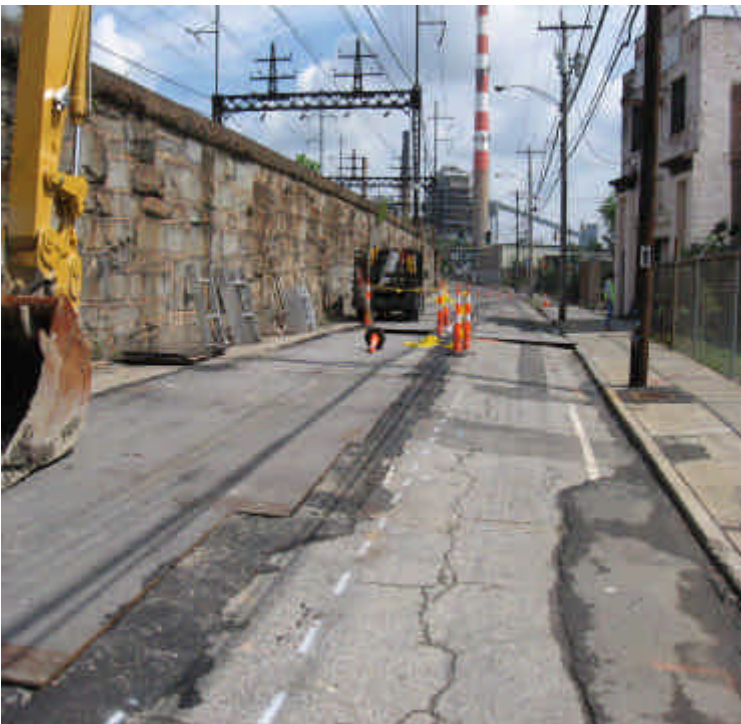
Photo of trench excavation activities on Railroad Ave. between Lafayette Ave. and Warren Ave. Photo taken facing Lafayette Ave.

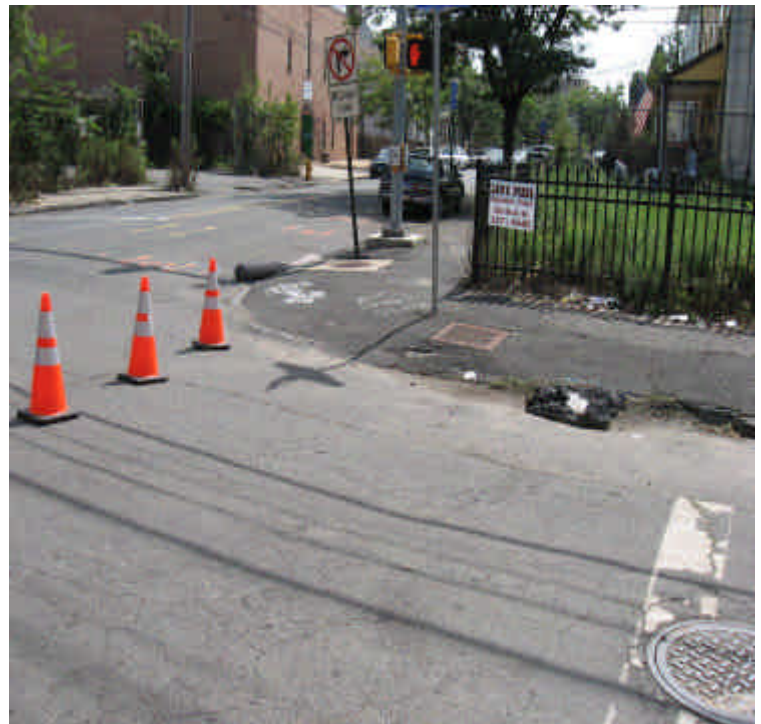
Appropriate catch basin protection at the corner of Lafayette Ave. and Railroad Ave.

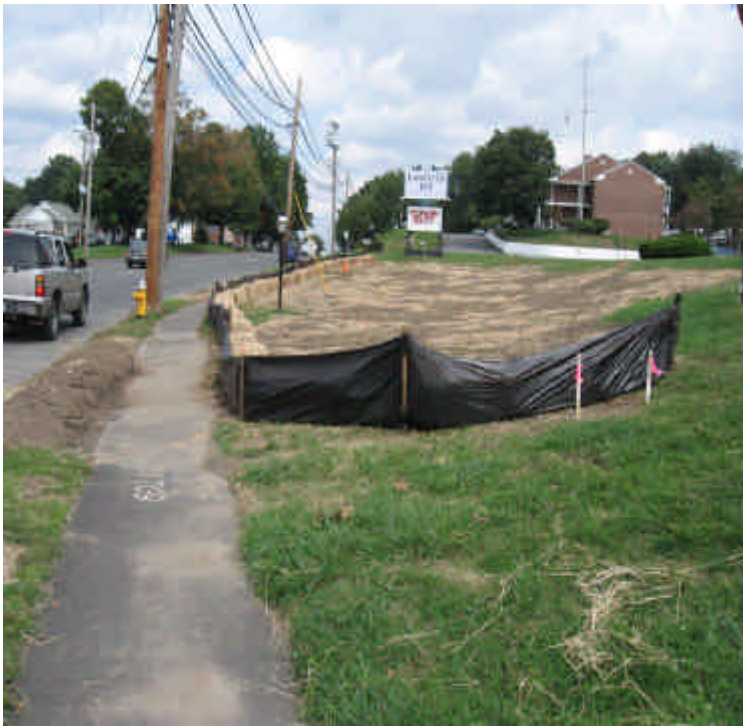
Vault #7537 construction area on the shoulder of Rt. 1. Work is complete in this area and disturbed soils have been seeded and mulched. Continue to monitor and repair/reinforce controls if runoff to the roadway is noted.

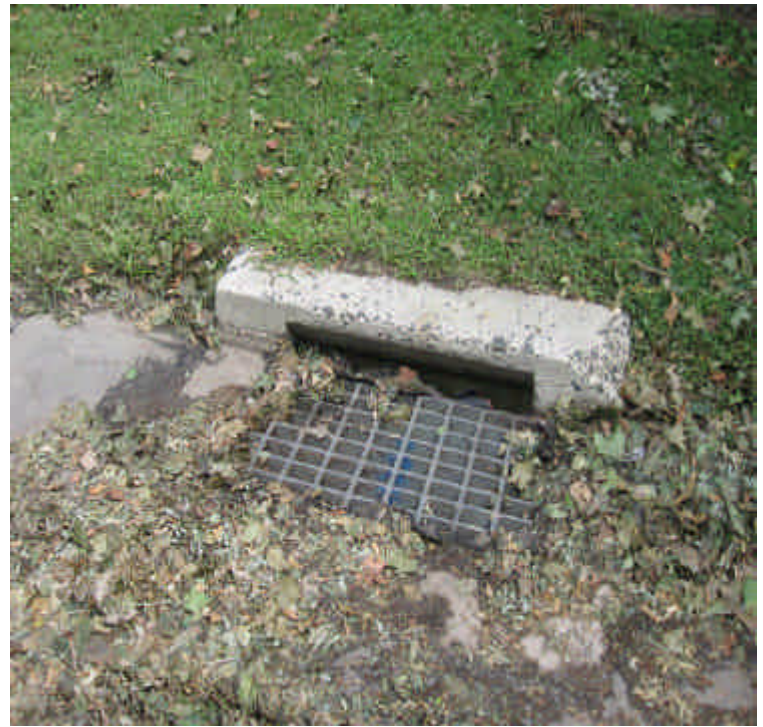
Catch basin located on Old Post Road. This basin accepts most stormwater associated with the vault #7537 construction. Controls should be installed if appropriate with CTDOT specifications.

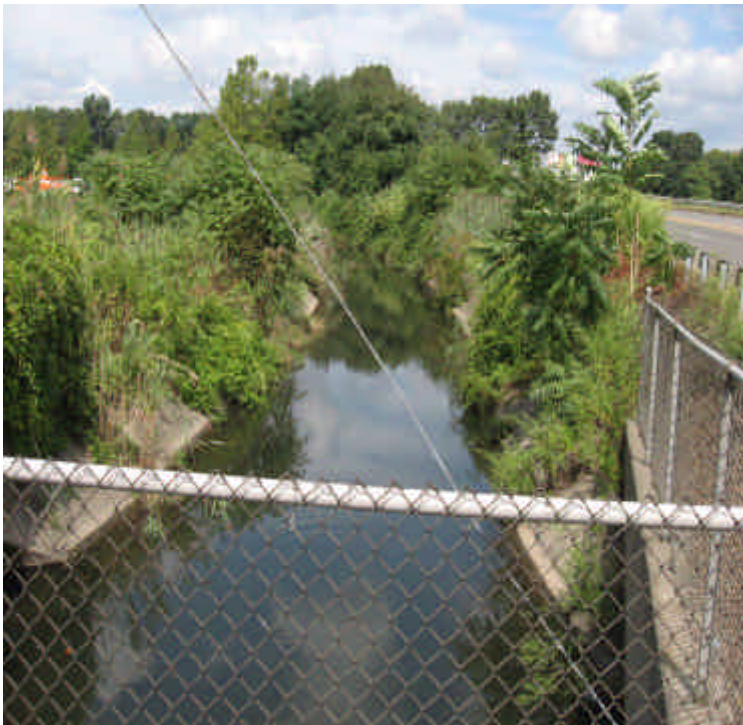
Waterway located off Kings Highway adjacent to the storage yard.

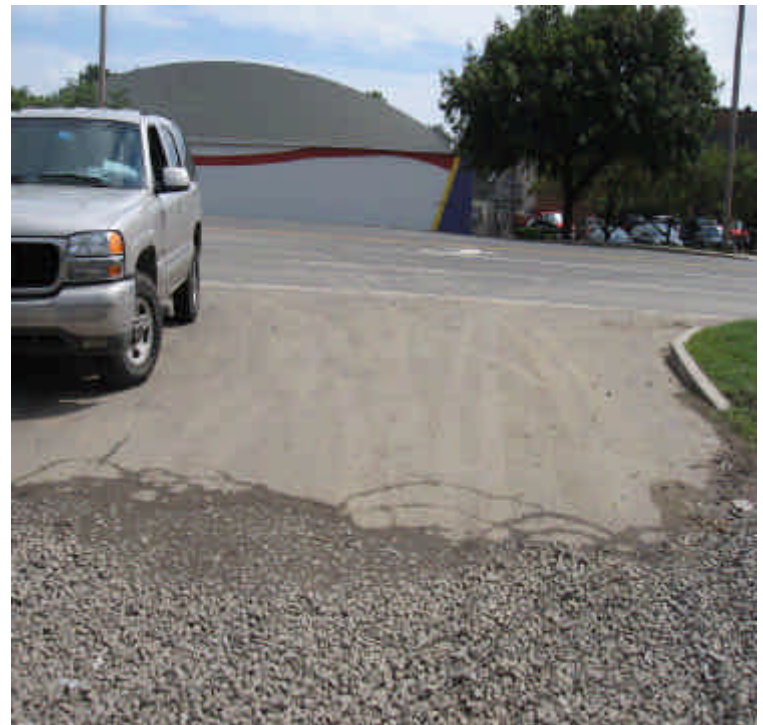
Construction entrance of the Kings Highway storage yard. Very minor amounts of sediment were tracked on the roadway in comparison to last week's inspection. The controls were improved

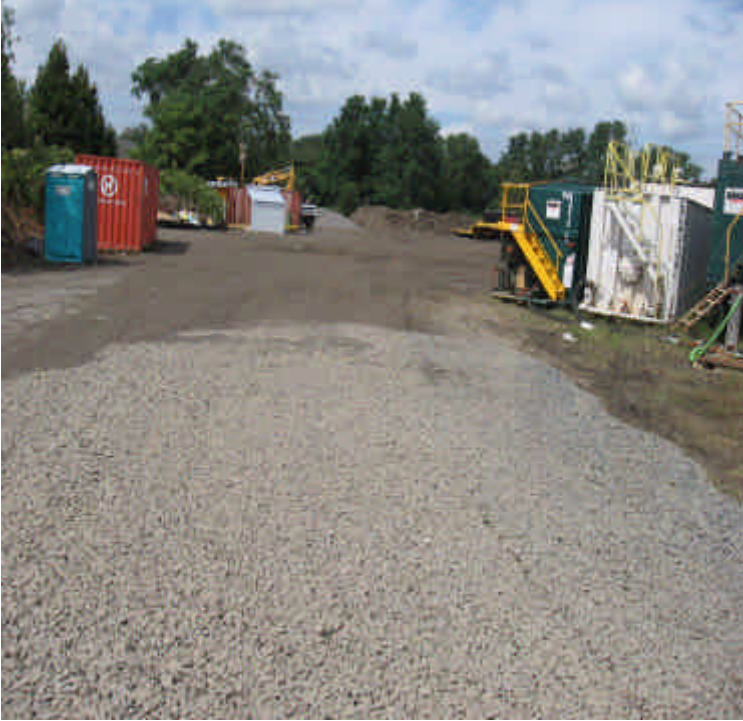
Kings Highway storage yard and construction entrance. The material used to reduce mud in the yard has visibly reduced vehicle tracking

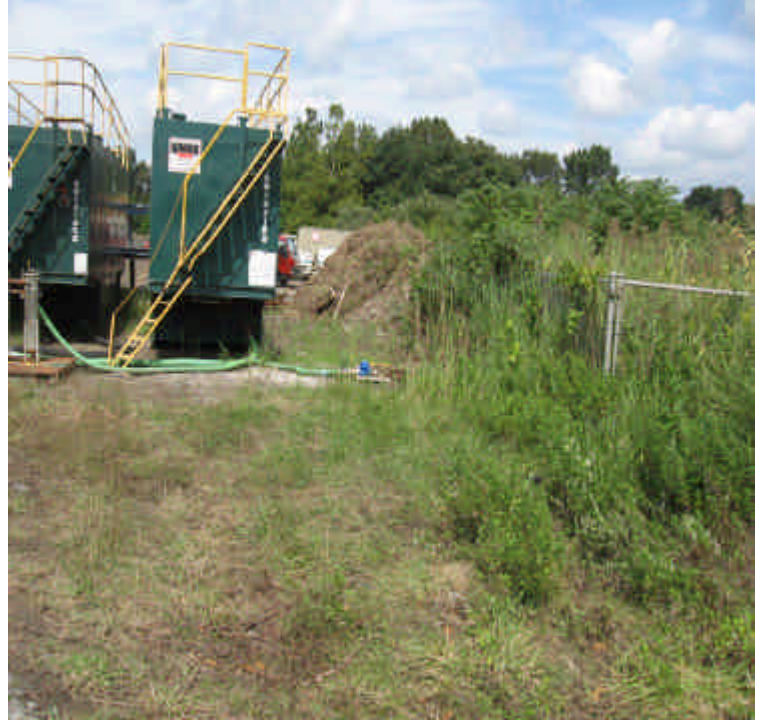
Silt fence/erosion controls still need to be properly installed in this area between the yard (and stockpile) and the waterway

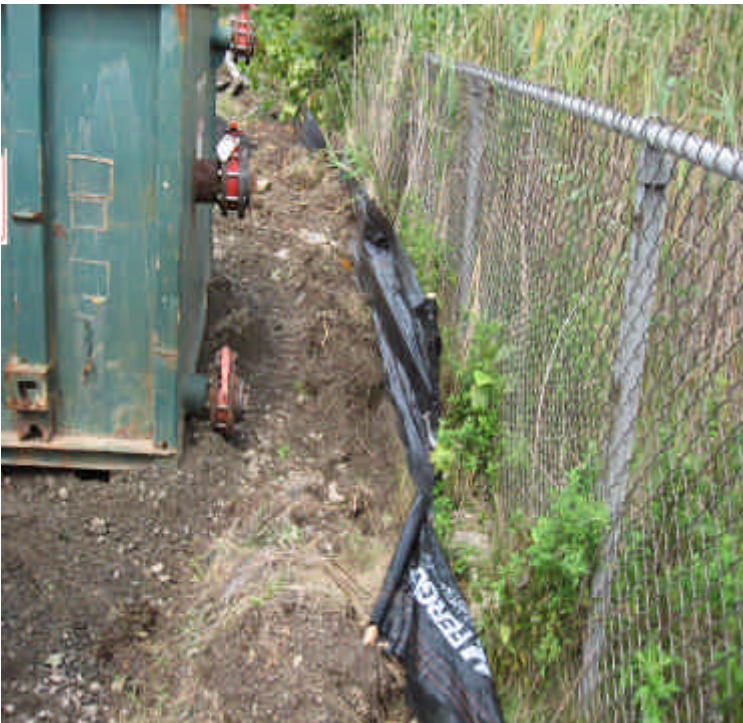
Silt fence has been installed between the Kings Highway storage yard and waterway. Portions of the silt fence have not been installed properly, either slumping or not toed-in.

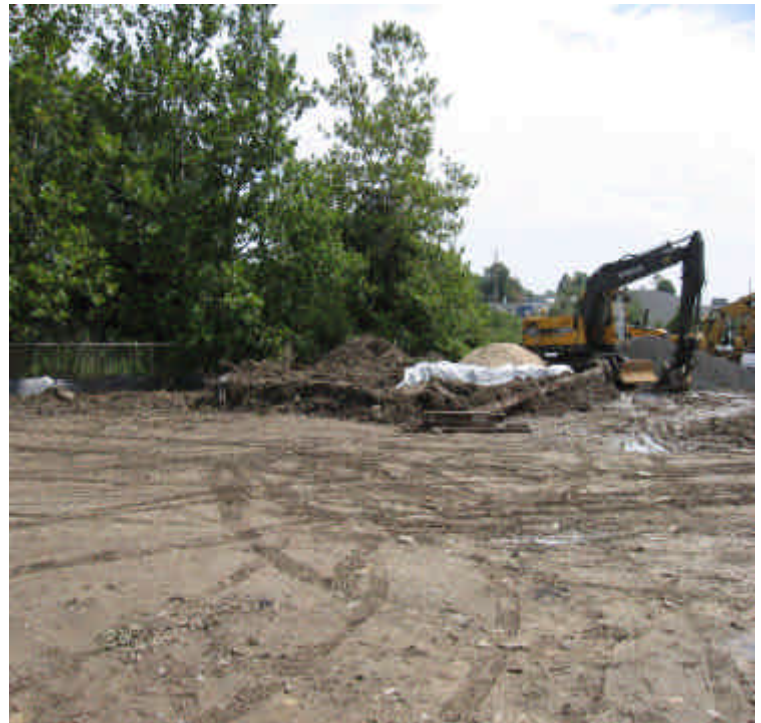
Photo of a lined pit, designated for concrete wash-out which has been installed since last week's inspection. However, it is located adjacent to the perimeter fence and would be best moved away from the sensitive areas.

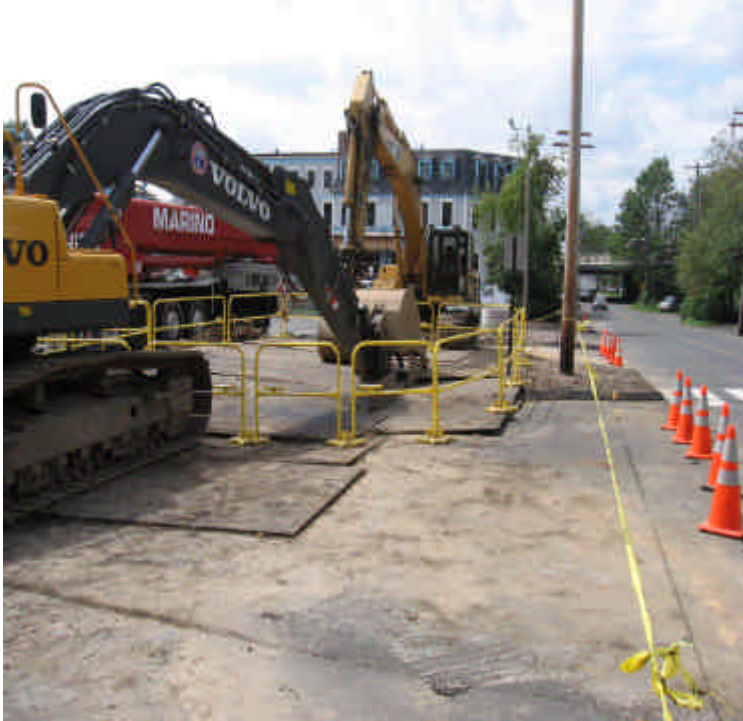
Photograph of vault #6428 construction on Old Post Road. It appears that sweeping the sediment from the asphalt had been attempted, but some was left behind. Watch for sediment migration or dust production and re-sweep if necessary.

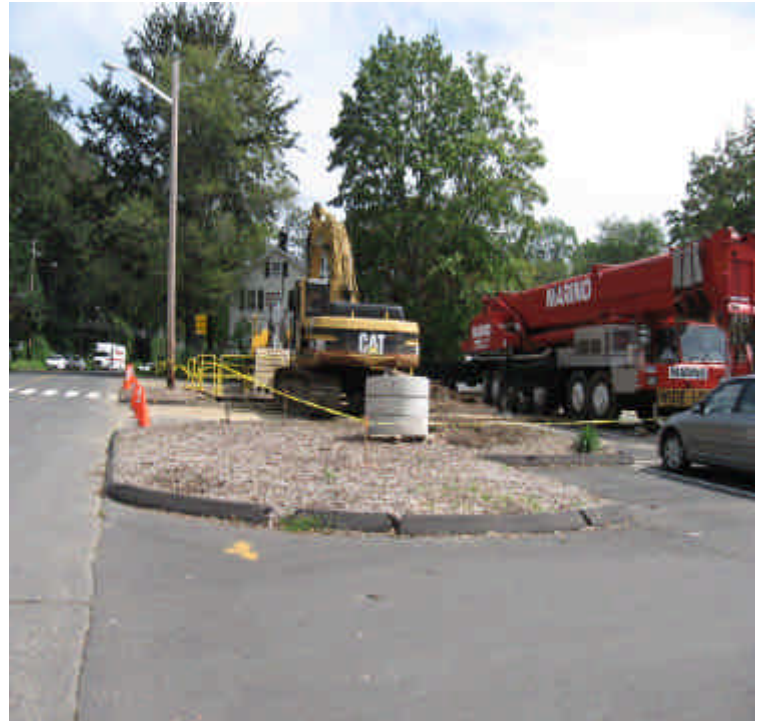
Photo of vault #6428 construction. Three trees were removed from the landscaped islands to accommodate the construction activities.

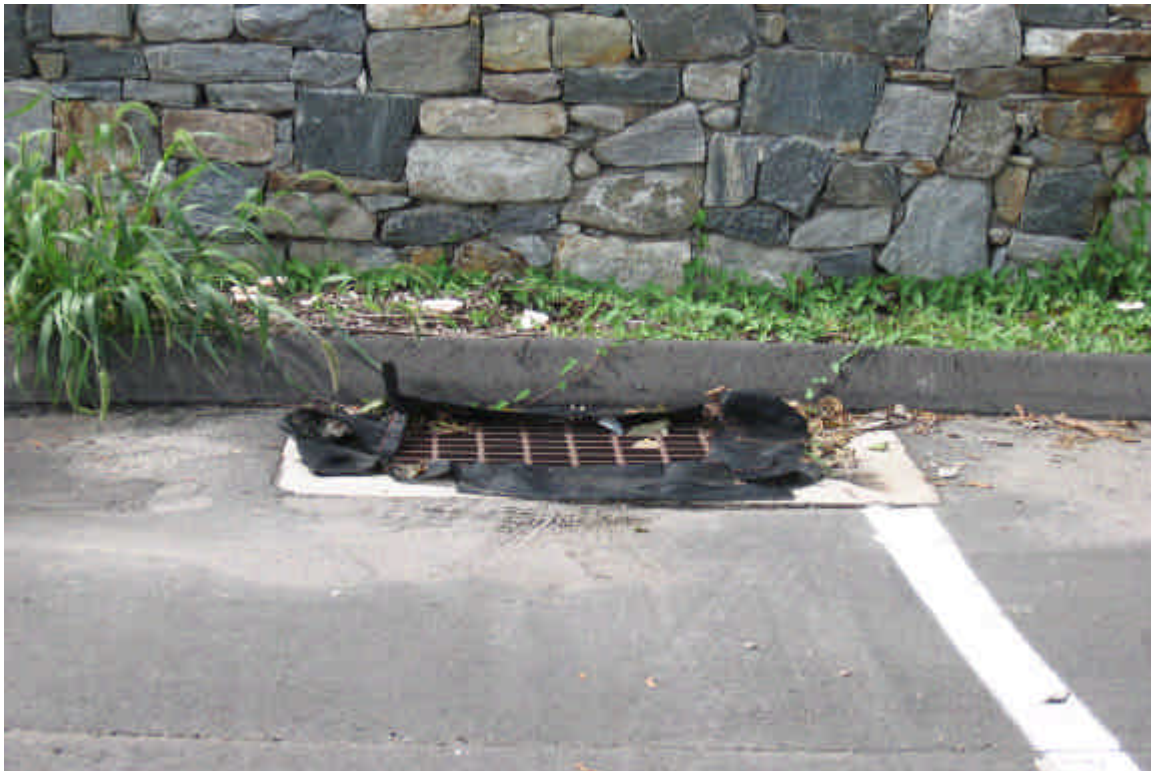
Photo of properly protected catch basin located in parking lot adjacent to vault 27 construction activities.
