**Docket No. 272 – Development and Management Plan Inspection**

**Segment 4a Underground Line**

**Date:** September 13, 2006

**Location:** Singer Substation to Fairfield/Westport Town Line

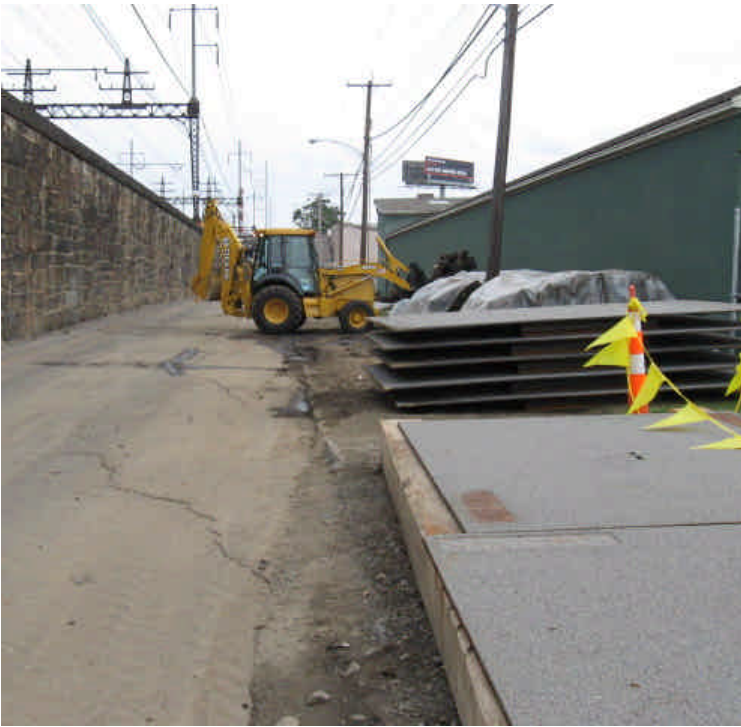
**Photograph taken on Railroad Ave. looking towards Iranistan Ave.**

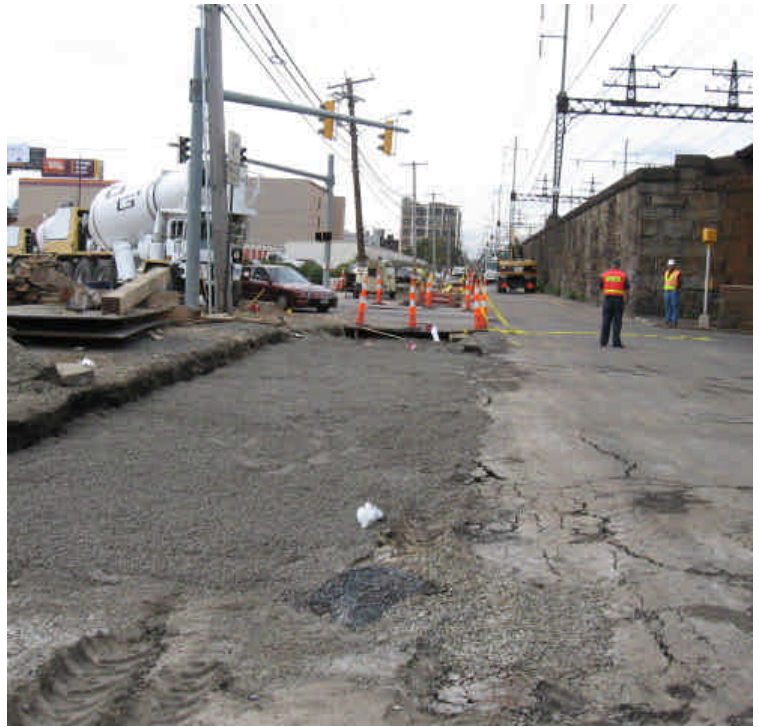
**Photo taken on Railroad Ave. at its intersection with Wordin Ave. The trench in this area is being backfilled and trenching activities are progressing towards Howard Ave.**

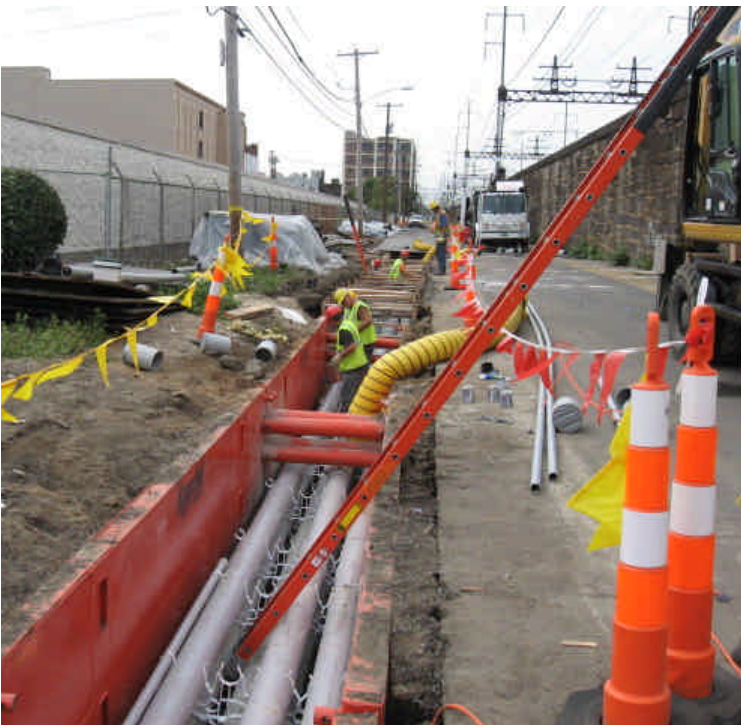
**Photo of trench activities on Railroad Ave. between Wordin Ave. and Howard Ave.**

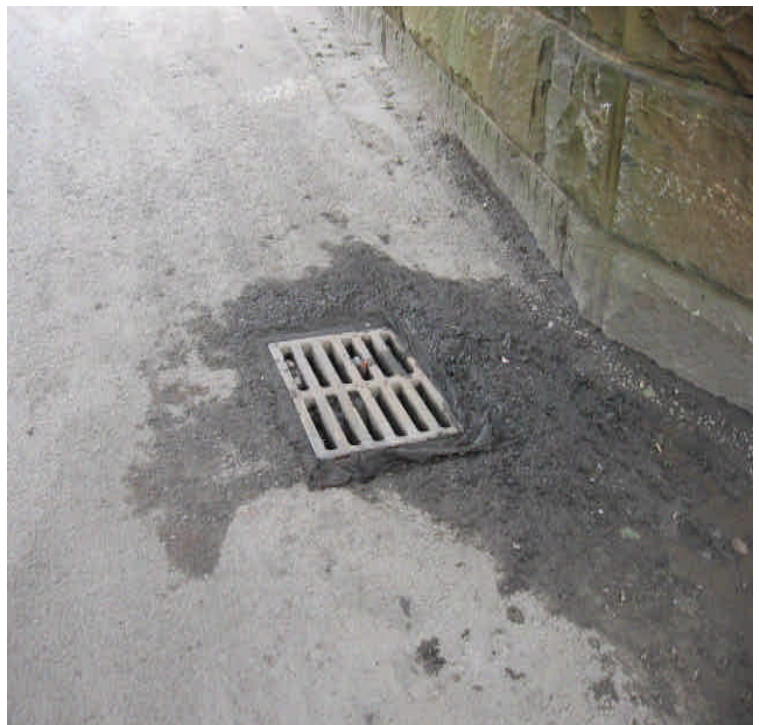
<p><b>Erosion and Sediment Controls            Bridgeport</b></p>	<p>Filter fabric or filter socks are installed in all catch basins adjacent to the construction activities. 9/13/06</p> <p>Attempts were made to replace the filter fabric controls in the two catch basins located at the intersection of Railroad Ave. and Wordin Ave. However, the catch basin grate could not be removed. The fabric and sediment was removed without removing the grate but replacement controls could not be installed. 9/13/06</p> <p>Any exposed soils have potential for airborne dust migration. Contractors are aware of the potential. 9/13/06</p>	<p>Continue to also place gutter buddy (or similar) in any catch basins with a curb/gutter drop inlet to prevent sediment from entering basin. 9/13/06</p> <p>Proactively prevent sediment from entering catch basins. 9/13/06</p> <p>Prevent dust migration by regularly watering down exposed soils and sweeping immediately. If exposed soils are not to be worked within 14-21 days, they should be</p>	<p>Catch basins were protected.(Proactively)</p> <p>Attempts were made to maintain the controls. Needs regular attention.</p> <p>Needs regular attention</p>

**Catch basin located at the intersection of Wordin Ave. and Railroad Ave. When attempting to refresh filter fabric, it was found that the grate could not be removed without potentially causing damage.**

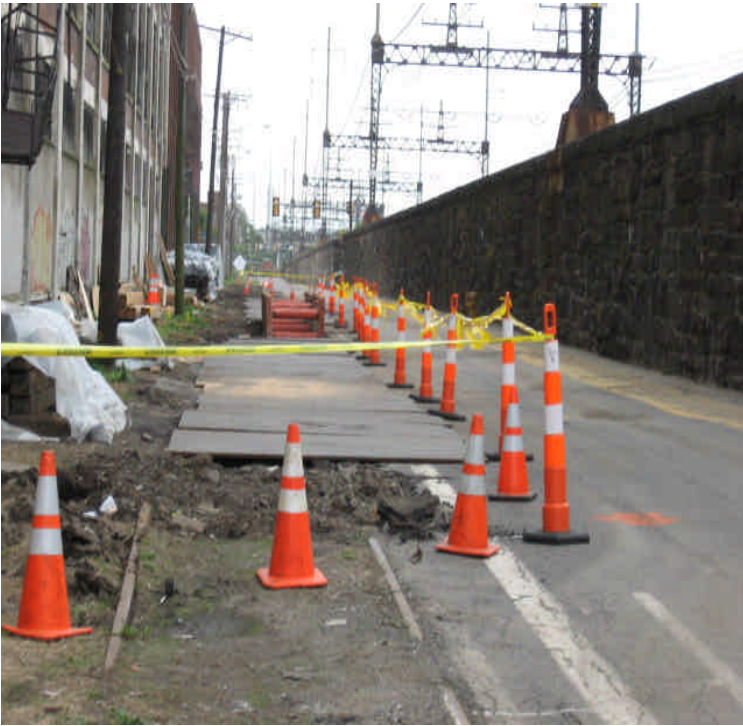
**Trenching activities located on Railroad Ave. between Howard Ave. and Hancock Ave.**

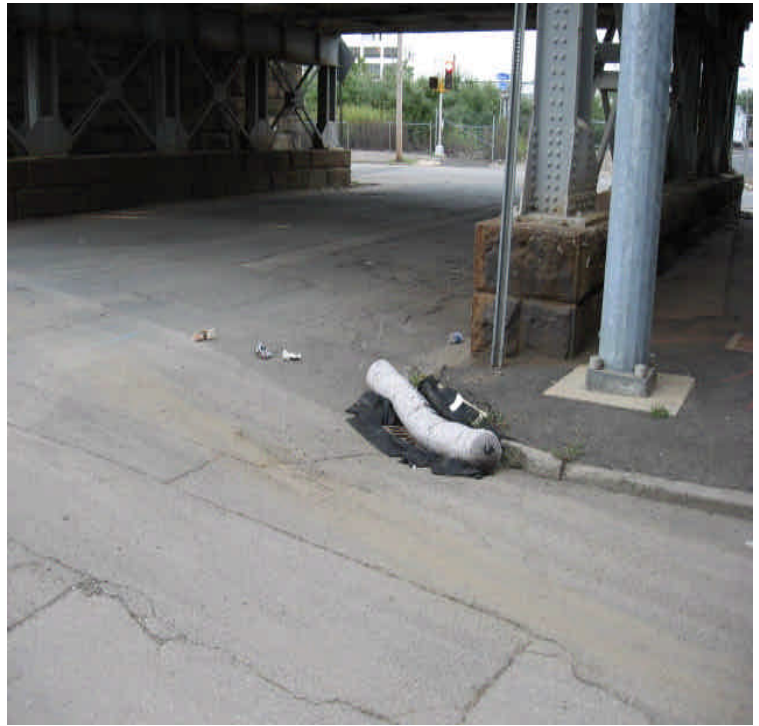
**Catch basin protected at the intersection of Railroad Ave. and Hancock Ave.**

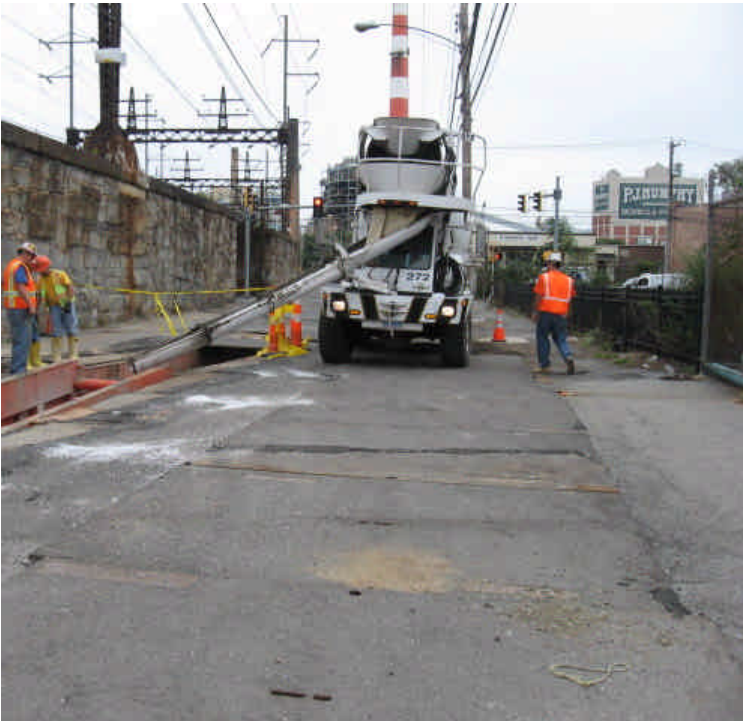
**Trench being backfilled with concrete on Railroad Ave. between Lafayette Ave. and Warren Ave.**

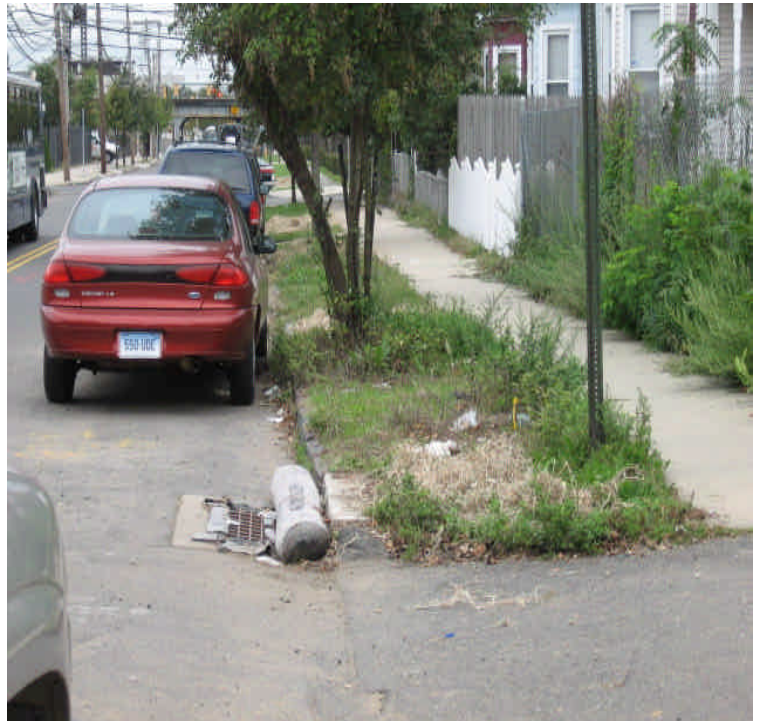
**Photograph taken on Broad St. near Atlantic Ave. of catch basin protection and previously disturbed soils seeded and mulched with hay.**

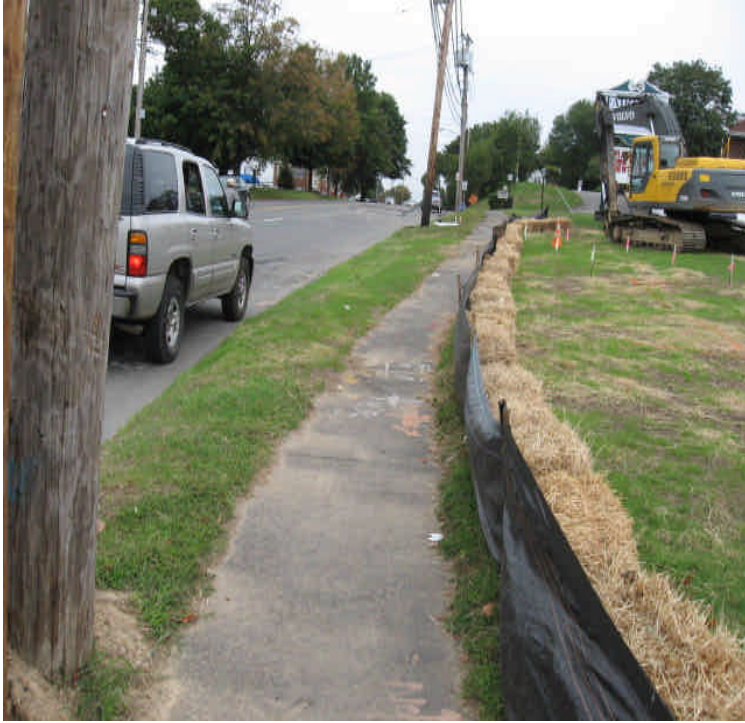
**Vault #7537 construction area on the shoulder of Rt. 1. Grass is rapidly establishing in the restored area. No erosion was observed in this area.**

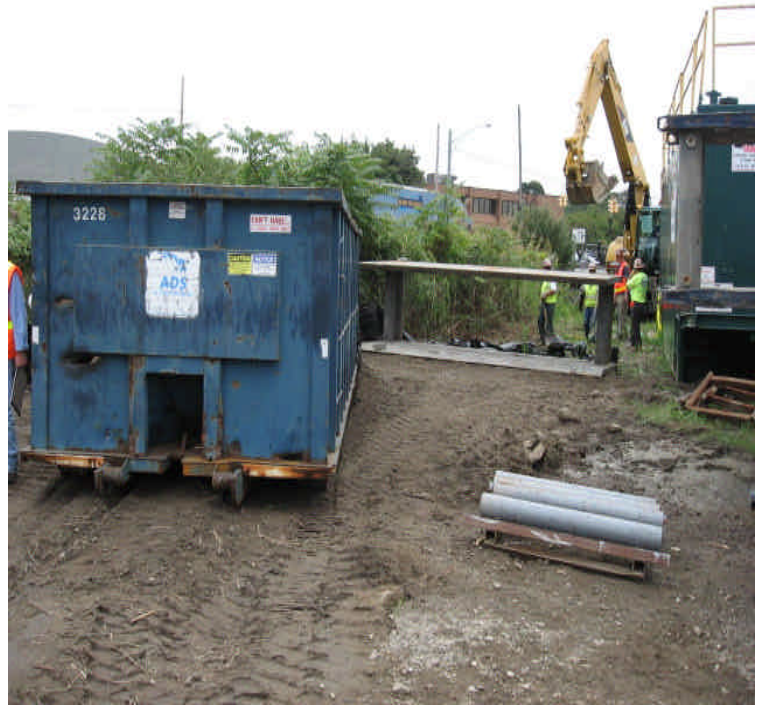
**Photograph of former stockpile location and crews installing silt fence in the Kings Highway storage yard.**

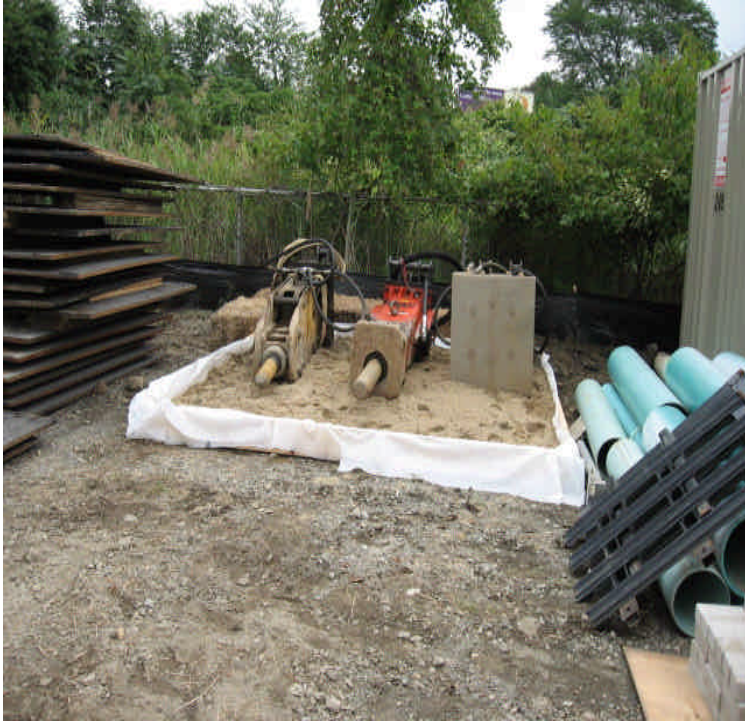
**Containment area constructed within the Kings Highway storage area for the temporary storage of oil filled equipment.**

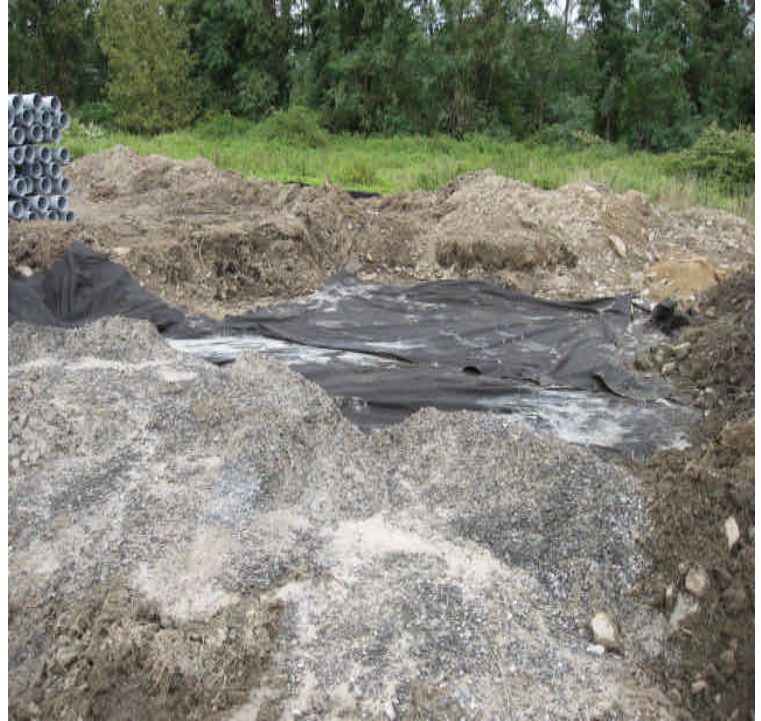
**New concrete washout basin within the Kings Highway yard. Improvements to the geotextile fabric liner are still needed.**

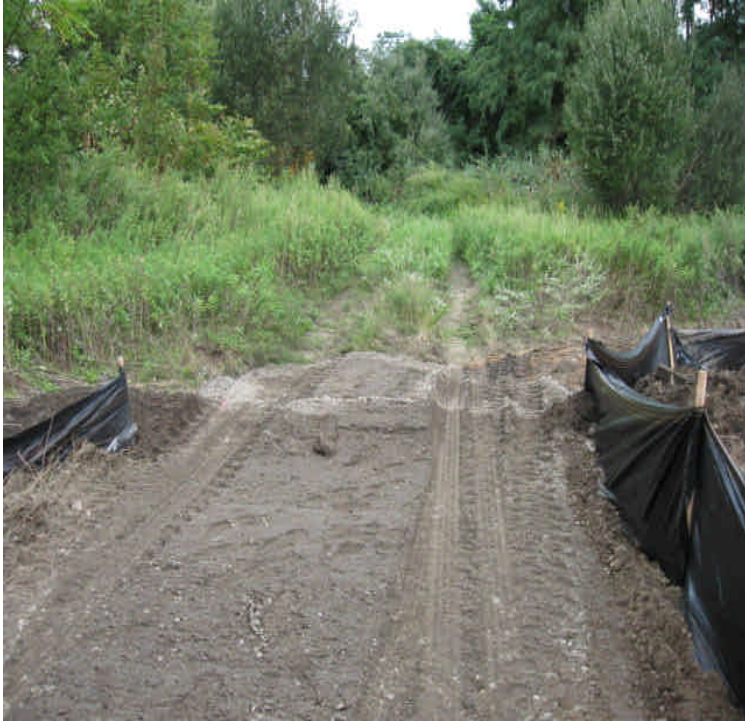
**Photograph of area within the Kings Highway storage yard that requires regular access by the Fairfield Sewer Dept. The access way can not be closed off with silt fence, other methods of control will be implemented. (i.e. stone berms)**

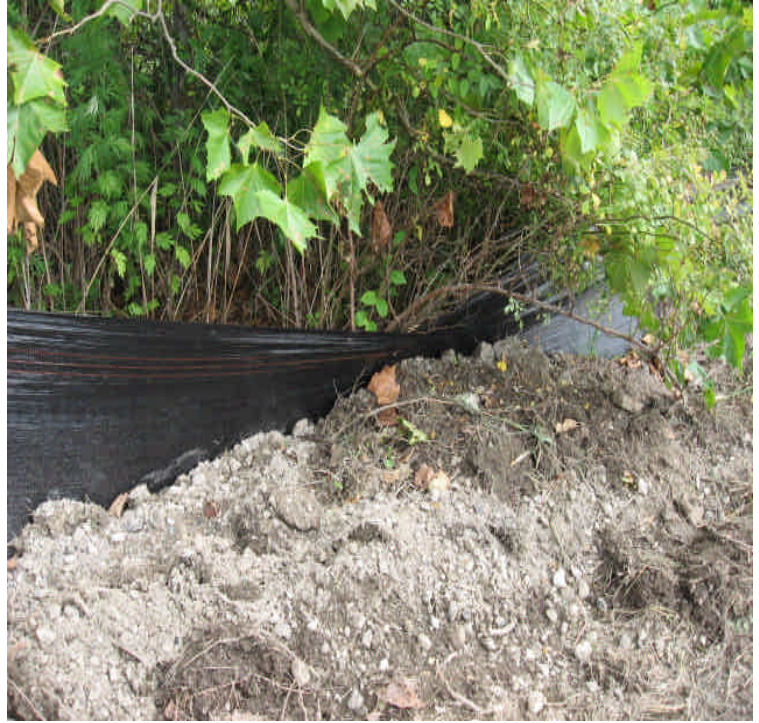
**Portion of silt fence against the perimeter fence within the Kings Highway storage yard that has soils piled against them. The soils should be pulled back so that the controls are not compromised.**

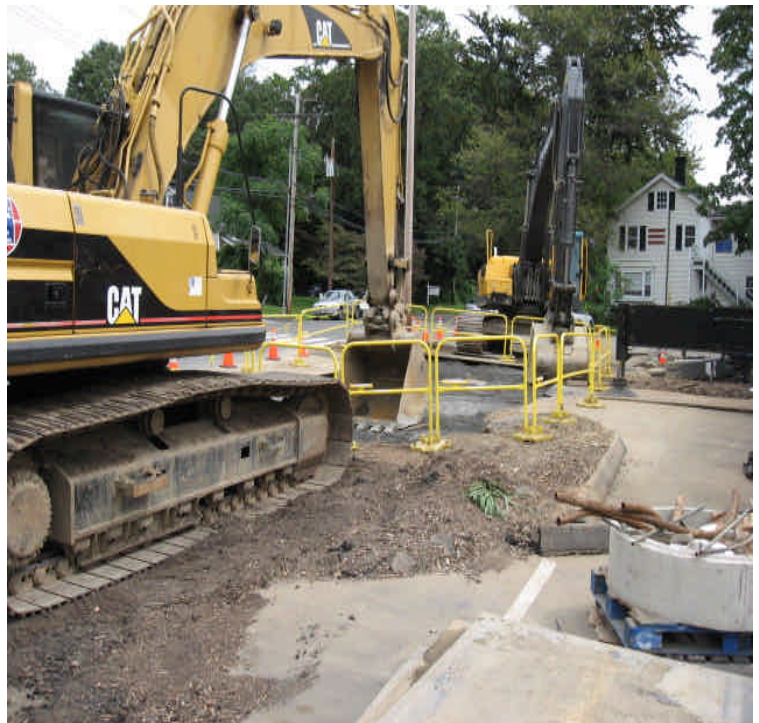
**Photograph of vault #6428 construction area on Old Post Rd. The trench is being backfilled.**
