Docket No. 272 – Development and Management Plan Inspection

Segment 4a Underground Line

Date: September 27, 2006 (night inspection)

Location: Singer Substation to Fairfield/Westport Town Line

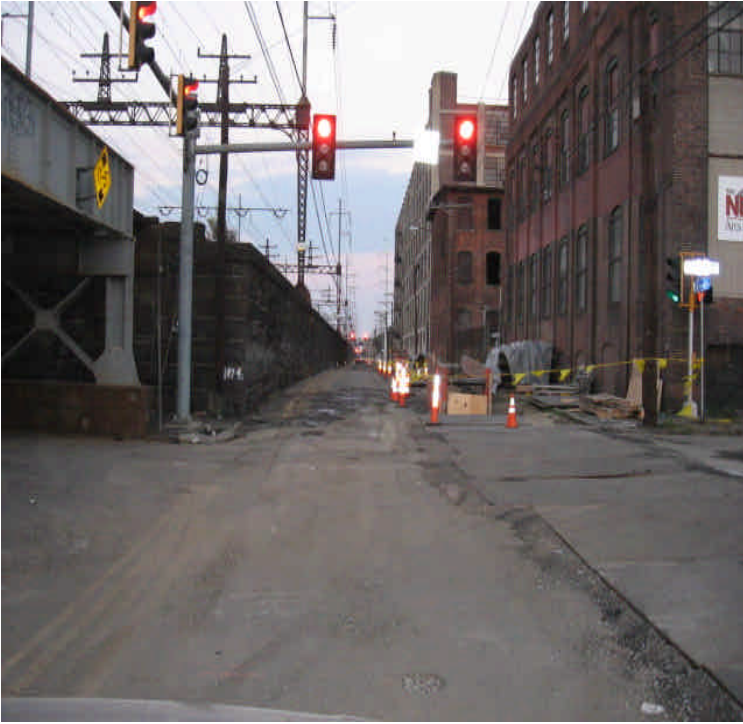
Photograph taken facing east of the intersection of Railroad Ave. and Hancock Ave.

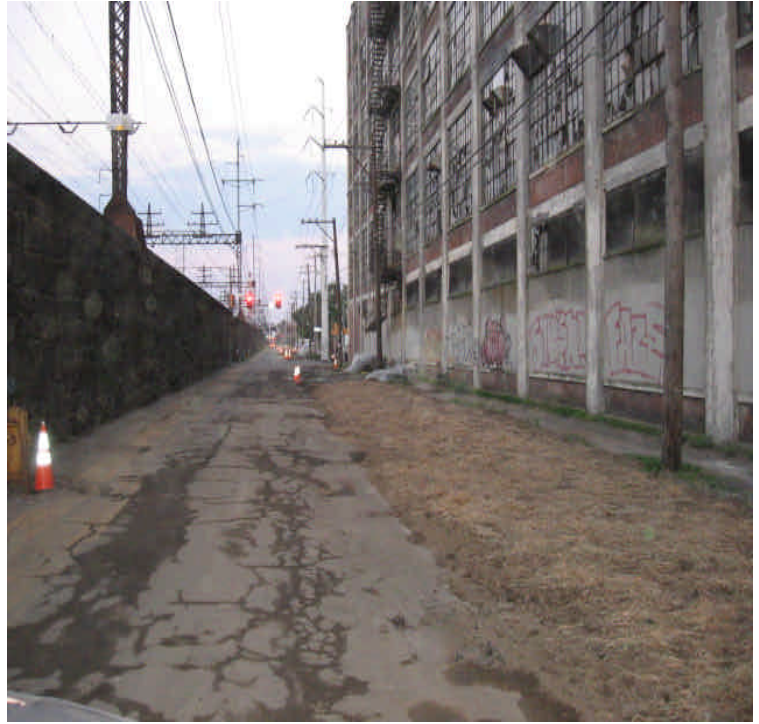
Photo taken facing east of the completed and restored trench area on Railroad Ave. between Hancock Ave and Howard Ave.

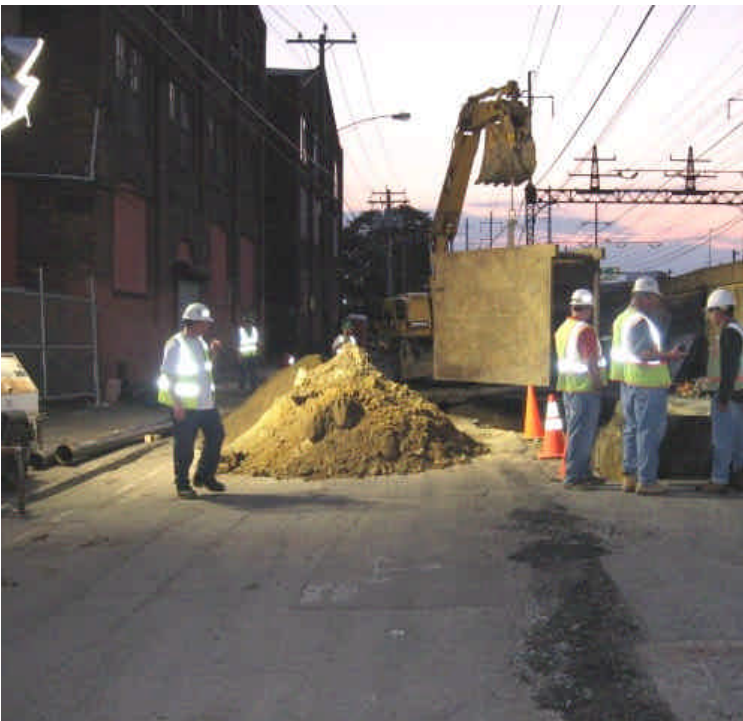
Photo taken facing west of utility work on Railroad Ave. Soil pile will be used to backfill the trench, any remaining soil should be properly disposed of.

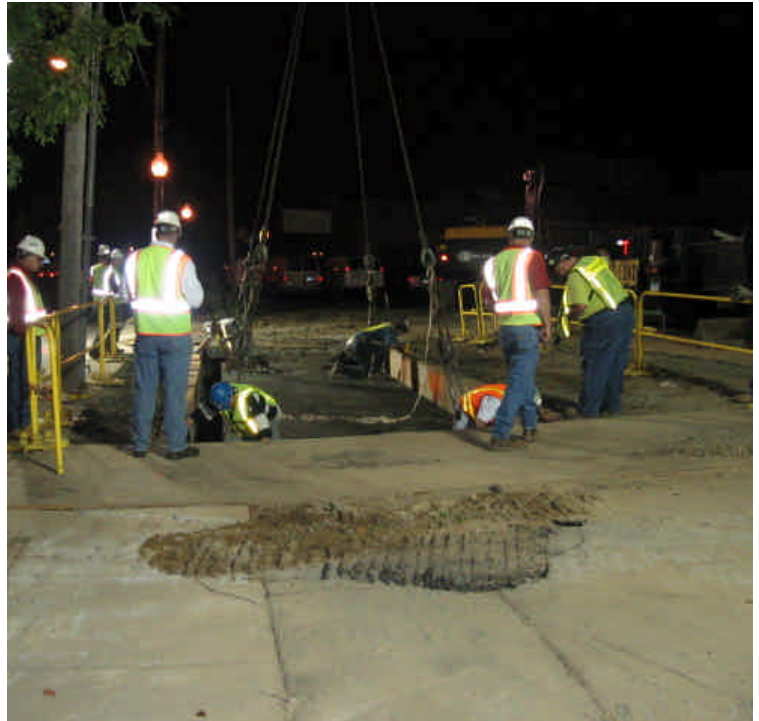
Photo of Vault #7439 in Bridgeport being lowered into the trench.

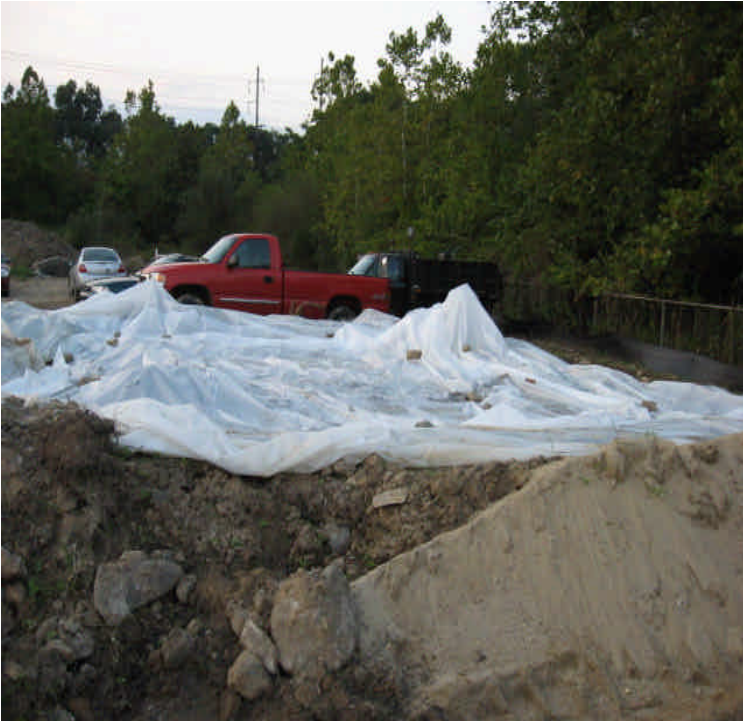
Abandoned concrete wash-out basin located in the Kings Highway laydown yard. The basin has been covered to discourage future use and prevent rainwater from mixing with the drying concrete

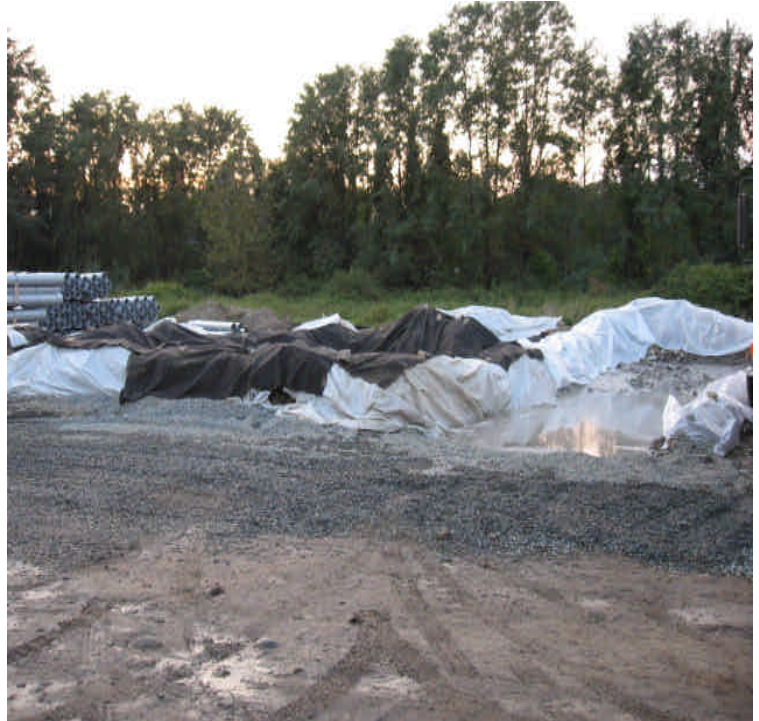
New concrete and sweeper wash-out basin located in the Kings Highway laydown yard. The basin is now properly lined.

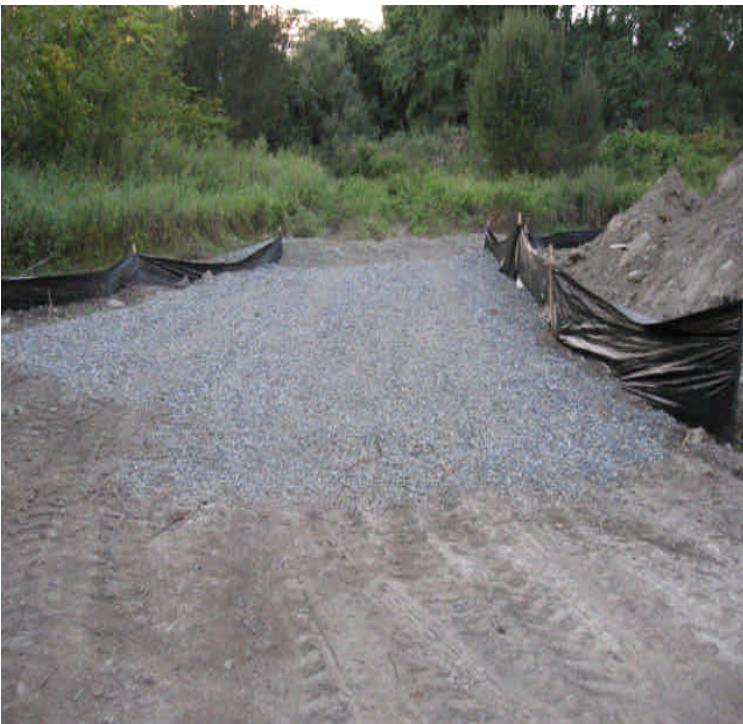
Photo showing stone berm that has been installed in the area that requires regular access by the Town of Fairfield in the Kings Highway laydown yard.

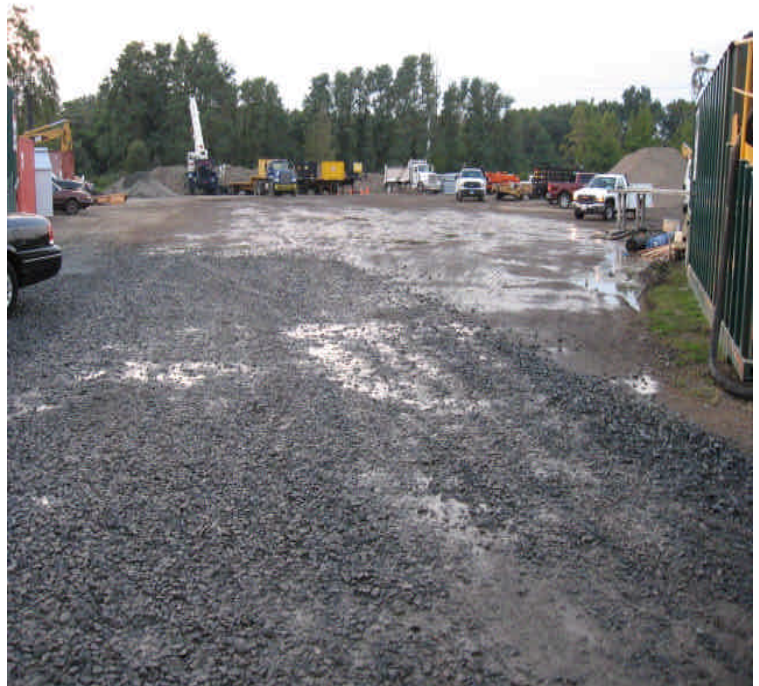
Photo of the Kings Highway laydown yard after soil surfaces were watered down before the mobilization of the night crews in an effort to prevent dust production.

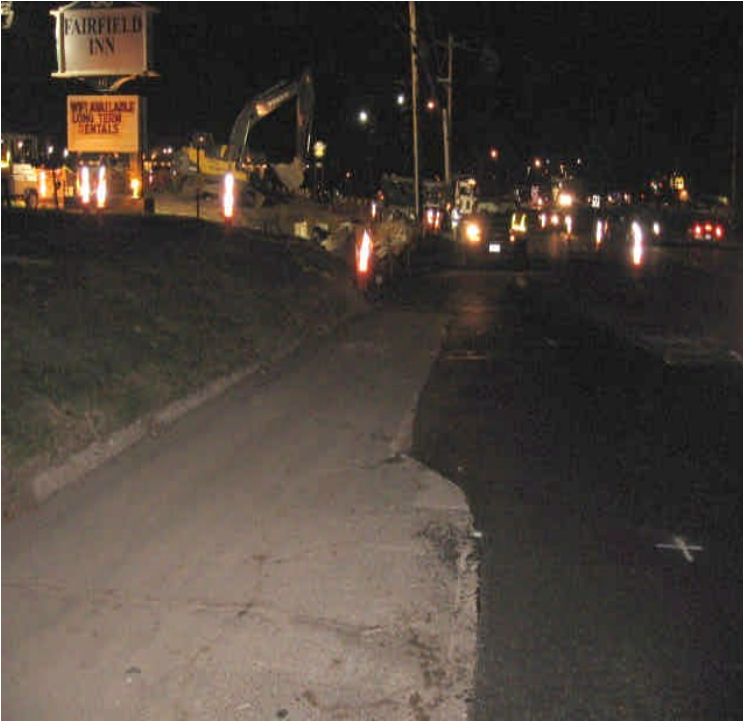
Photo of completed, as well as currently active, portions of trench work being conducted in front of the Fairfield Inn.

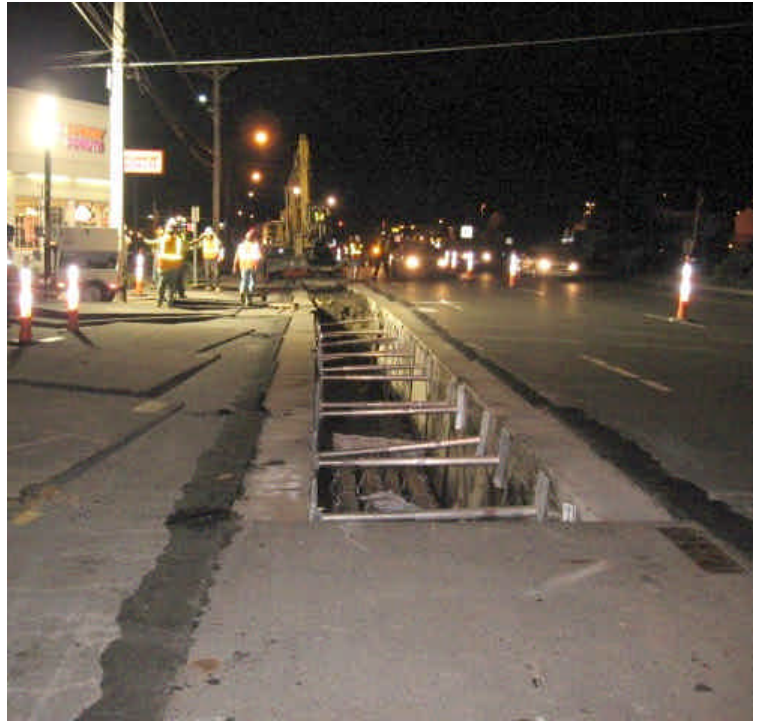
Photo taken facing west of trenching activities west of Old Post Rd.

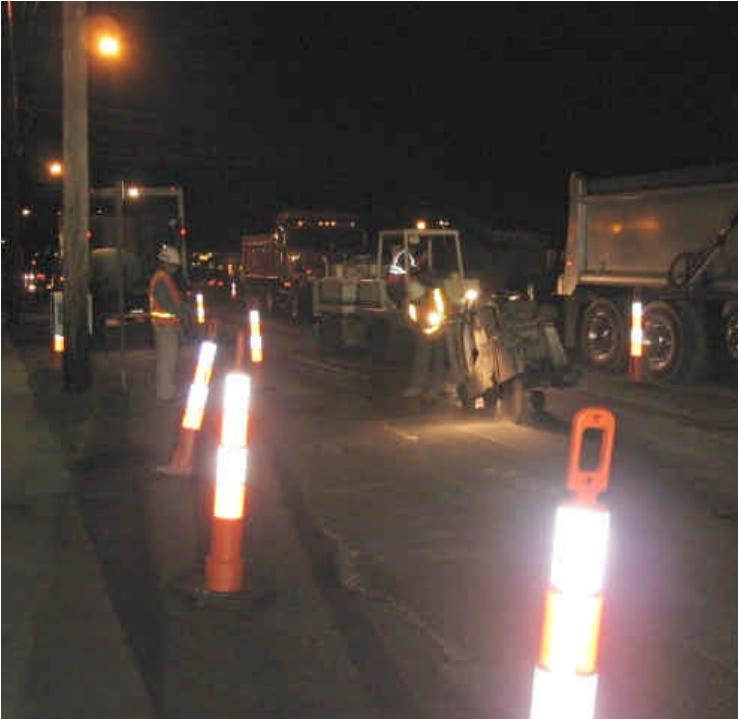
Photo of saw cutting activities along Rt. 1, west of Old Post Rd. Please note that the sweeper is immediately following saw cutting.

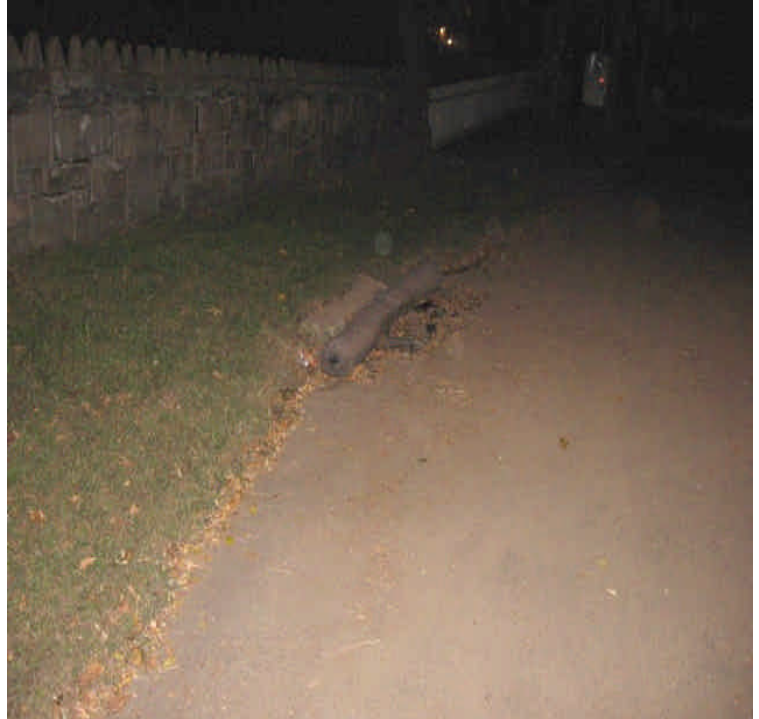
Catch basin properly protected in Old Post Rd. The inlet receives stormwater runoff from activities in front of the Fairfield Inn.

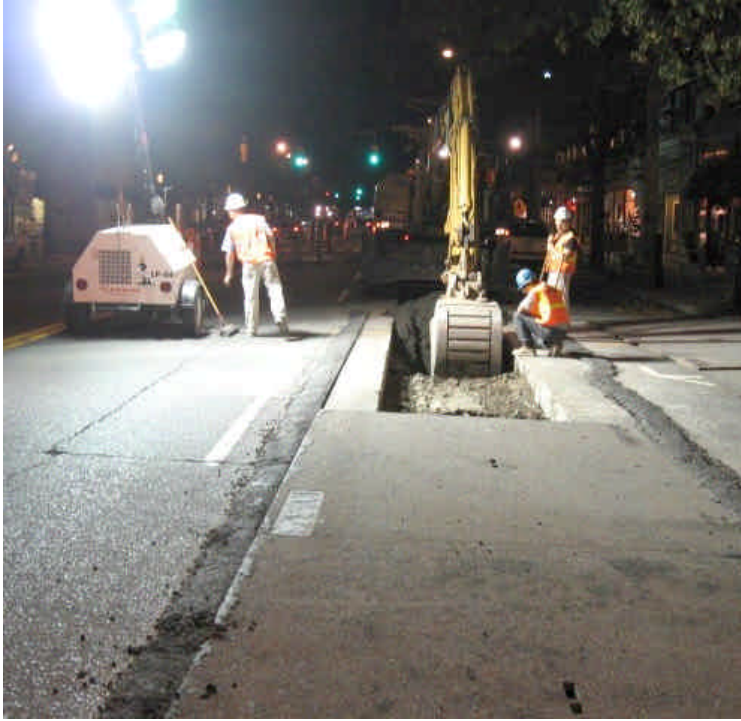
Photo taken of trenching activities on Rt. 1 between Round Hill Round Hill Rd. and Unquowa Rd.

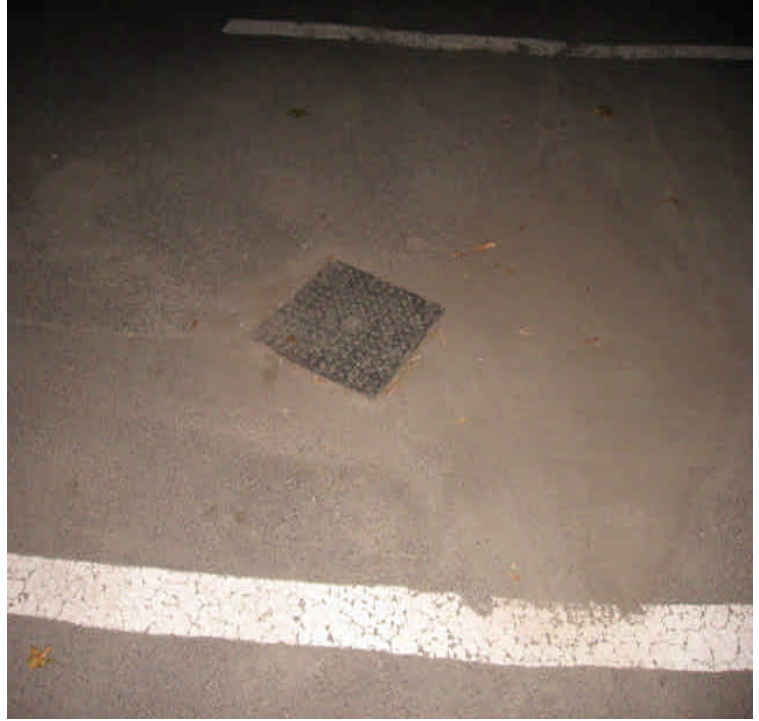
Catch basins located in the parking area adjacent to Vault #6428. Excess sediment has been removed from around the inlet.

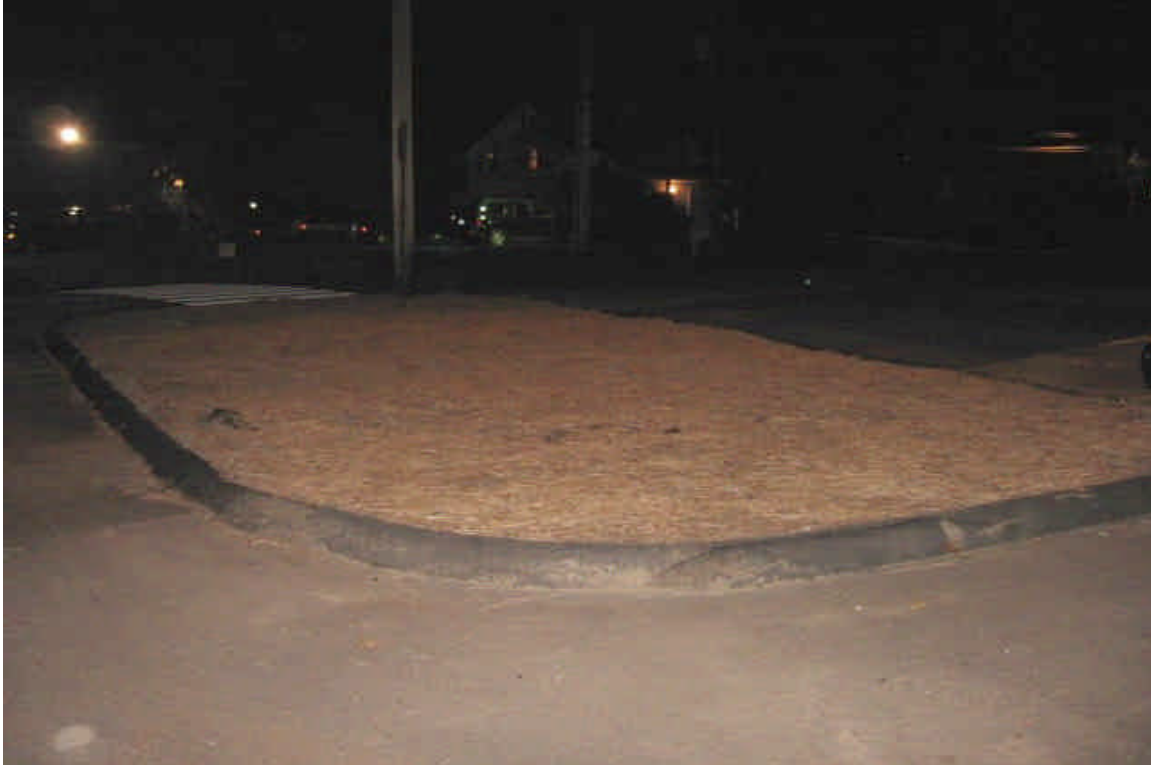
Island within parking area adjacent to Vault #6428 that has been restored and stabilized with hay mulch.
