Docket No. 272 – Development and Management Plan Inspection

Segment 4a Underground Line

Date: October 4, 2006

Location: Singer Substation to Fairfield/Westport Town Line

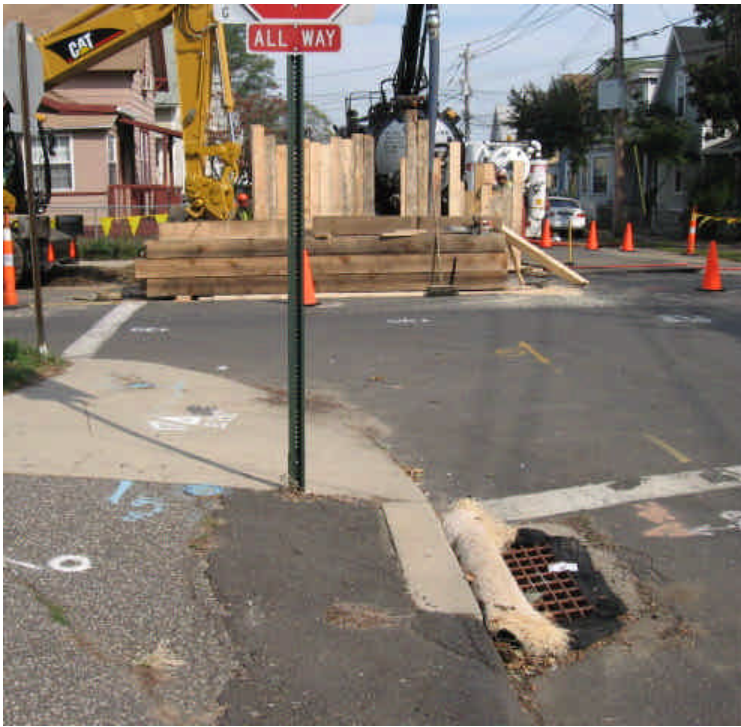
Trenching activities at the intersection of Atlantic Ave. and Broad St. Please note protected catch basin.

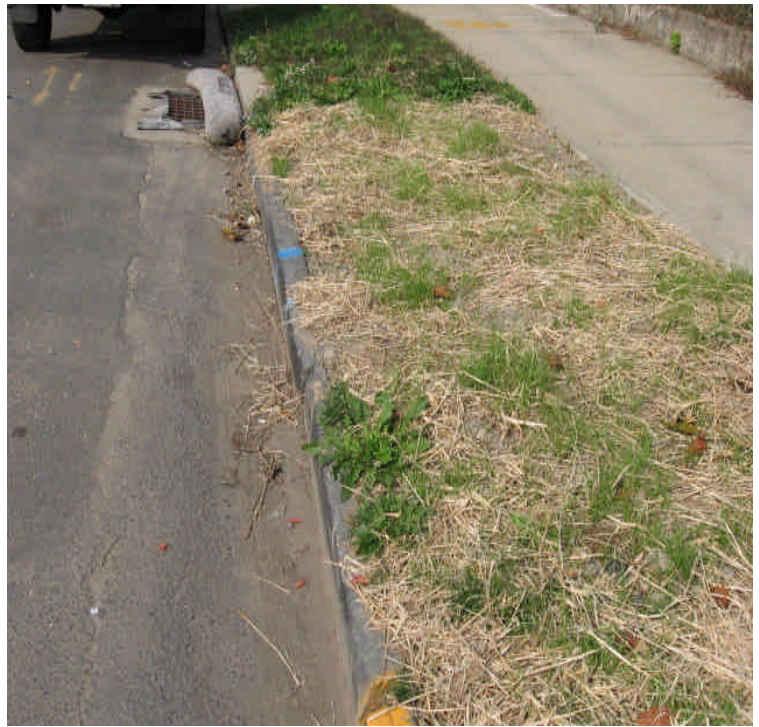
Location of previously excavated area for utility work on Broad St. Please note that grass is starting to establish in the area.

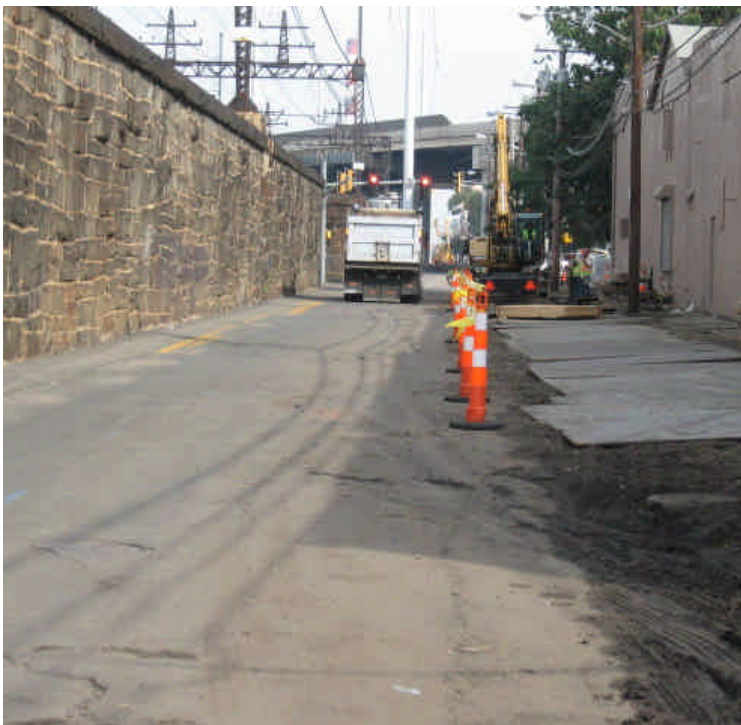
Trenching work on Railroad Ave. between Iranistan Ave. and Howard Ave.

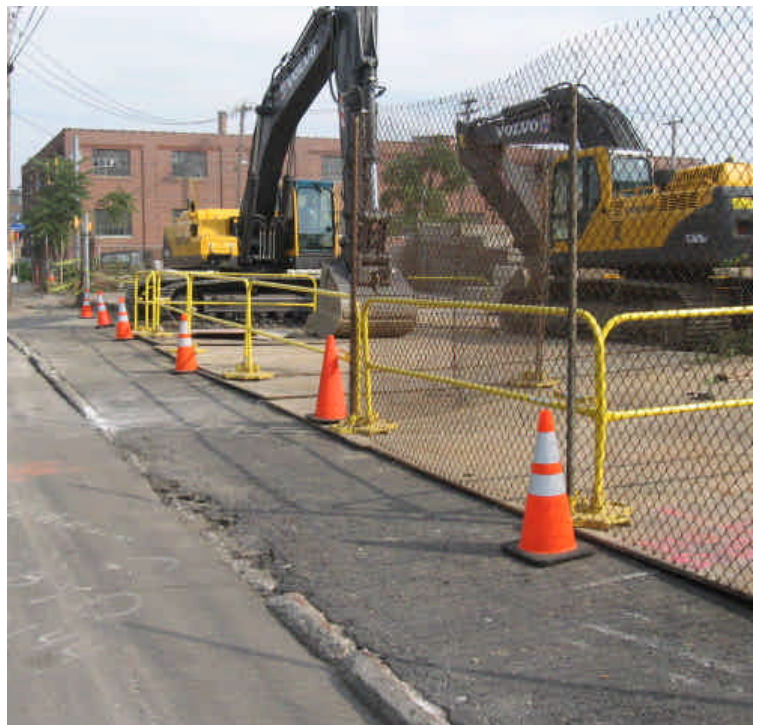
Area prepared for the installation of Vault # 7546 on Railroad Ave., north of Bostwick Ave.

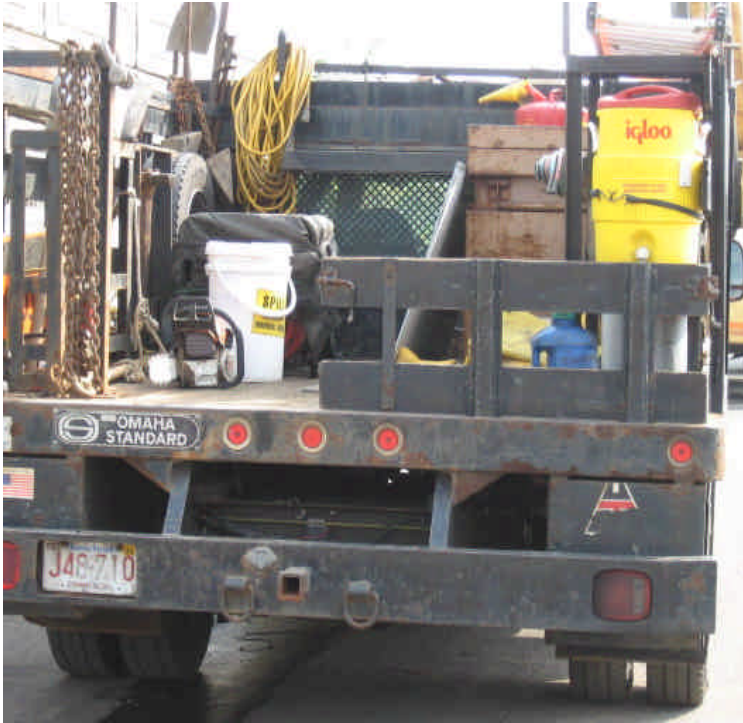
Photograph of spill kit located on the back of a contractor truck.

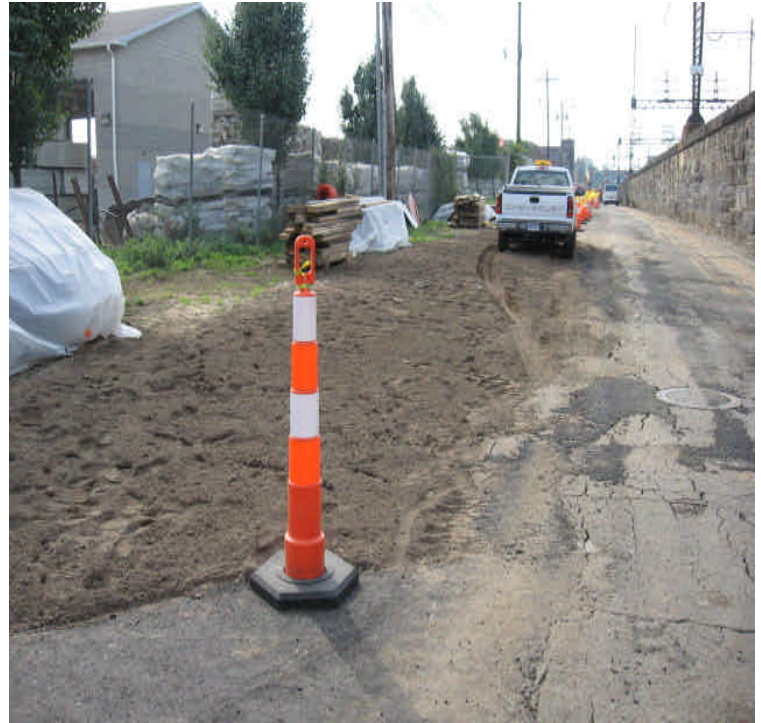
Portion of backfilled trench along Railroad Ave. near Howard Ave. It is anticipated that the area will be seeded and mulched within the week.

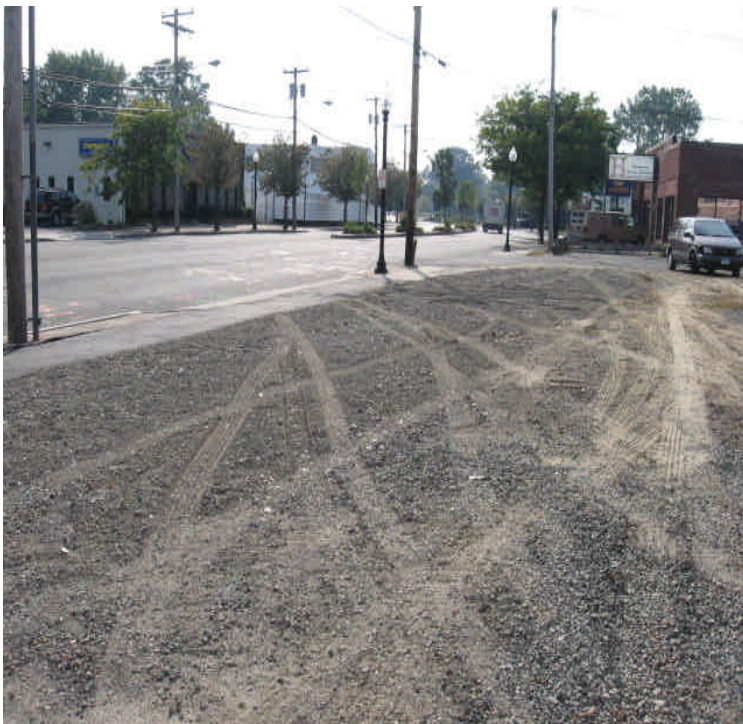
Location of Vault # 7539 which was installed last week.

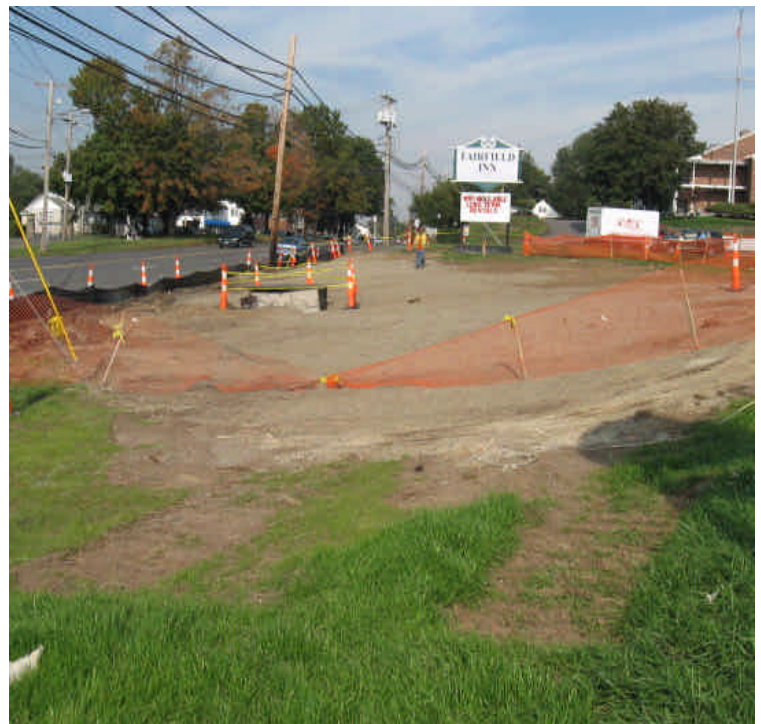
Photograph of site conditions off Rt. 1 in front of the Fairfield Inn. Erosion controls are in good shape here.

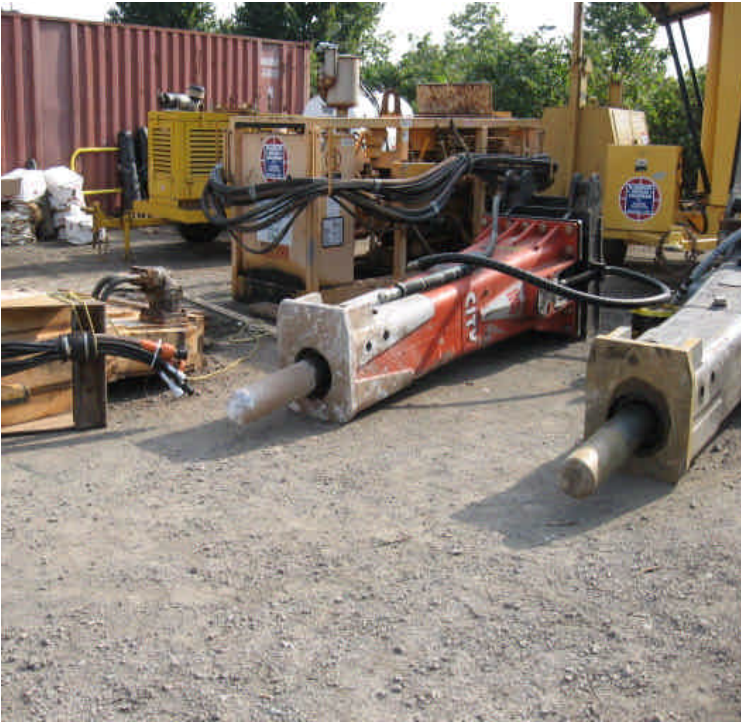
Attachments with fluid-filled hoses are being stored in the yard. In an effort to contain potential spills, equipment could be stored on pads or similar in case of leaks or breakages.

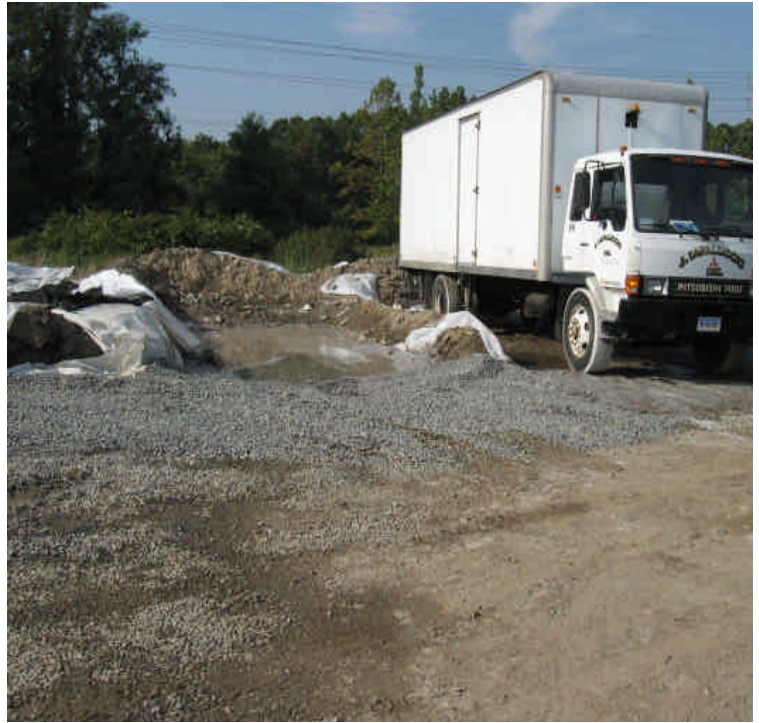
Sweeper washout area is not containing all of the washout materials to the basin. Run-off (potentially saw cutting cast-off) is located under, and in front of the right front tire of the box truck.

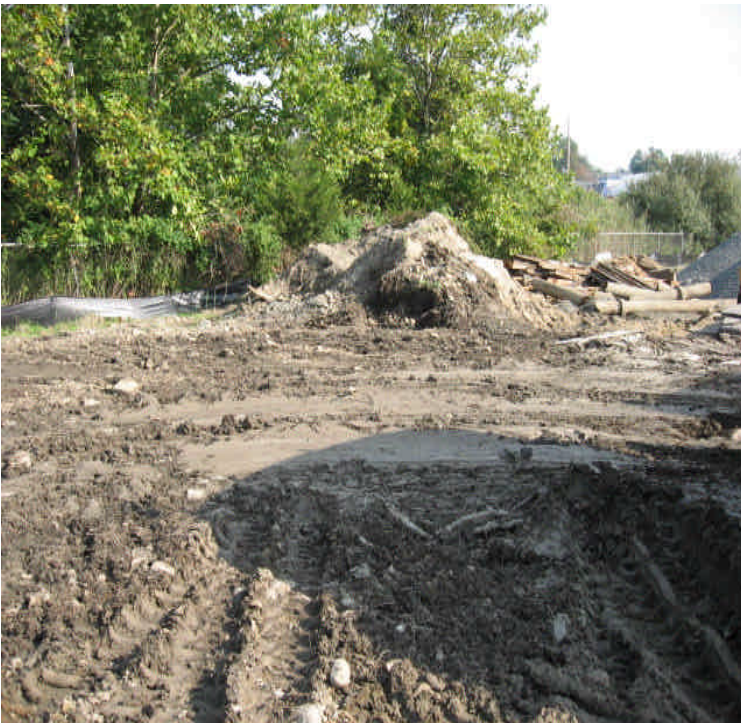
Previous location of original concrete washout basin. The soil pile should be located away from the perimeter fence

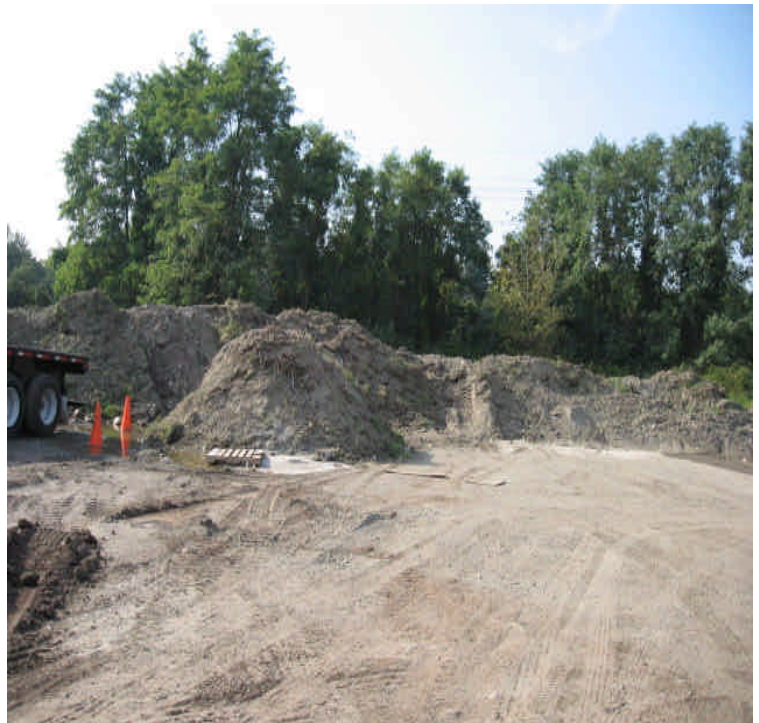
Inactive soil piles within the yard. If the resulting soil piles have been or will be inactive for 30 days they should be seeded appropriately to control dust production.
