Docket No. 272 – Development and Management Plan Inspection

Segment 4a Underground Line

Date: October 20, 2006

Location: Singer Substation to Fairfield/Westport Town Line

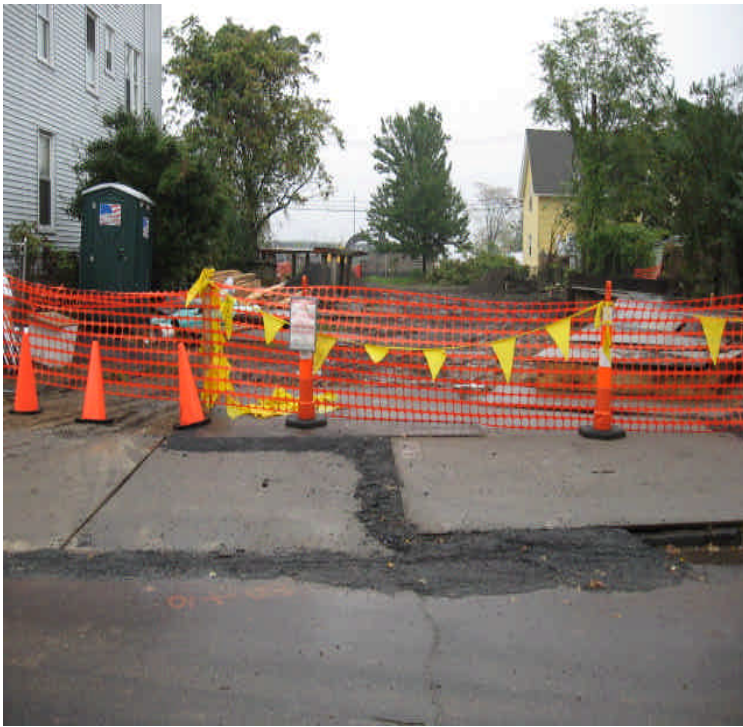
Former location of garage/shed on Broad St. that has been removed for utility installation.

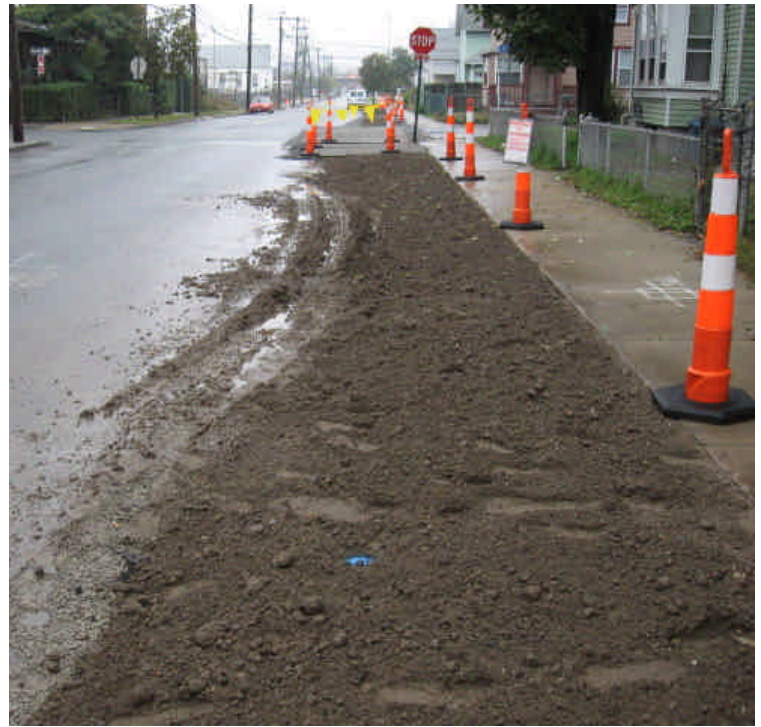
Former trench location that has been backfilled and loamed. The area should be temporarily stabilized with mulch.

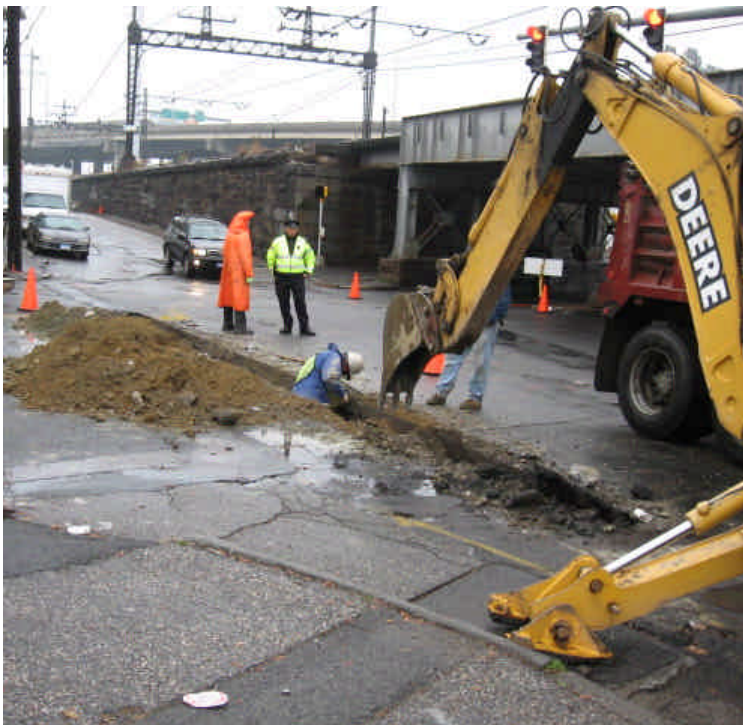
Photo of trenching activities at the intersection of Railroad Ave. and Park Ave.

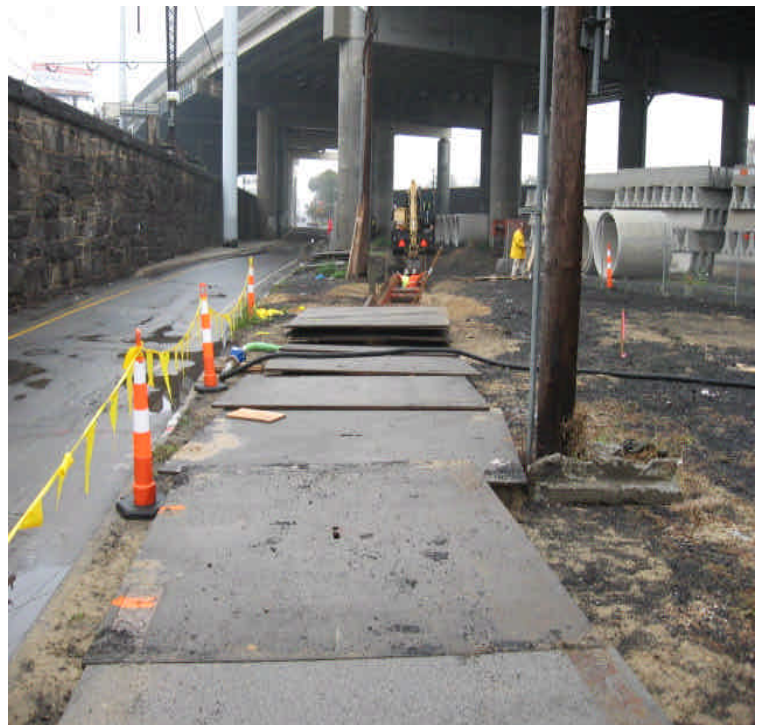
Trenching activities on Railroad Ave. near its intersection with Iranistan Ave. Area to the right is being used to temporarily store materials and frac tanks.

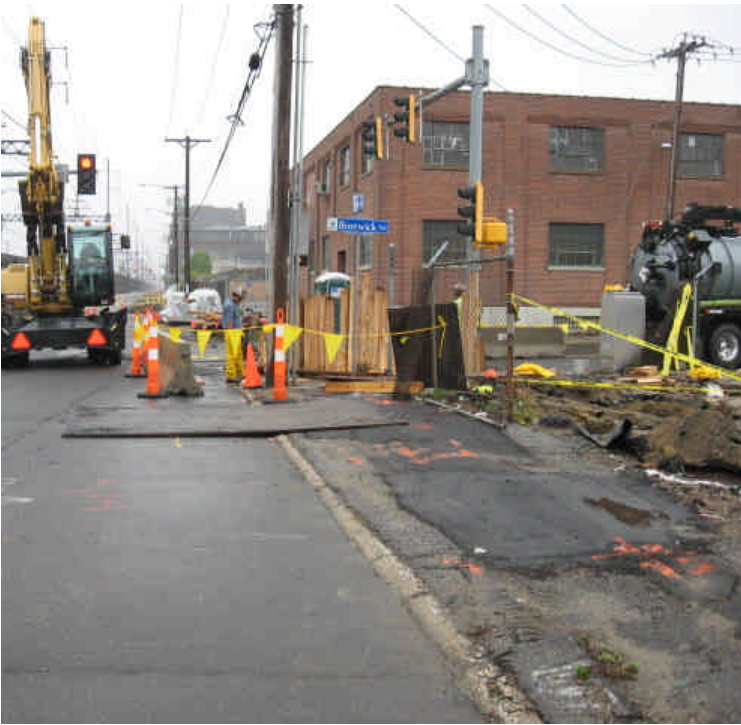
Trenching activities at the intersection of Railroad Ave. and Bostwick Ave. Vac truck is being used to excavate around utilities.

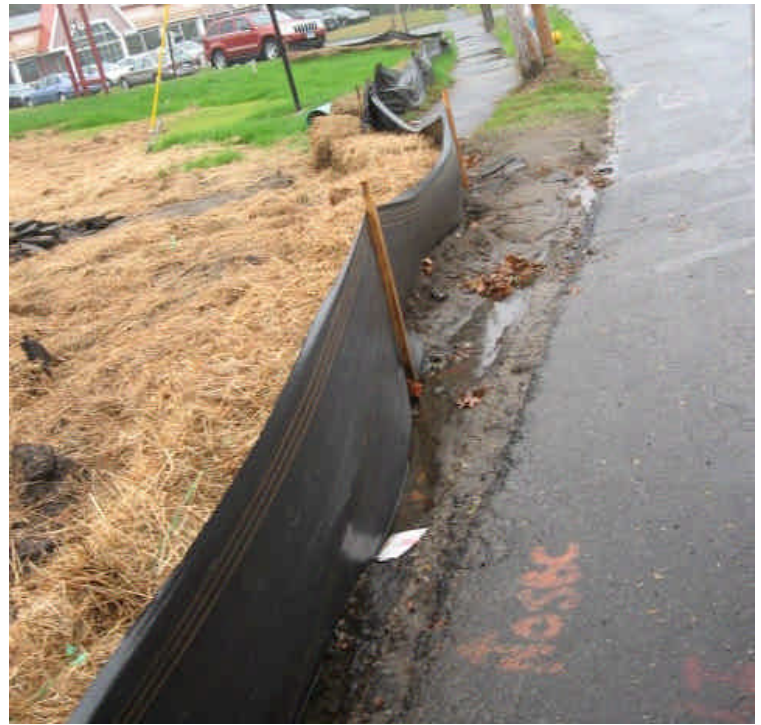
Photo of Rt. 1 in front of Fairfield Inn. Sediment in roadway has been removed. Eroded area remains between the roadway and the silt fence to be stabilized.

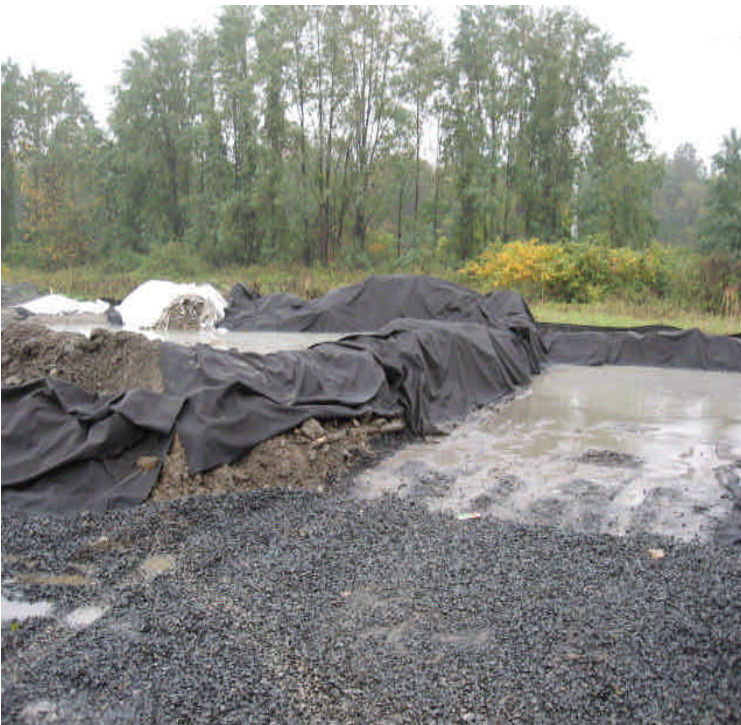
Sweeper washout area located in the Kings Highway Laydown has been re-established so that all washout materials are contained.

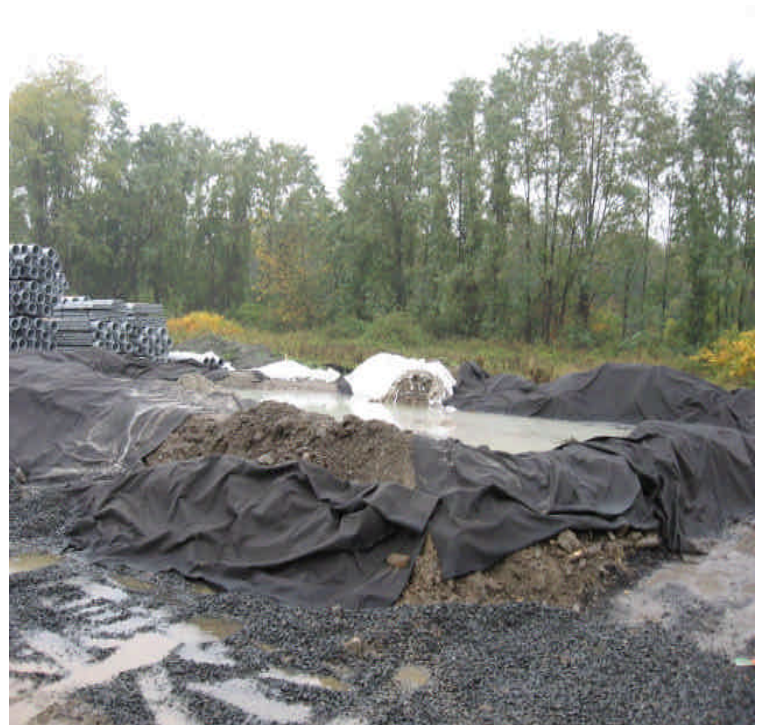
Concrete washout basin located in the Kings Highway Yard Laydown is near capacity and should be emptied when possible.
