**Docket No. 272 – Development and Management Plan Inspection**

**The Connecticut Light and Power Company Certificate of Environmental Compatibility and Public Need for the construction of a new 345-kV electric transmission line and associated facilities between Scovill Rock Switching Station in Middletown and Norwalk Substation in Norwalk, Connecticut, including reconstruction of portions of existing 115-kV and 345-kV electric transmission line, the construction of Beseck Switching Station in Wallingford, East Devon Substation in Milford, (and Singer Substation in Bridgeport), modifications at Scovill Rock Switching Station and Norwalk Substation, and the reconfiguration of certain interconnections.**

**Segment 4a Underground Line**

**Date:** October 27, 2006

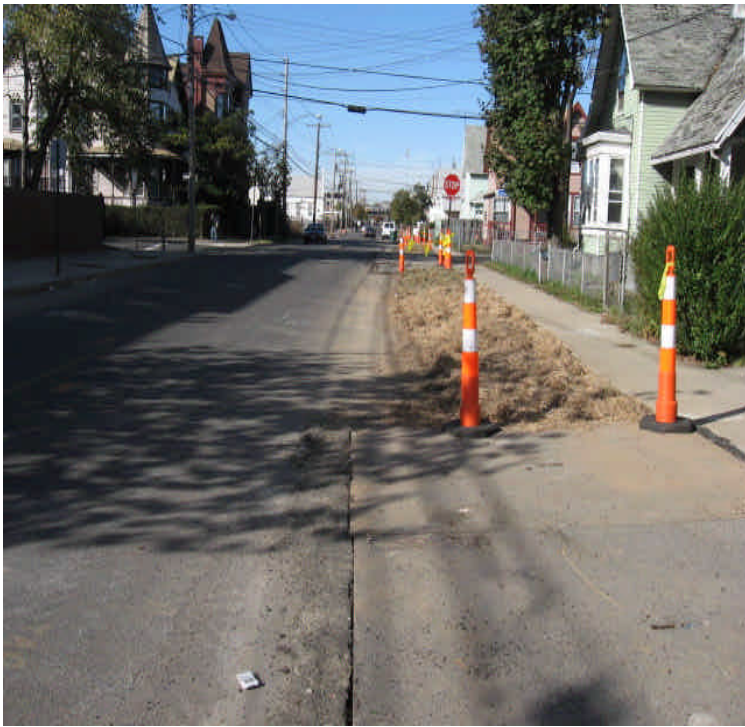
**Former trench location on Broad St. that has been temporarily stabilized with hay mulch.**

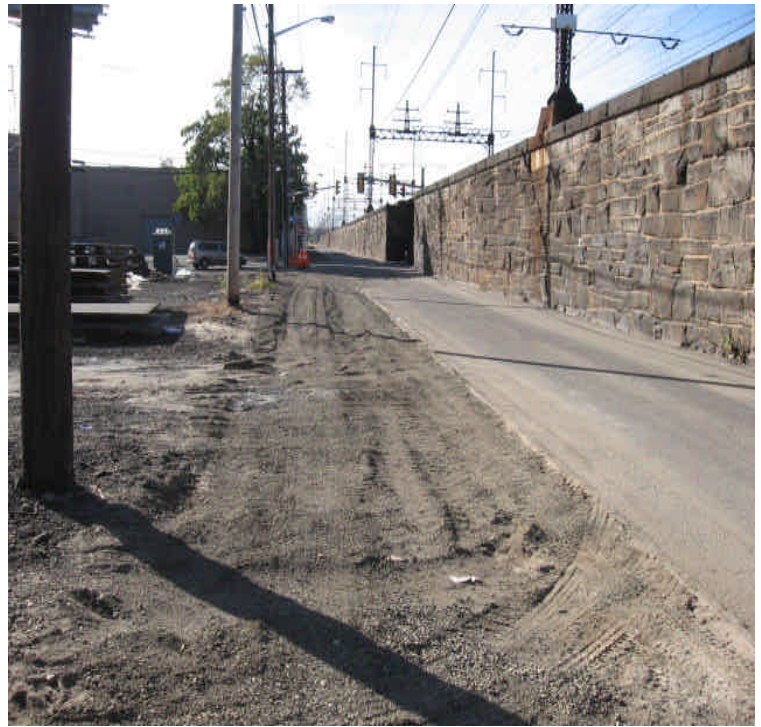
**Photo taken on Railroad Ave. at the corner of Iranistan Ave. Former trench location has been closed and stabilized with stone.**

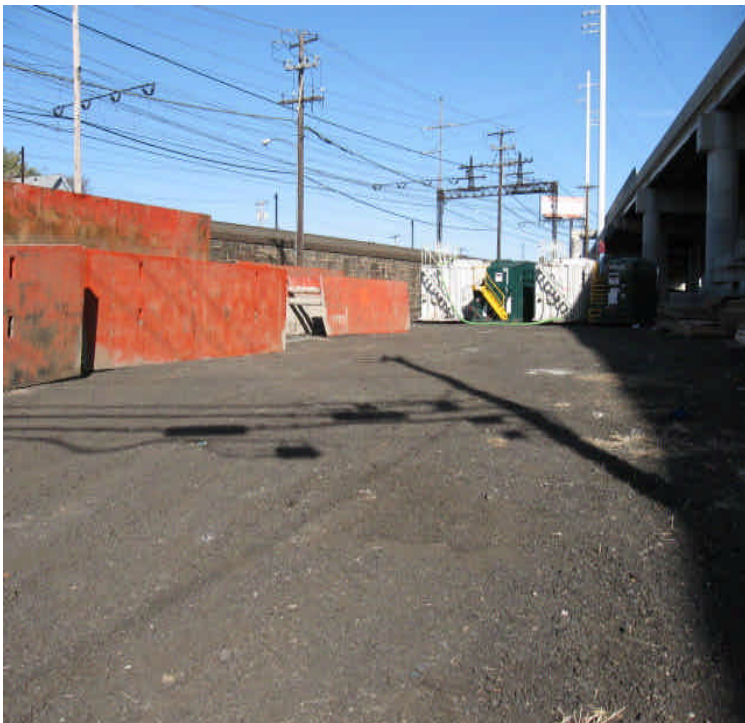
**Photograph of temporary storage yard at the corner of Railroad Ave.**

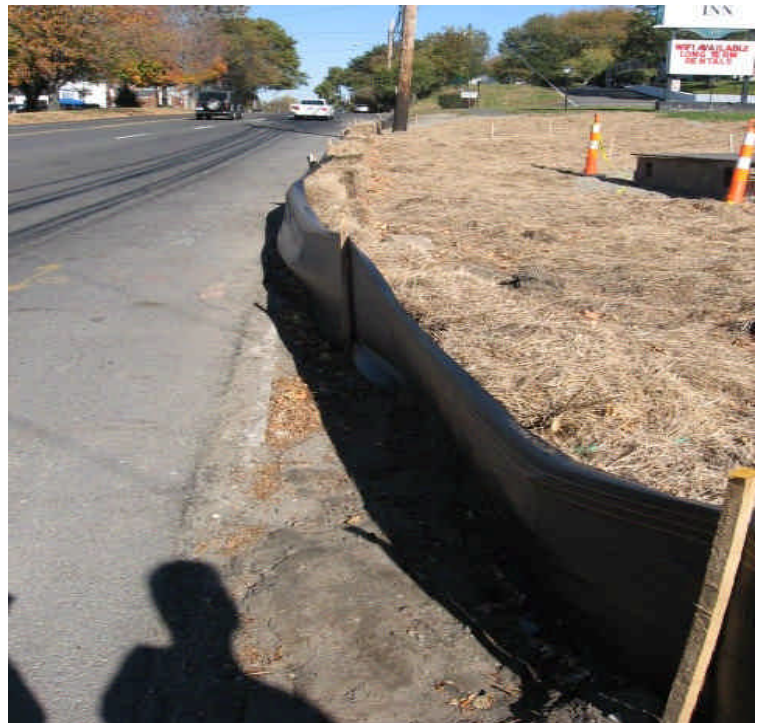
**Photo of Rt. 1 and the Fairfield Inn construction area that previously experienced erosion. Area should be monitored during rain events to prevent any additional sedimentation.**

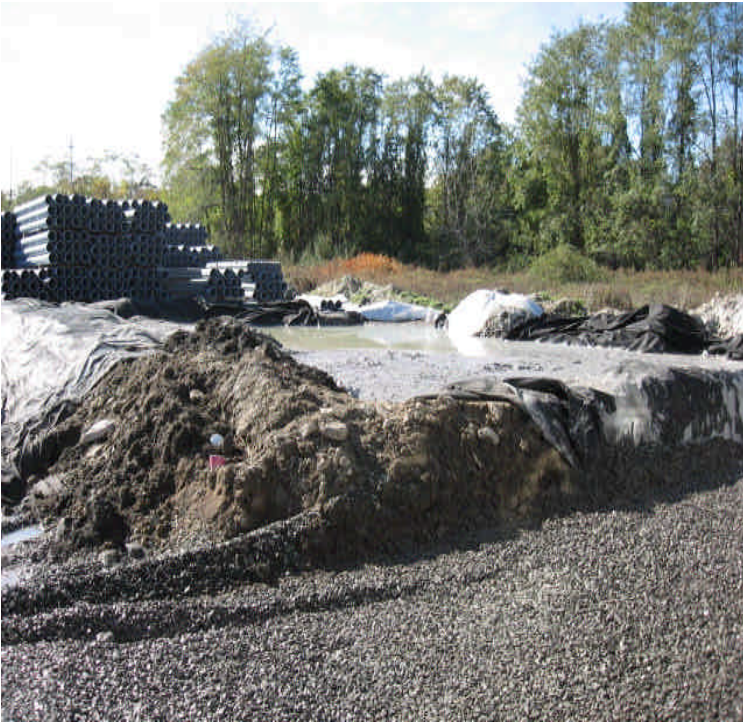
**Concrete washout basin located within yard that is near capacity.**

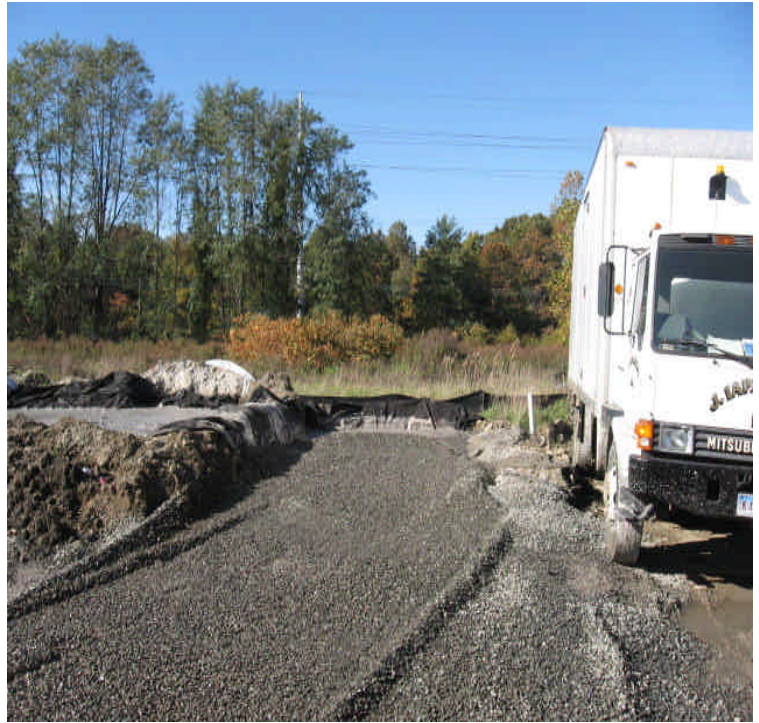
**Sweeper washout area within yard is being contained.**

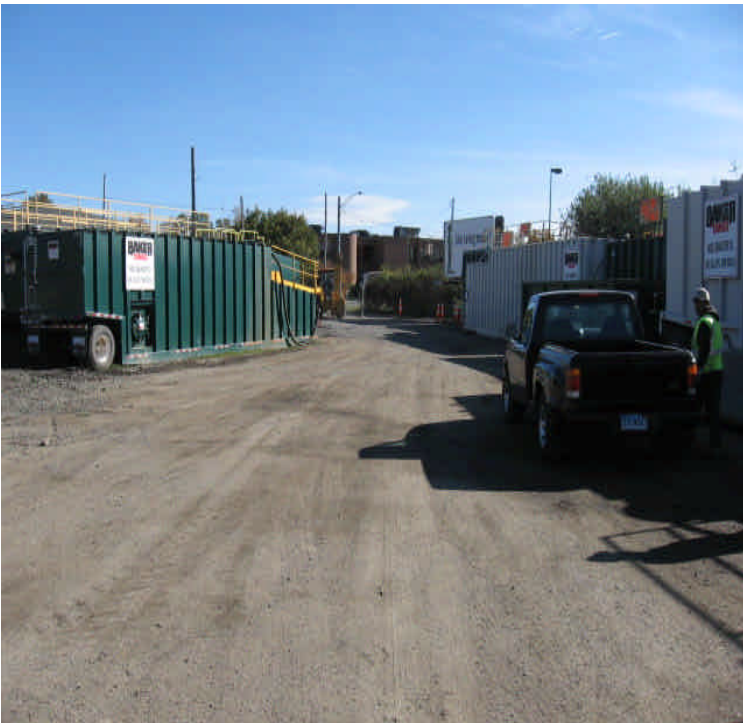
**Photo taken looking towards entrance of yard.**

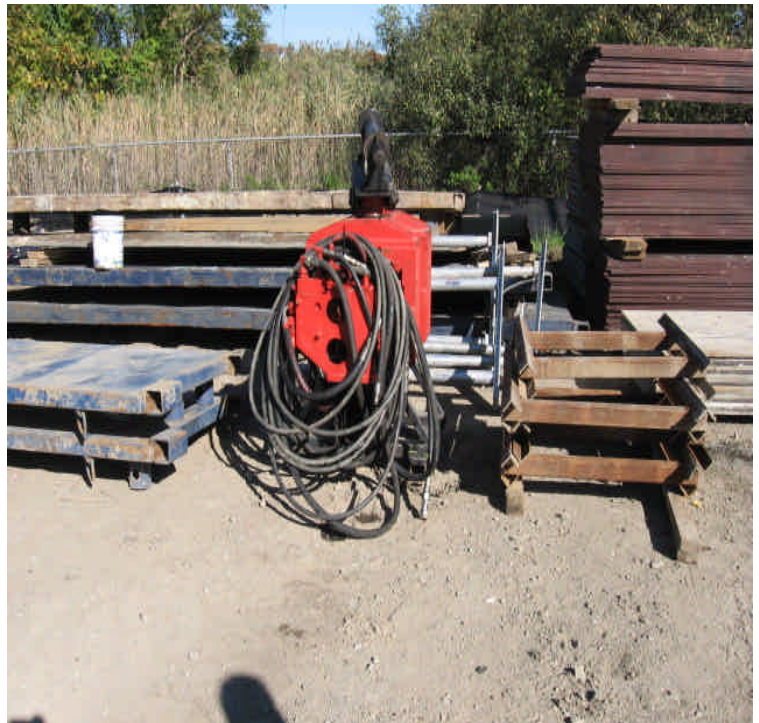
**Fluid-filled equipment/attachments located in the yard. The equipment is leaking and is not contained.**
