Docket No. 272 – Development and Management Plan Inspection

Segment 4a Underground Line

Date: November 1, 2006 (Evening inspection)

Location: Singer Substation to Fairfield/Westport Town Line

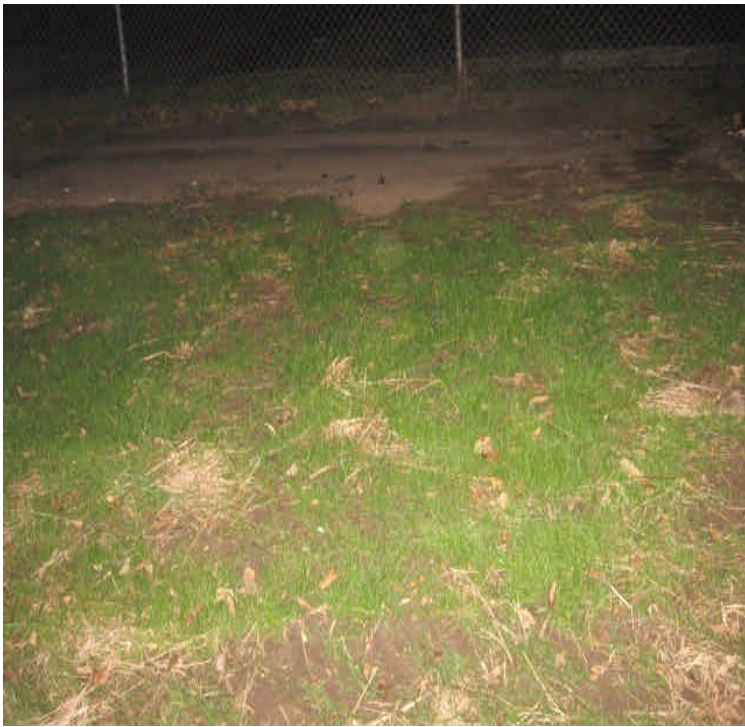
Former trench location on Railroad Ave that has temporarily stabilized with grass.

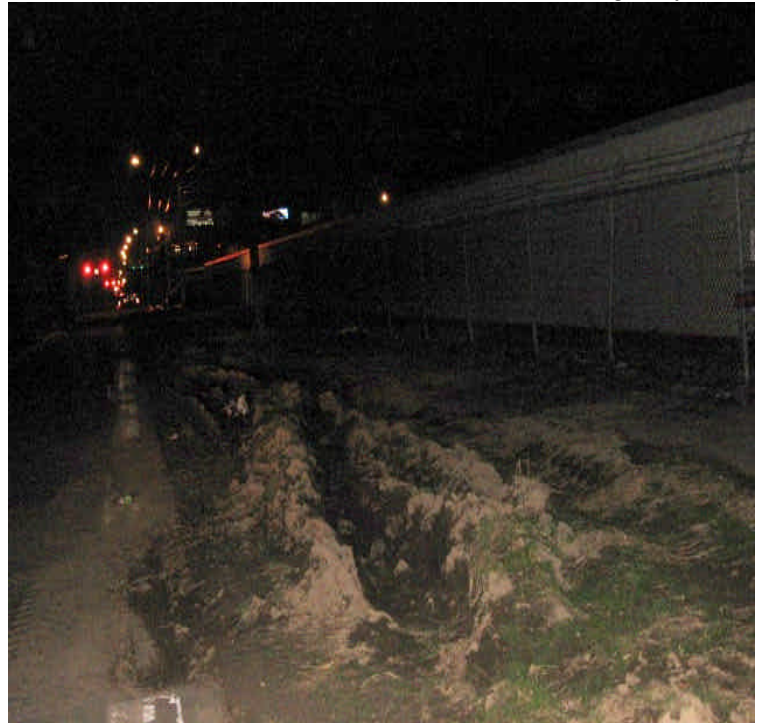
Photograph taken on Railroad Ave. near its intersection with Wordin Ave. of former trench location that has tire tracks. Tire ruts should be regraded and the area temporarily stabilized.

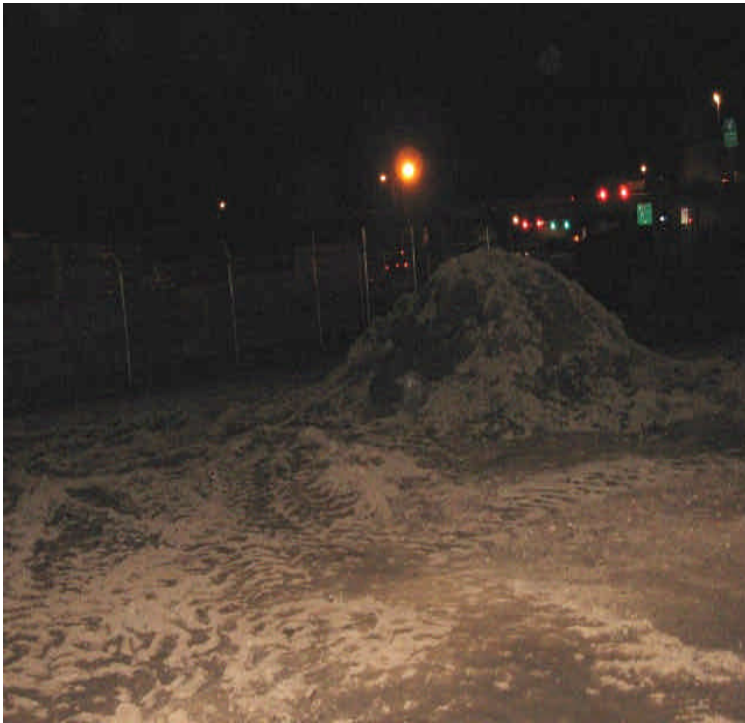
Photograph of soil pile at the intersection of Railroad Ave. and Wordin Ave. If pile is to remain, it should be temporarily stabilized.

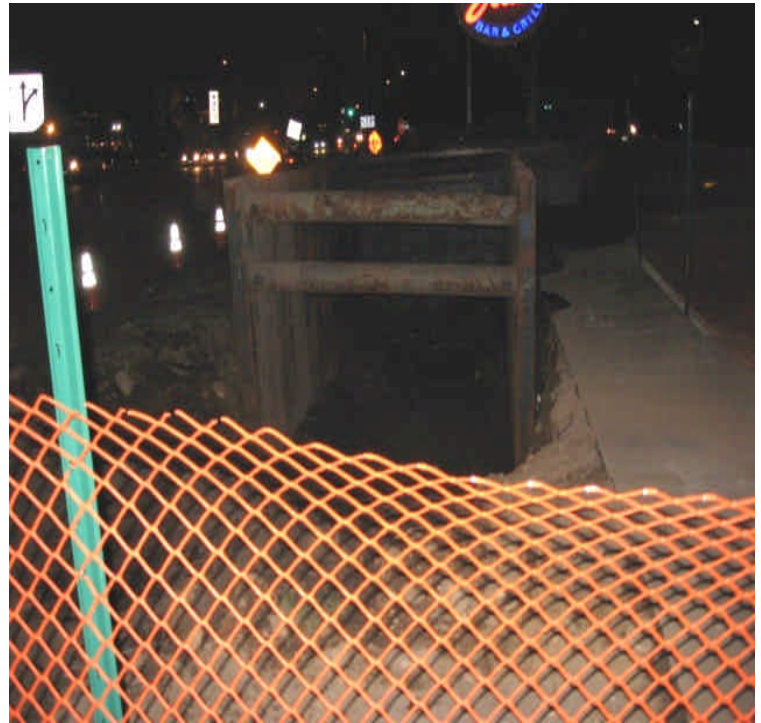
Vault #7536 construction. Four ornamental plum trees were removed for vault construction.

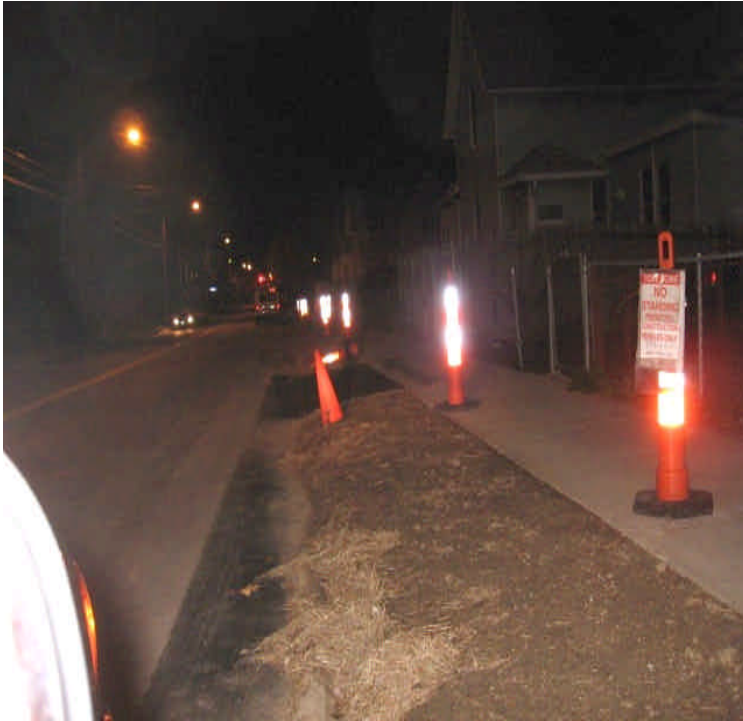
Former trench location on Broad Street that had hay mulch sparsely applied or that had blown away. Mulch should be re-applied and possibly tackified to protect exposed soils.

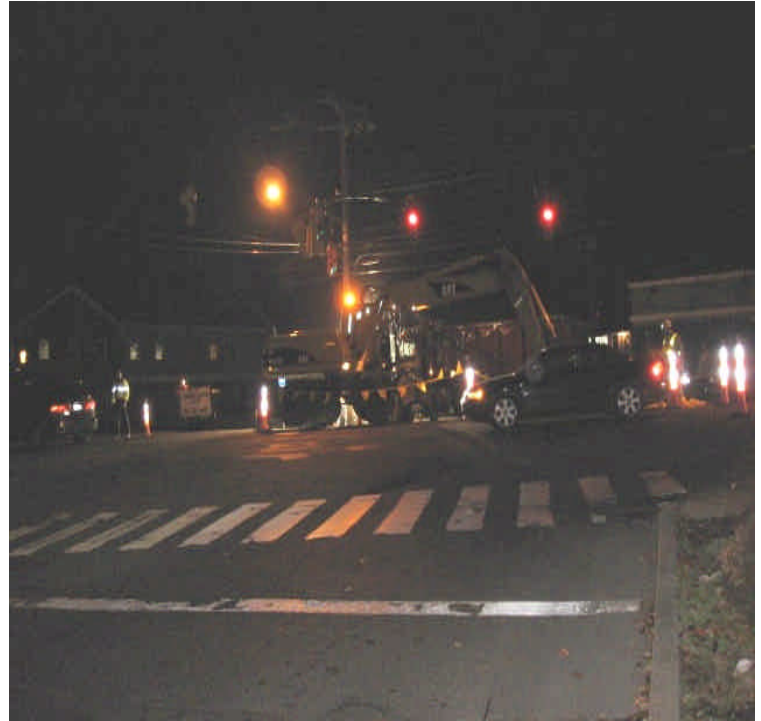
Photograph taken from Mill Plain Rd. of trenching activities of on Rt. 1. Just behind photo is an overpass with two unprotected catch basins on Mill Plain Rd. that need controls.

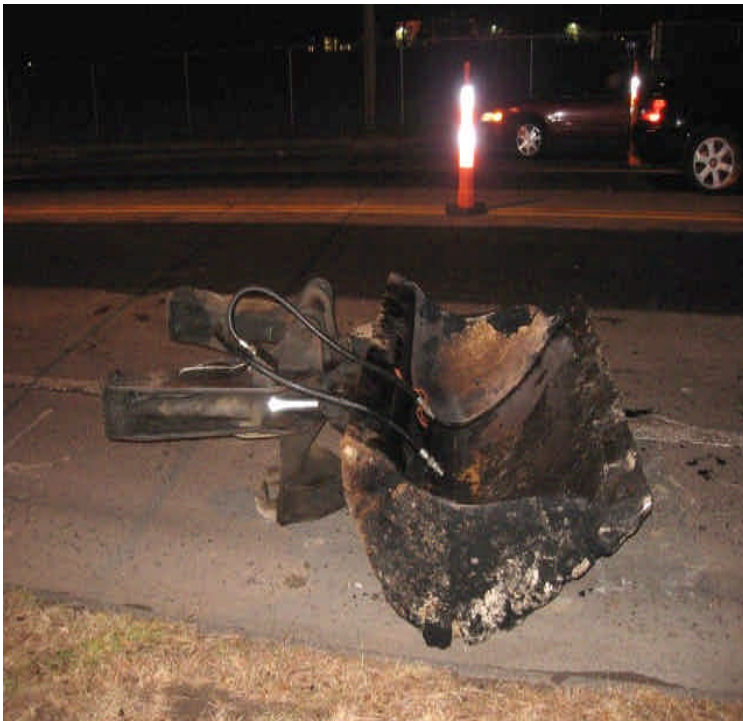
Photograph of unused bucket where hydraulic hoses were stored to contain any drips/leaks of fluids.

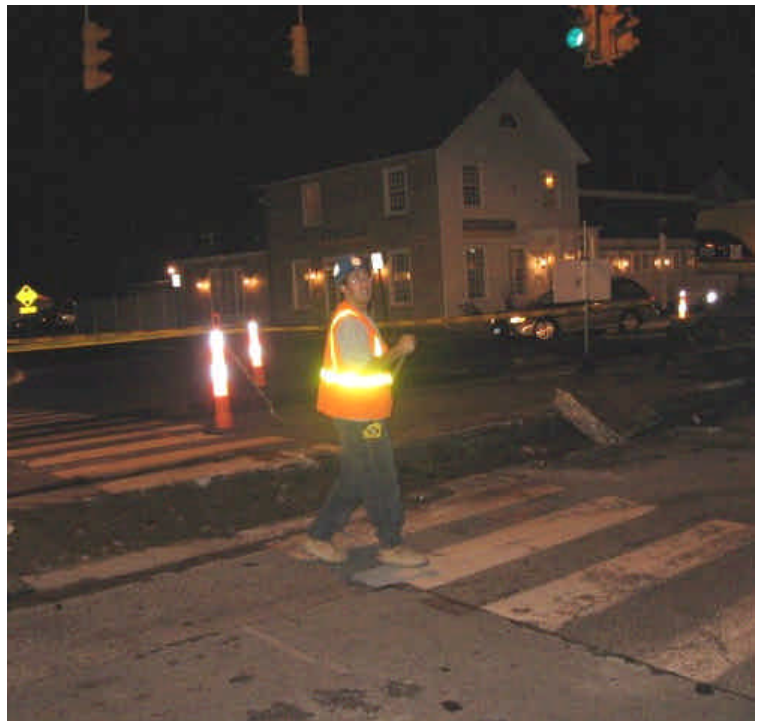
Photo of Rt. 1 trenching activities. Roadway being swept immediately following excavation of trench.

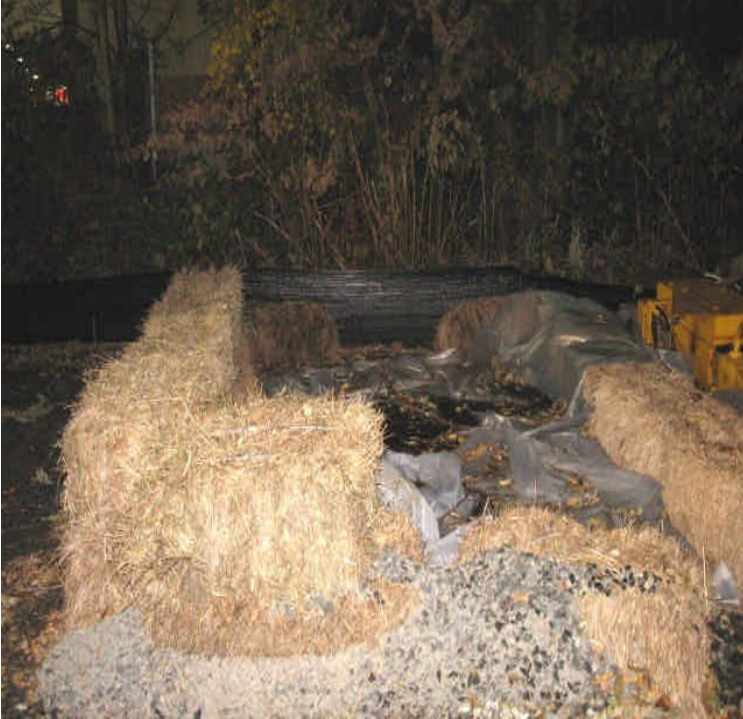
KING'S HIGHWAY LAYDOWN YARD

Fluid filled attachment containment area within yard. All equipment was in use at the time of inspection. Continue to store in a fully contained area.

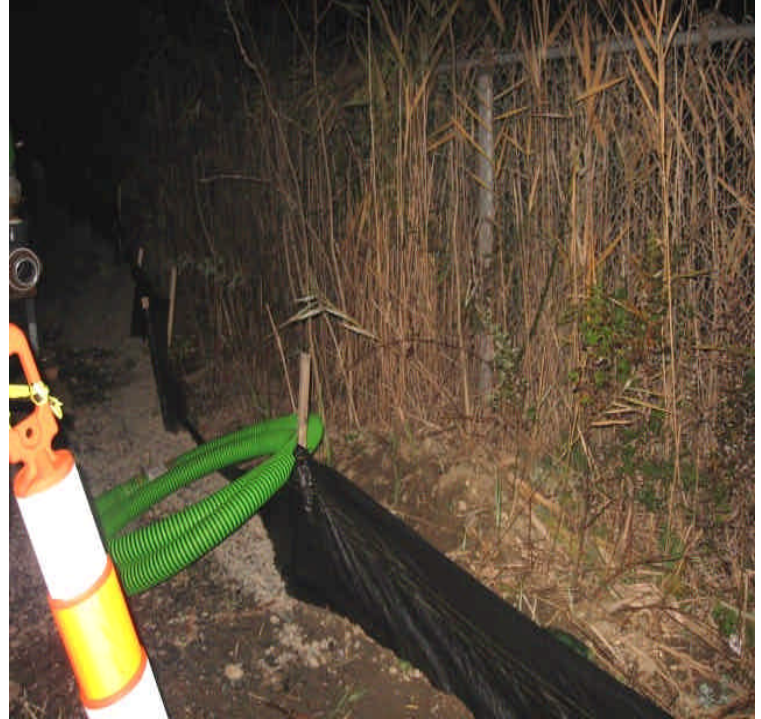
Erosion controls adjacent to resource area, and along the boundary of the yard are being compromised by stored materials.

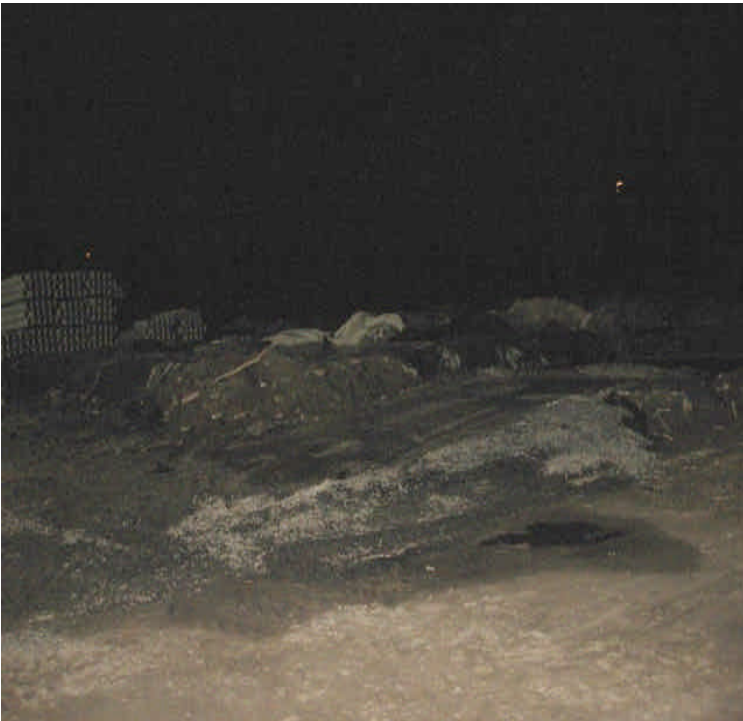
Sweeper washout area being overwhelmed and the concrete washout area is at capacity. All materials remain contained to the yard.

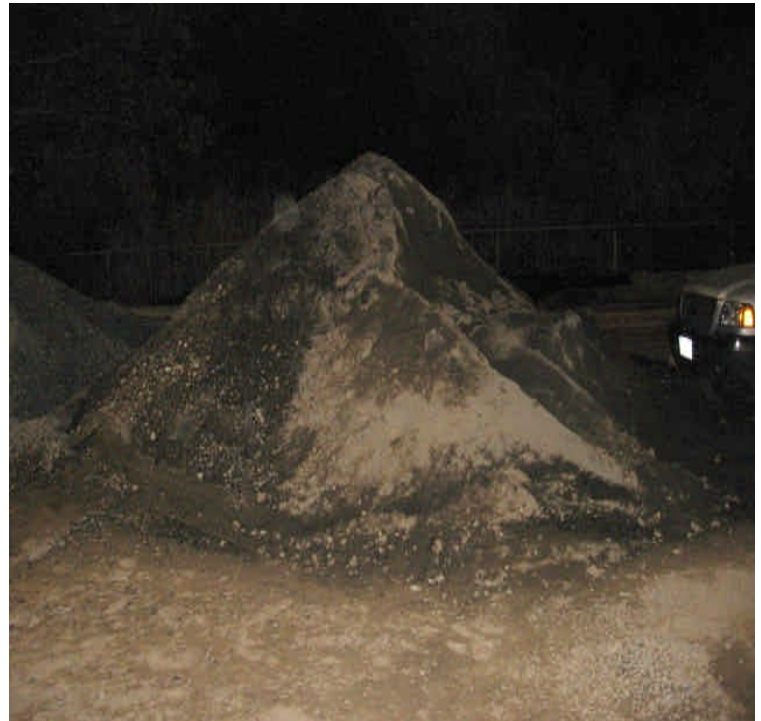
Stockpile being stored adjacent to site boundary/ perimeter fence near the resource area. Move further into the yard.
