Docket No. 272 – Development and Management Plan Inspection

Beseck Switching Station Inspection

Date: December 5, 2006

Location: Beseck Switching Station

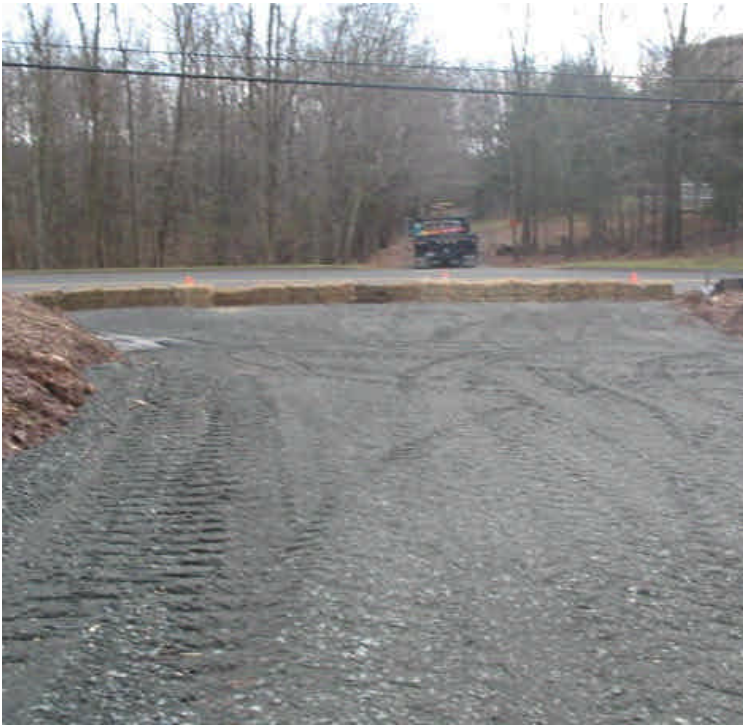
The new access drive has been graded. Silt fence was removed; haybales were installed to prevent run-off. 12/5/06	Controls are intact but significant amounts of exposed soil are present upgradient. Reinforce controls or add diversions	Continue to monitor.

New entrance off Carpenter Lane at final grade with haybale barrier in place.

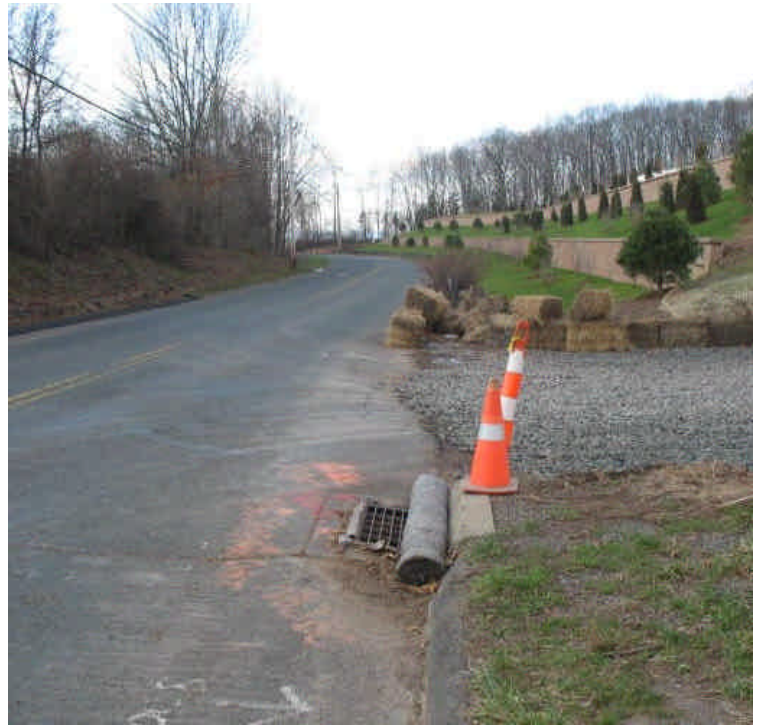
View of Carpenter Lane and retaining walls. No sediment was noted leaving the site entrance. Minor sediment was noted in the gutters.

Areas of Inspection	Observation	Recommended Action	Corrected Action
Access roads and adjacent roadways	All traffic leaving the site is using stone entrance on east side. Carpenter Lane had some minor sediment along the gutter. 12/5/06	Clean/sweep roadway regularly. Continue to monitor stormwater leaving the site; replace and add more controls as needed. Clean gutters by hand as needed. 12/5/06	NA.
	Stone access pad is clean. No turbid run-off was noted during this inspection. Turbidity seems to increase with truck traffic for deliveries etc. 12/5/06	Continue to maintain stone construction entrance. Determine how to prevent all run-off from reaching the road. Monitor haybales and replace or reposition as needed to filter run-off. Evaluate additional containment. 11/20-12/5/06	Continue to evaluate.
	Minor sediment was noted at the culvert under the ROW access road. It was well contained within the sediment trap. 12/5/06	This area will still require regular attention by all contractors (BSS and 1A) to reduce sediment tracking. Maintain basin/traps and haybales at the outlet when necessary. 12/5/06	NA.

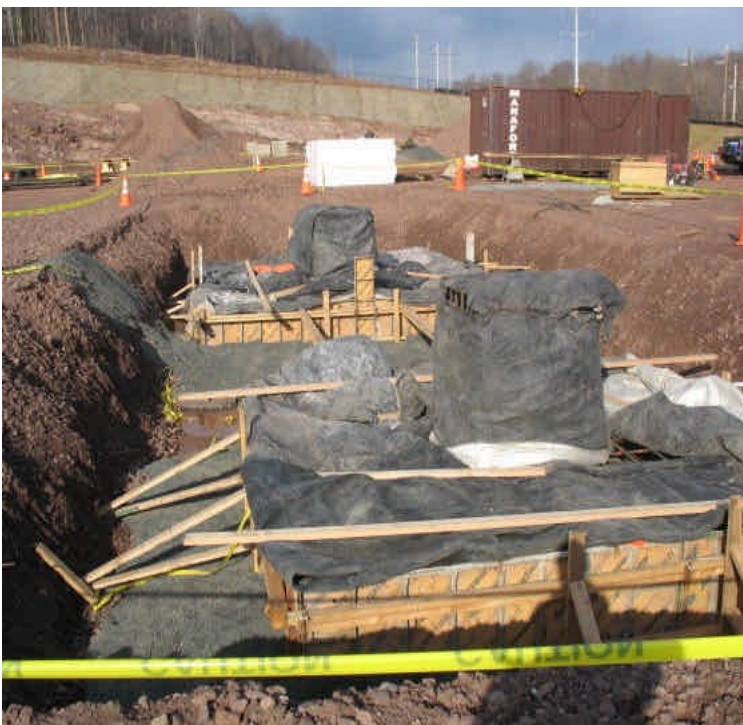
View of site looking from south to north. Foundation installation continues.

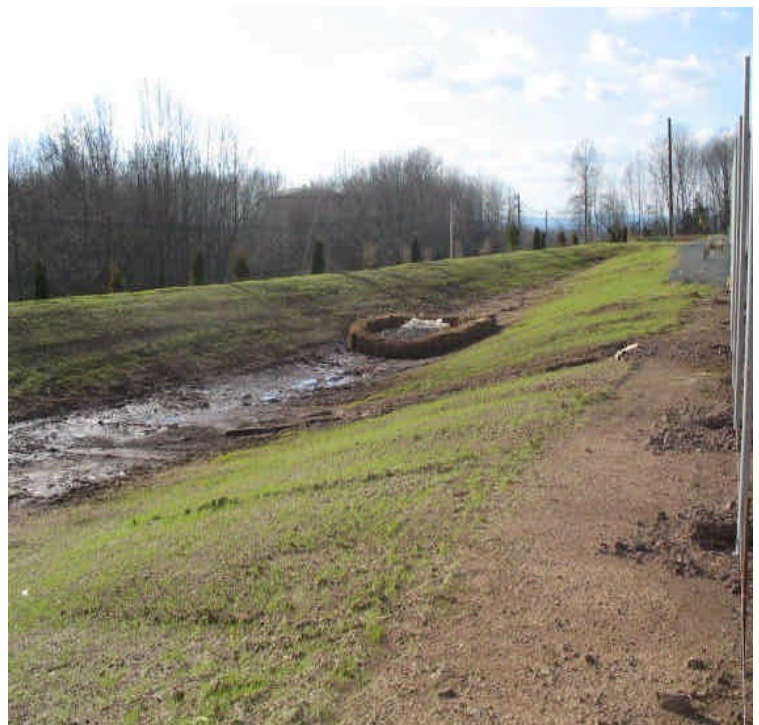
Areas of Inspection	Observation	Recommended Action	Corrected Action
<p>Erosion and sediment controls (continued)</p>	<p>permanent detention basins. However, it appears that stormwater has pooled and overtopped the controls during large rain events, allowing turbid run-off to enter the storm drain. New haybales were installed. 12/5/06</p> <p>The storm water outlet pipe at the wetland across Carpenter Lane has standing water with settled sediment at the bottom. Wetland contains clear standing water with a fine layer of sediment on the leaf litter. 12/5/06</p> <p>Most exposed soil surfaces on site have been graded and hydroseeded. Erosion control mats are also in place on steeper slopes. Some grass growth was observed during the warmer weather. 12/5/06</p>	<p>reduced. Alternative controls may still be needed. 12/5/06</p> <p>Haybales should be replaced/repositioned. Stormwater still needs to be filtered better before leaving the site. Determine the source of turbidity, stabilize exposed soils and add controls as necessary. 11/14-12/5/06</p> <p>Continue to temporarily stabilize any remaining areas as soon as possible. Monitor areas for erosion and run-off. 12/5/06</p>	<p>Needs attention and evaluation.</p> <p>NA.</p>

Some grass growth was observed on the seeded side slopes of the detention basins. Additional/alternative controls are still recommended to protect the inlet as turbid water may pool over and into the drain inlet.

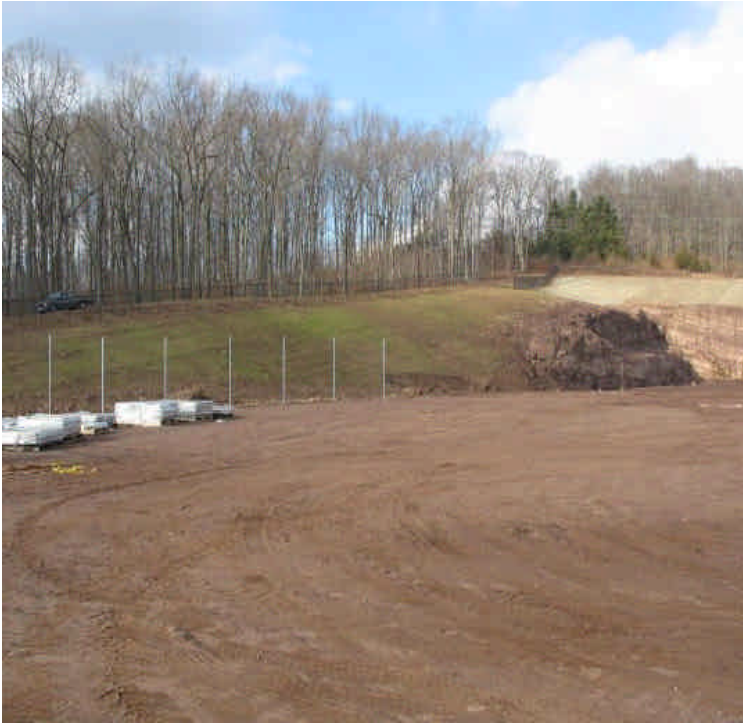
Grass growth observed on slopes during the warmer weather. Fence installation in progress.

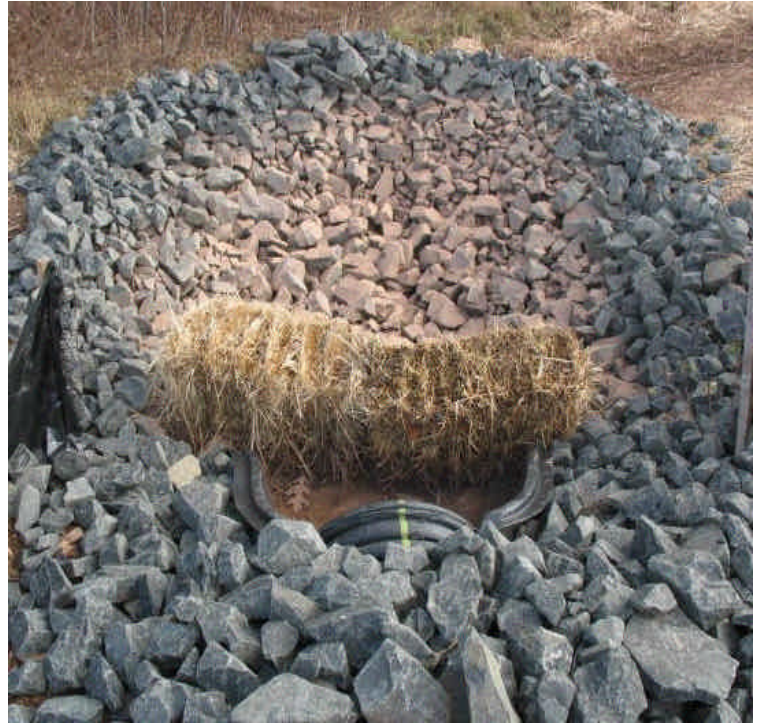
View of the culvert under the new access road. Some minor sediment was noted but was well contained in the trap. Beseck and Seg. 1A contractors are sharing the joint access road.

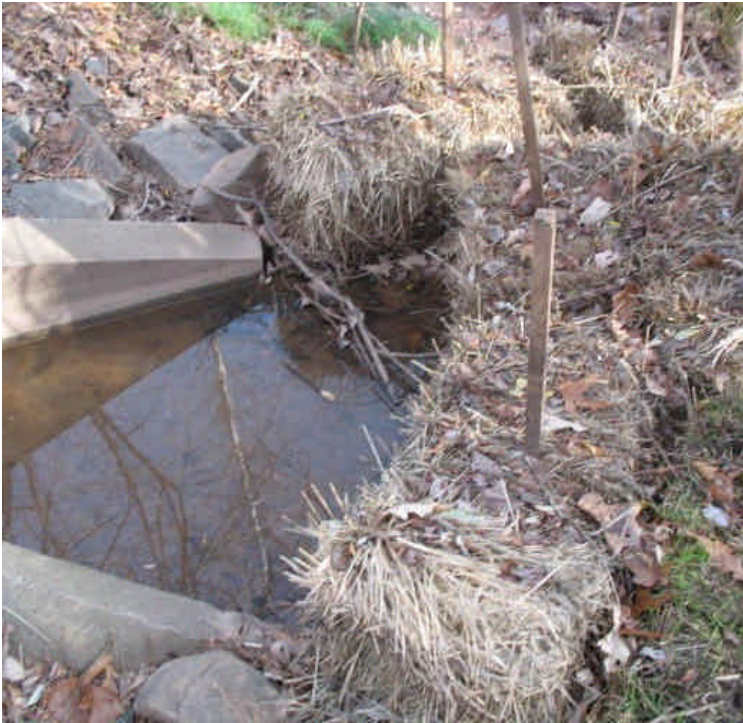
Storm drain outlet across Carpenter Lane contained settled sediment with clear standing water at the outlet pipe.

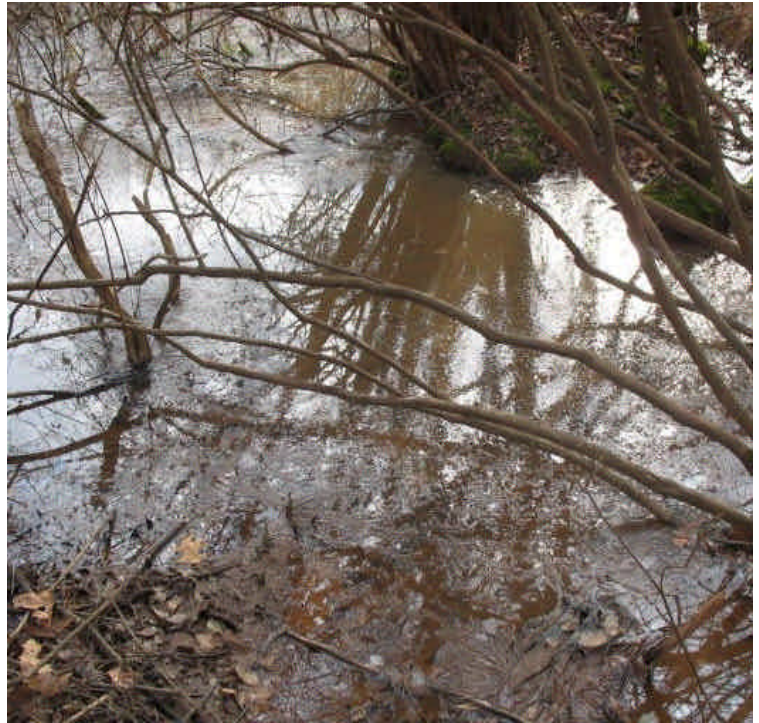
<p>Inland Wetland and Watercourse encroachment and mitigation</p>	<p>The wetland and outlet across Carpenter Lane contained clear standing water with a fine layer of sediment on the leaf litter. This may be difficult to remove but also has the potential to mix into the water column. 12/5/06</p> <p>Wetlands on east side of site were clean and well protected. 12/5/06</p>	<p>Several areas appear to have minor sediment accumulation. Sediment should be removed from the outlet when dry. The definite source of turbidity needs to be identified and controlled. 12/5/06</p> <p>Continue to monitor. See Segment 1a report for further information.</p>	<p>Needs evaluation.</p> <p>NA</p>
<p>State species of concern, threatened and endangered species.</p>	<p>According to the D&M plan, state-listed species are not located in this work area.</p>	<p>None 12/5/06</p>	<p>NA</p>
	<p>Most exposed soil surfaces around the site</p>	<p>Place hay mulch (or similar) for temporary</p>	<p>NA.</p>

Sediment has completely settled out in the wetlands across Carpenter Lane. A fine layer of sediment has accumulated on the leaf litter. This may be difficult to remove while standing water is present but it may continue to get mixed into the water column during storms. Evaluate whether any can be removed without causing further harm.
