Docket No. 272 – Development and Management Plan Inspection

Beseck Switching Station Inspection

Date: December 19, 2006

Location: Beseck Switching Station

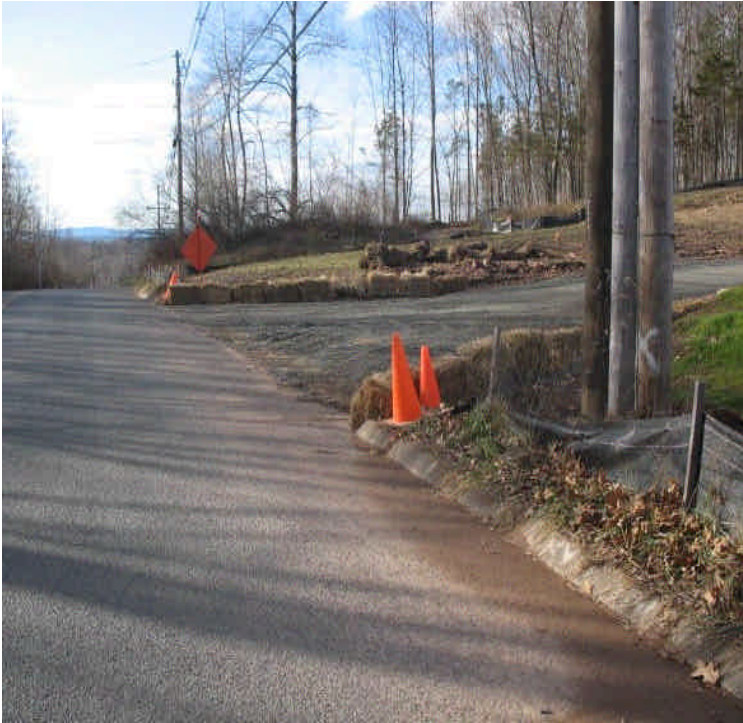
New entrance off Carpenter Lane at final grade, erosion controls have been removed. Monitor carefully for run-off.

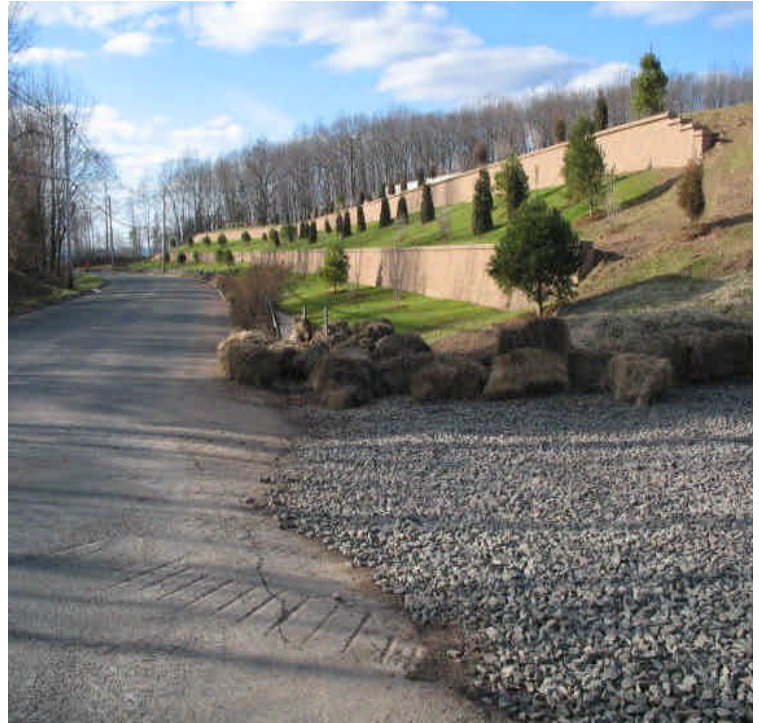
View of Carpenter Lane and retaining walls. Minor sediment accumulation was noted in the gutters on the north side of the road. This should be swept by hand to prevent entry into the catch basins.

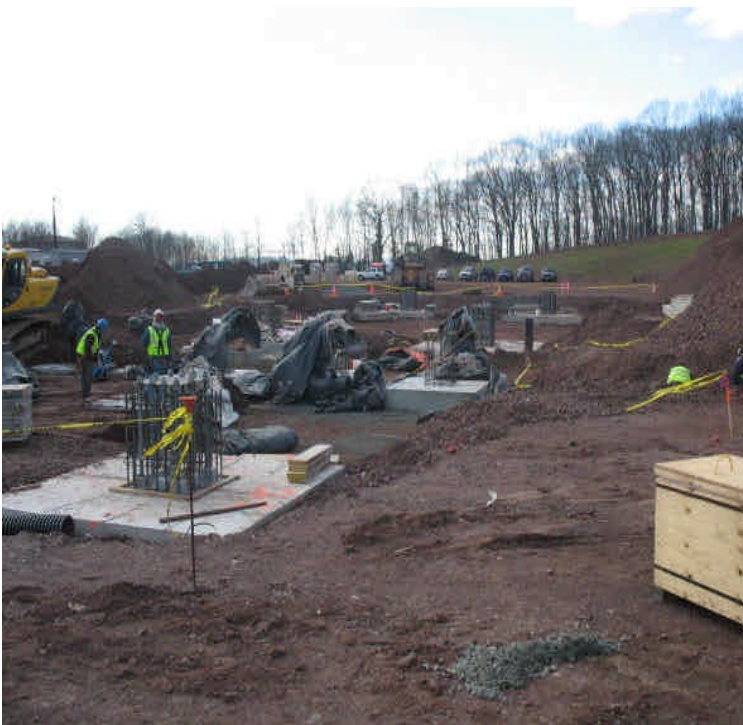
View of site looking from east to west. Foundation installation continues.

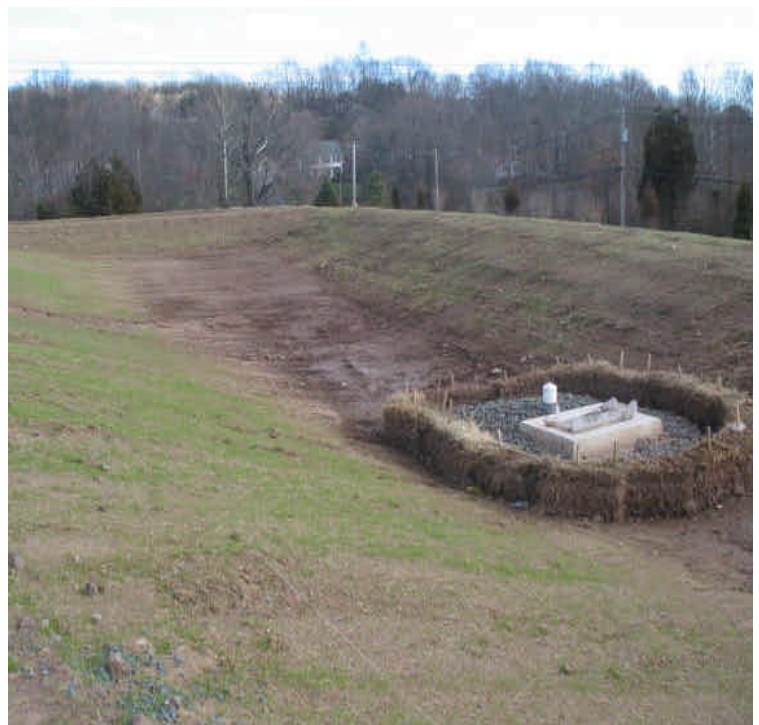
Some grass cover was observed on the seeded slopes of the detention basins. Additional/alternative controls are still recommended to prevent turbid water from reaching the inlet.

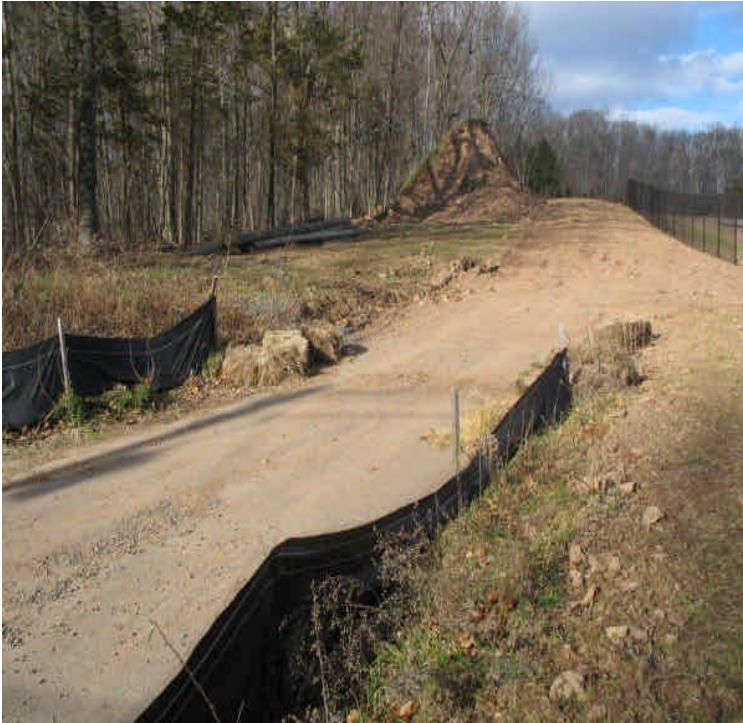
Replace haybales across the old Zolnik driveway (they had been moved for access). Adjacent areas have been graded and seeded.

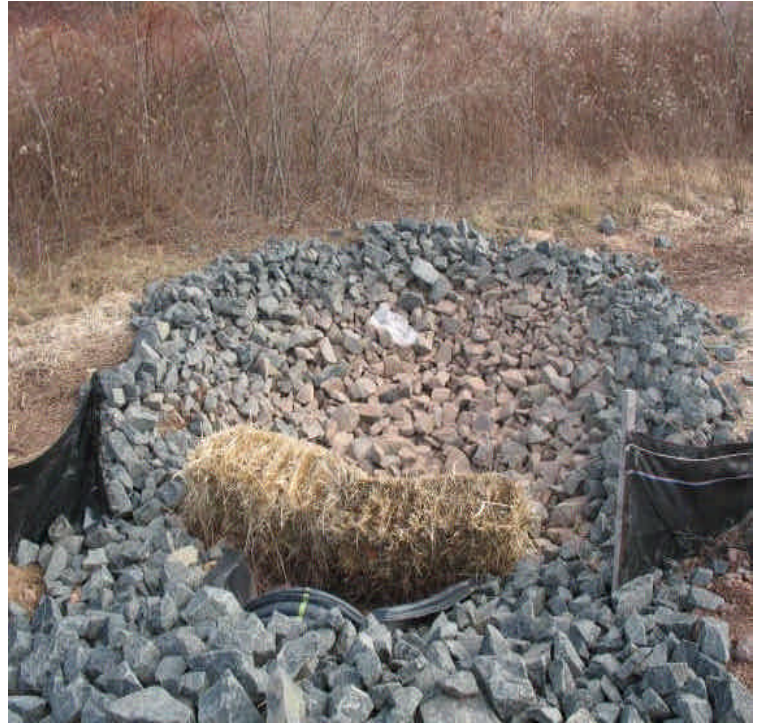
View of the culvert under the new access road. Some minor sediment was noted but was well contained in the trap. Beseck and Seg. 1A contractors are jointly sharing the access road.

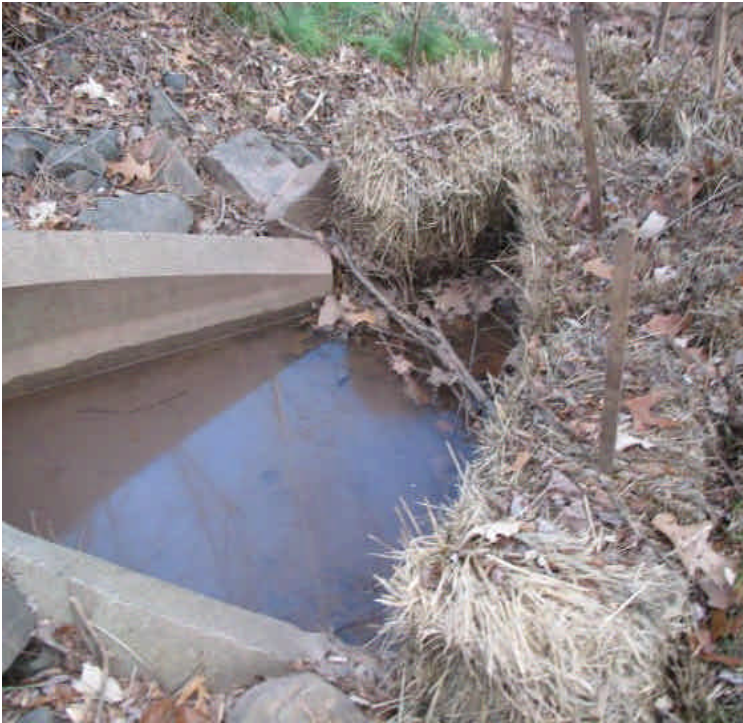
Storm drain outlet across Carpenter Lane contained settled sediment with clear standing water at the outlet pipe. The haybale configuration could still use some adjustment for better control.

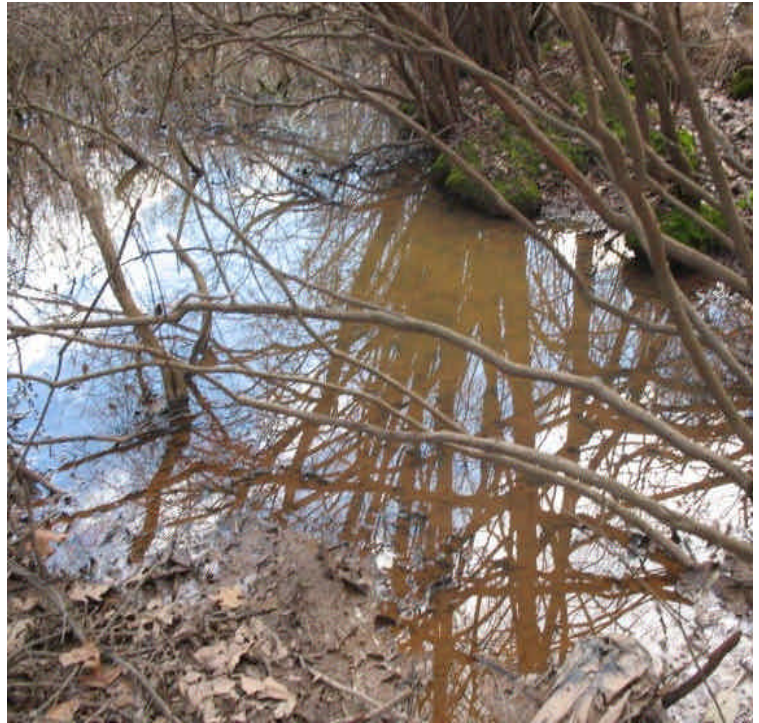
Sediment has settled out in the wetlands across Carpenter Lane, leaving a fine layer on the leaf litter. This may be difficult to remove while standing water is present but it may continue to get mixed into the water column during storms. Evaluate whether any can be removed without causing further harm to the wetland.
