Docket No. 272 – Development and Management Plan Inspection

Beseck Switching Station Inspection

Date: December 26, 2006

Location: Beseck Switching Station

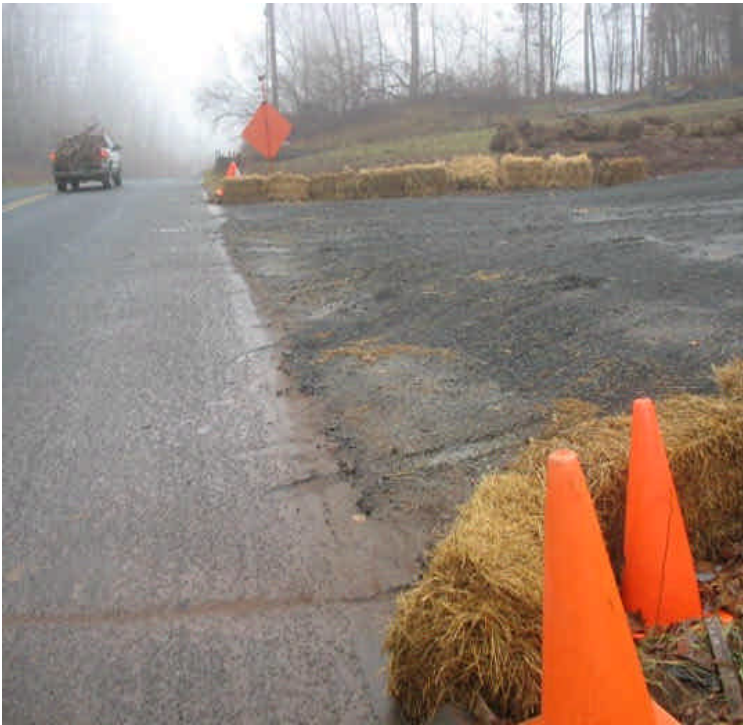
New entrance off Carpenter Lane at final grade; erosion controls have been removed. Monitor carefully for run-off.

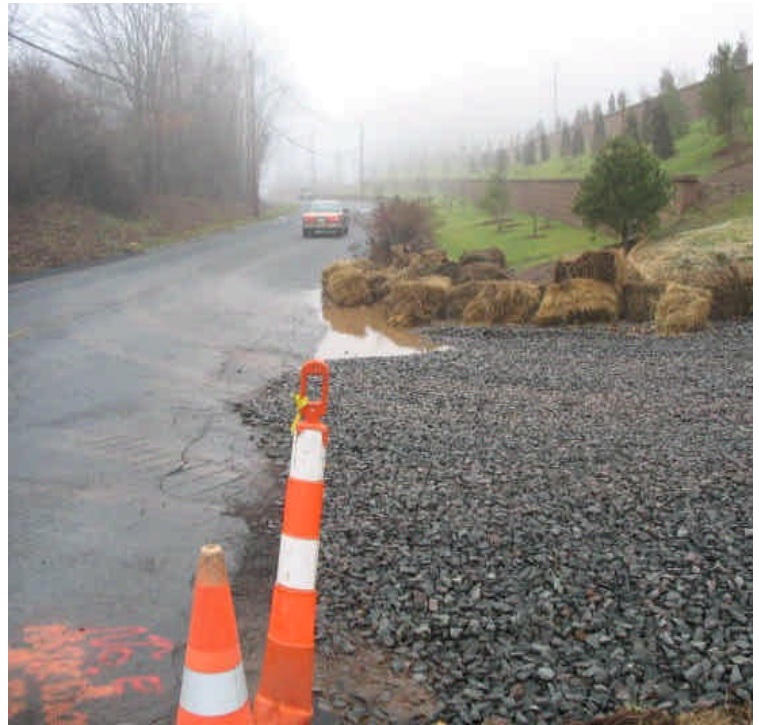
View of Carpenter Lane and retaining walls. Sediment accumulation was noted in the gutters. Turbid water was observed flowing past the controls at the site entrance.

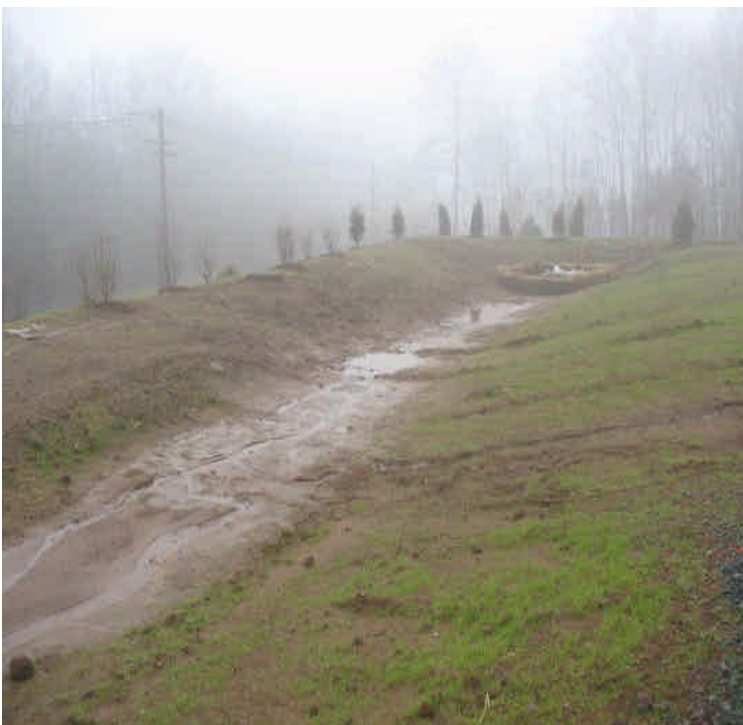
Some grass has become established in the western detention basin. No water was pumped into this basin.

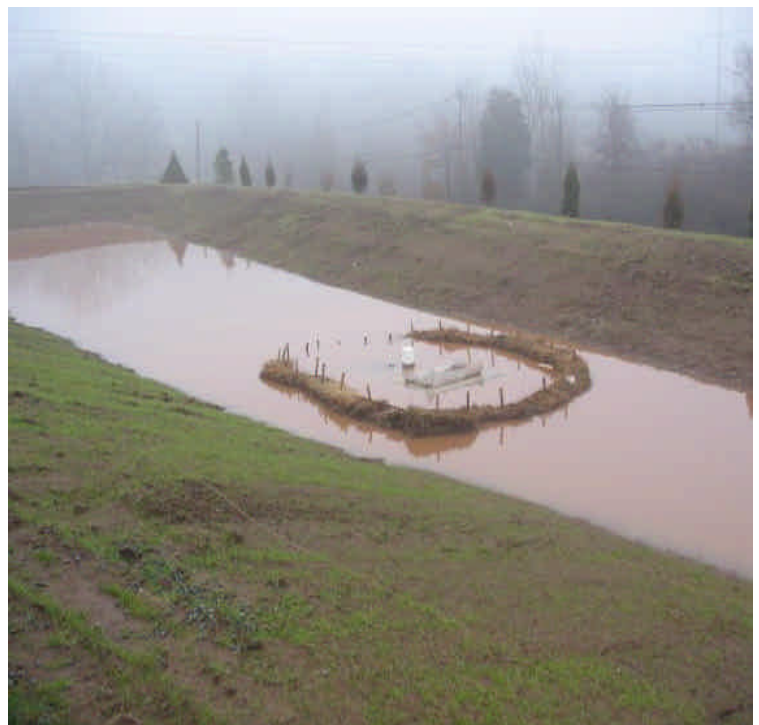
Additional/alternative controls are still recommended. Turbid water from dewatering activities has overtopped the controls at the inlet. Consider additional filtration/containment for dewatering discharge as well.

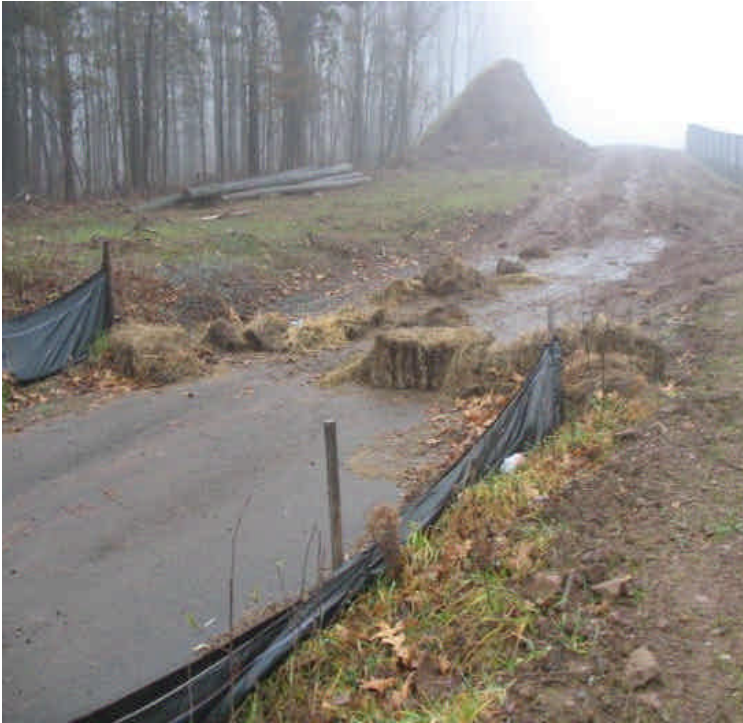
Replace haybales across the old Zolnik driveway. Adjacent areas have been graded and seeded.

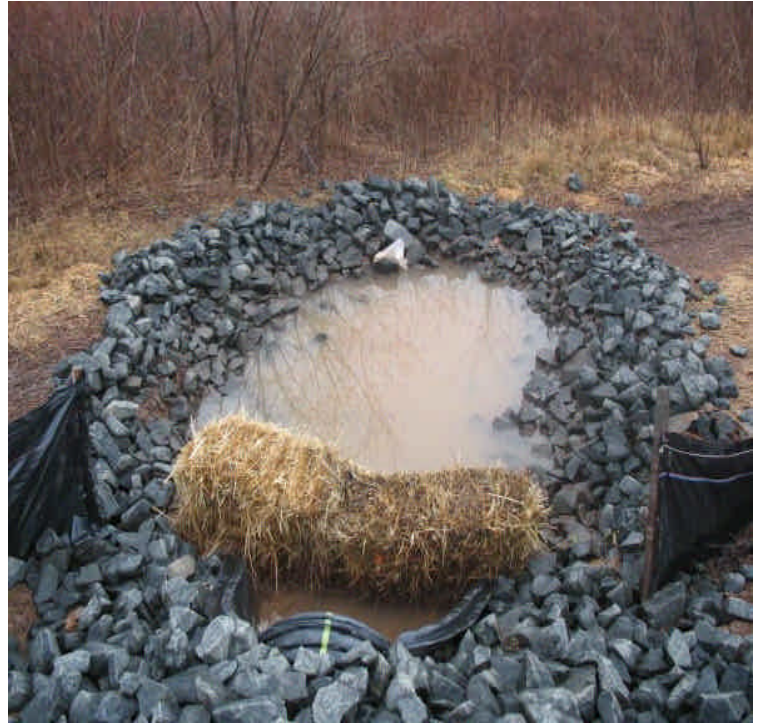
View of the culvert under the new access road. Some minor amounts of turbid water were noted but appears contained within the trap. Beseck and Seg. 1A contractors are jointly sharing the access road.

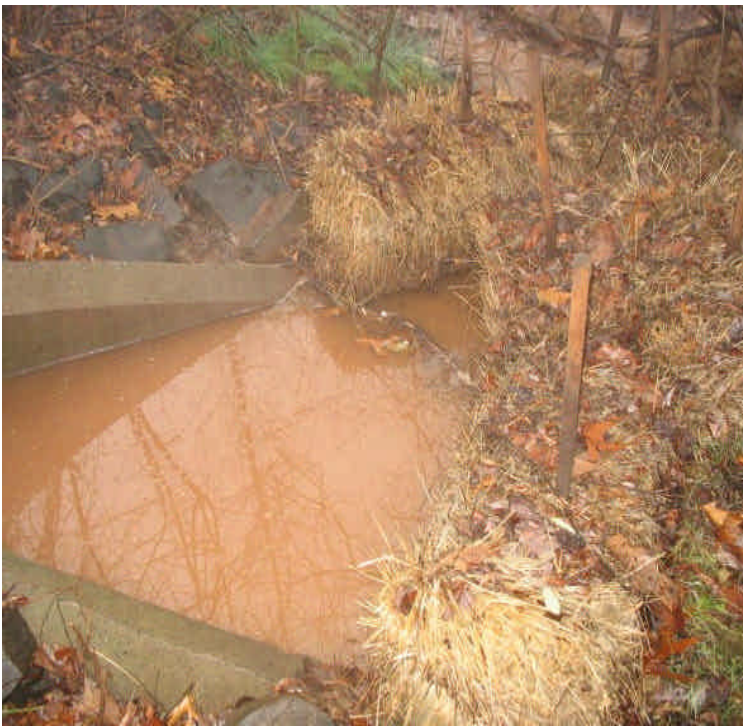
Storm drain outlet across Carpenter Lane again had turbid water flowing through the outlet pipe and past the degraded haybales into the wetland. New haybales and alternative controls on-site are needed.

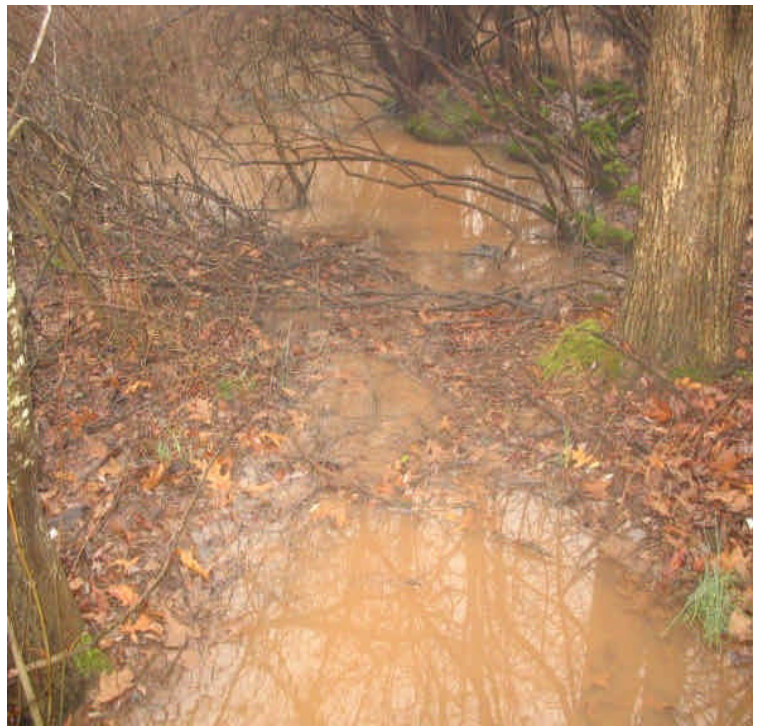
The wetlands across Carpenter Lane again contain turbid run-off from the site after several weeks of no incidents. Sediment removal may be necessary once the sediment settles out, and storm water subsides.
