Docket No. 272 – Development and Management Plan Inspection

Scovill Rock Switching Station Inspection

Date: December 5, 2006

Location: Scovill Rock Switching Station

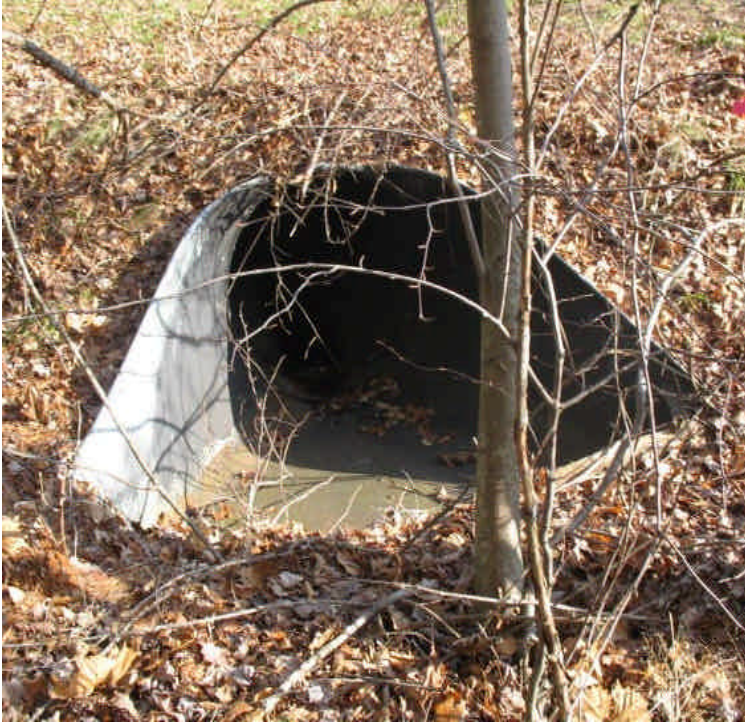
View of the culvert under the access drive. No sediment issues have been observed.

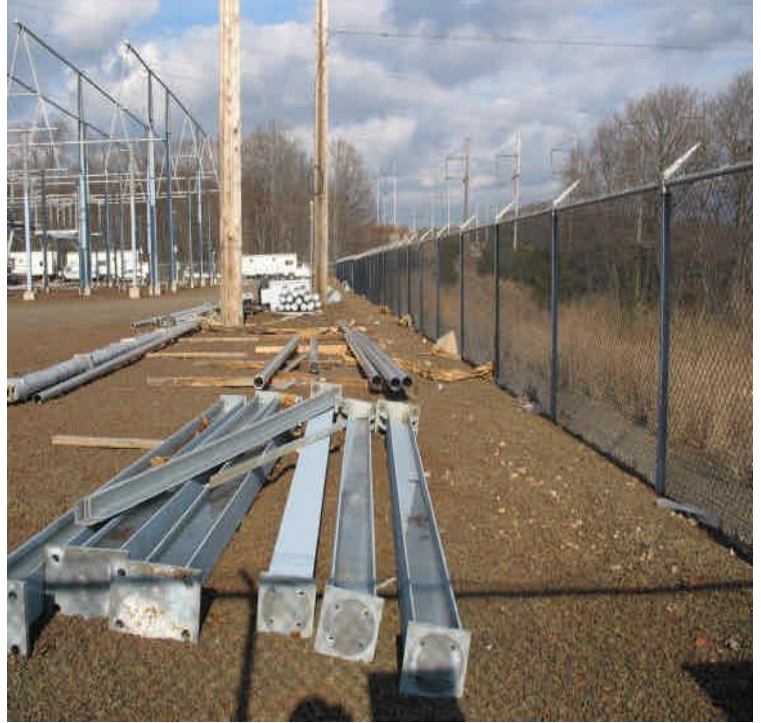
View of the perimeter of the yard. The site is stable and soil disturbing work is now complete.

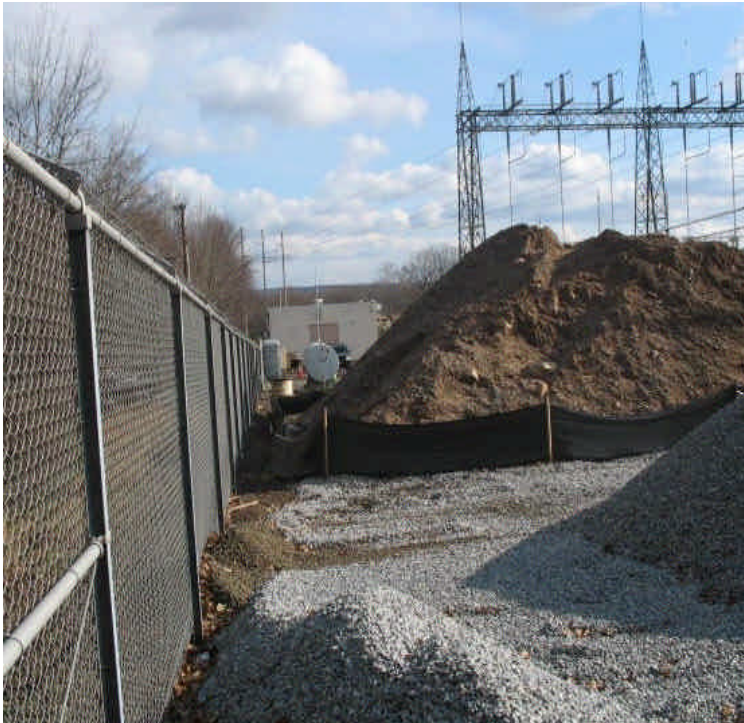
Only one stockpile remains within the yard. The stockpile is surrounded by silt fence and a flat stone surface. It will be removed from the site as soon as possible. 11/7-12/5/06	Once soil analysis is complete, remove soil and dispose of properly. Soils are contained within the yard. 11/21-12/5/06	Remove stockpile when feasible.

The remaining soil stockpile is surrounded by silt fence. Remove soil from site when feasible.

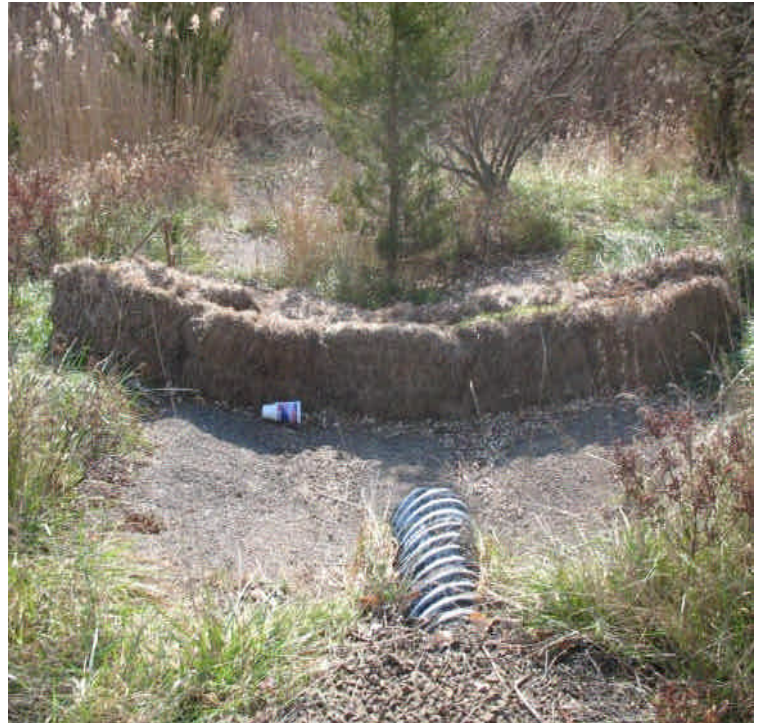
Remove degraded haybales when feasible. Site is stable.
