Docket No. 272 – Development and Management Plan Inspection

Scovill Rock Switching Station Inspection

Date: December 12, 2006

Location: Scovill Rock Switching Station

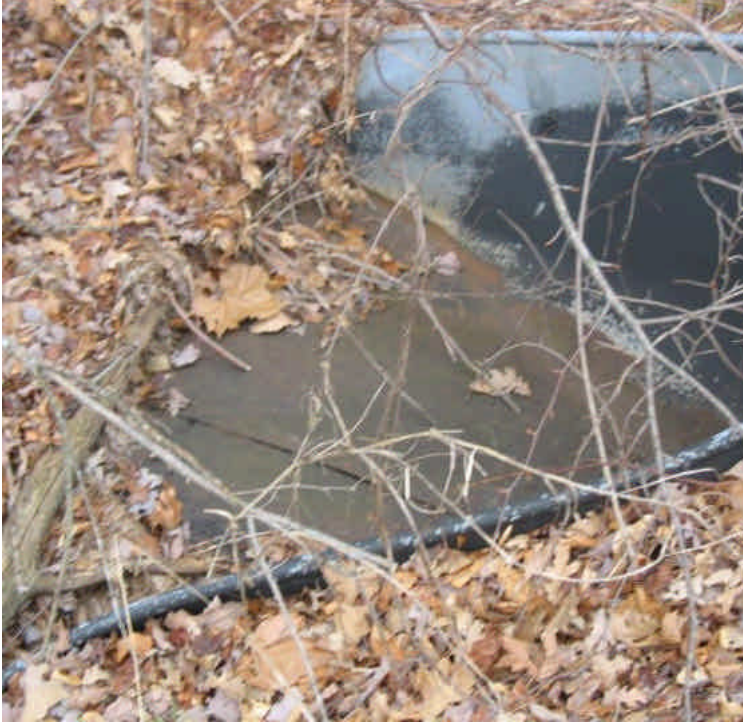
View of the culvert under the access drive. No sediment issues have been observed.

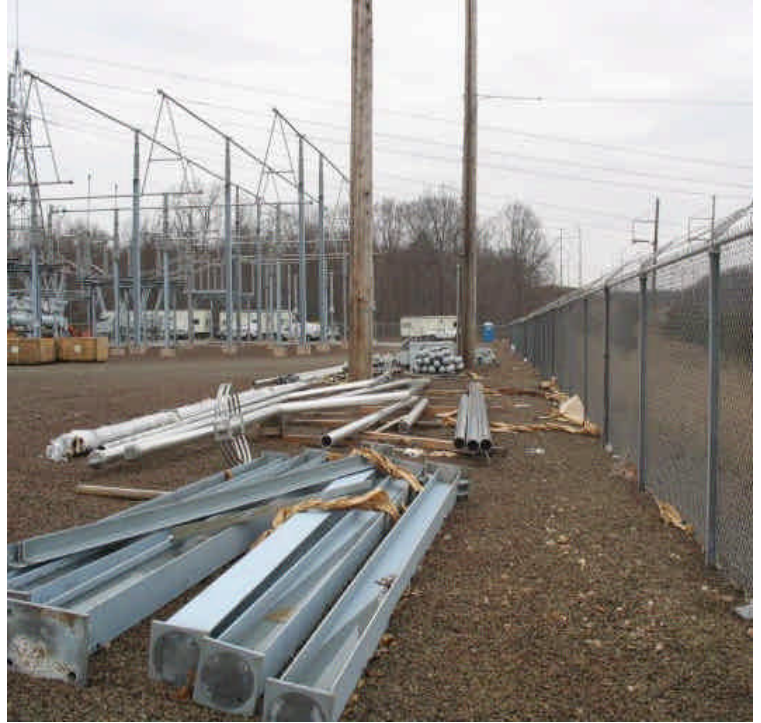
View of the perimeter of the yard. The site is stable and soil disturbing work is now complete.

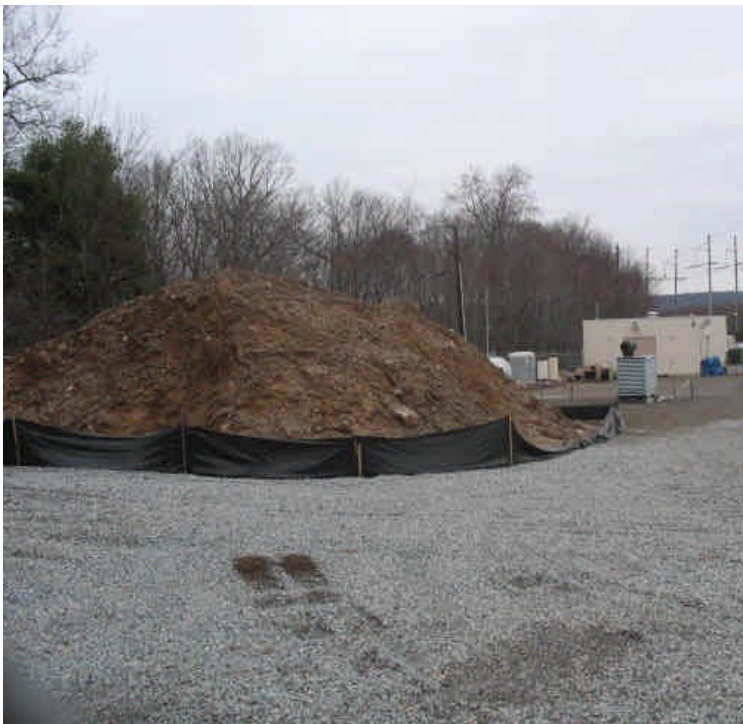
Only one stockpile remains within the yard, surrounded by silt fence and a flat stone surface. It will be removed from the site as soon as possible. 11/7-12/12/06 A small section of the surrounding silt fence has	Once soil analysis is complete, remove soil and dispose of properly. Soils are contained within the yard. 11/21-12/12/06 Fix fallen section of silt fence. 12/12/06	Silt fence needs attention when feasible

The remaining soil stockpile is surrounded by silt fence. Fix fallen section of silt fence and remove soil from site when feasible.

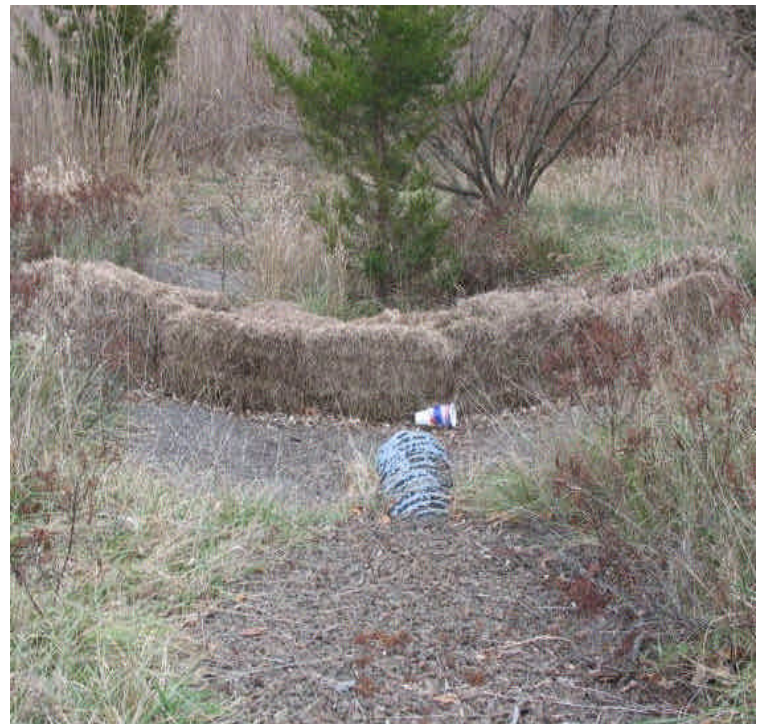
Remove degraded haybales when feasible. Site is stable.
