Docket No. 272 – Development and Management Plan Inspection

Scovill Rock Switching Station Inspection

Date: December 19, 2006

Location: Scovill Rock Switching Station

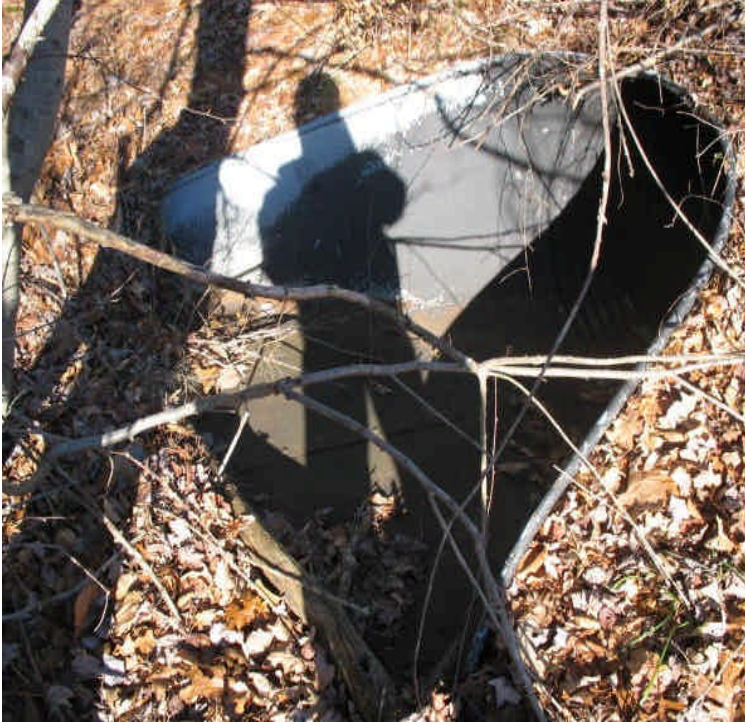
View of the culvert under the access drive. No sediment issues have been observed.

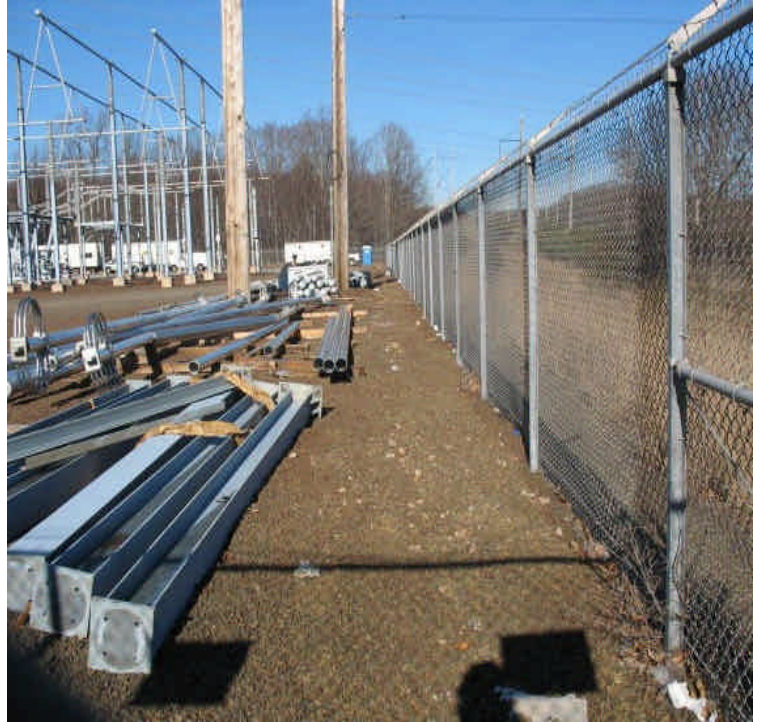
View of the perimeter of the yard. The site is stable and soil disturbing work is now complete.

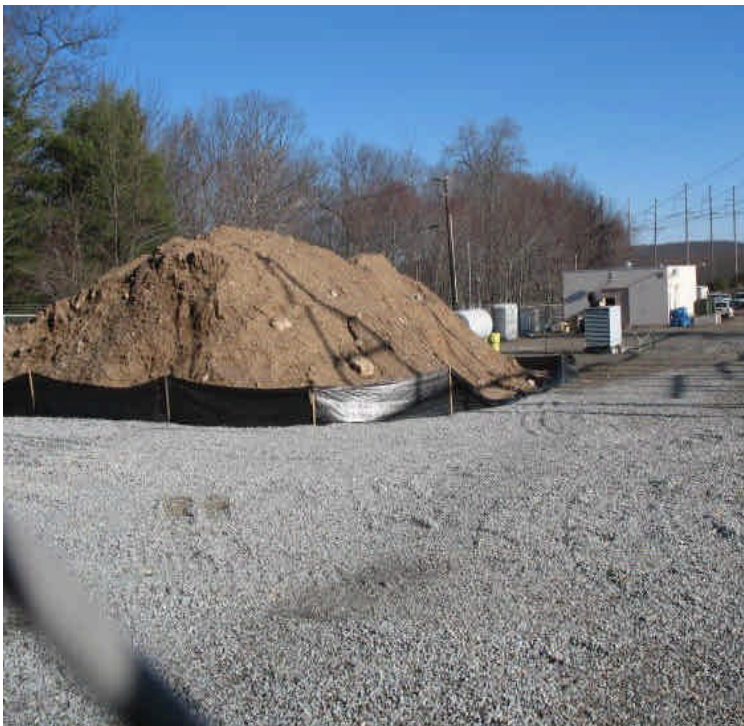
One stockpile remains in the yard, surrounded by silt fence and a flat stone surface. It will be removed as soon as possible. 11/7-12/19/06 A small section of silt fence has fallen. 12/12-12/19/06	Once soil analysis is complete, remove soil and dispose of properly. Soils are contained within the yard. 11/21-12/19/06 Repair fallen section of silt fence. 12/12-12/19/06	Silt fence needs attention when feasible
	The existing culvert	Closely monitor any work	NA

The remaining soil stockpile is surrounded by silt fence. Repair fallen section of silt fence and remove soil from site when feasible.

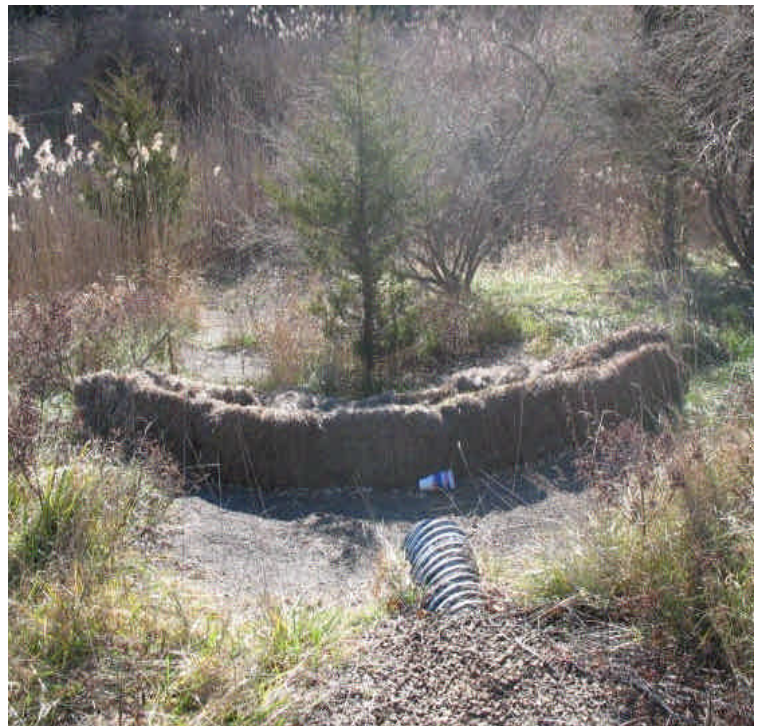
Remove degraded haybales when feasible. Site is stable.
