Docket No. 272 – Development and Management Plan Inspection

Segment 1a Inspection

Date: December 12, 2006

Location: Segment 1a – Scovill Rock Switching Station to Chestnut Junction, Oxbow Junction to Beseck Switching Station (excluding Royal Oak Bypass), Black Pond Junction to Beseck Switching Station

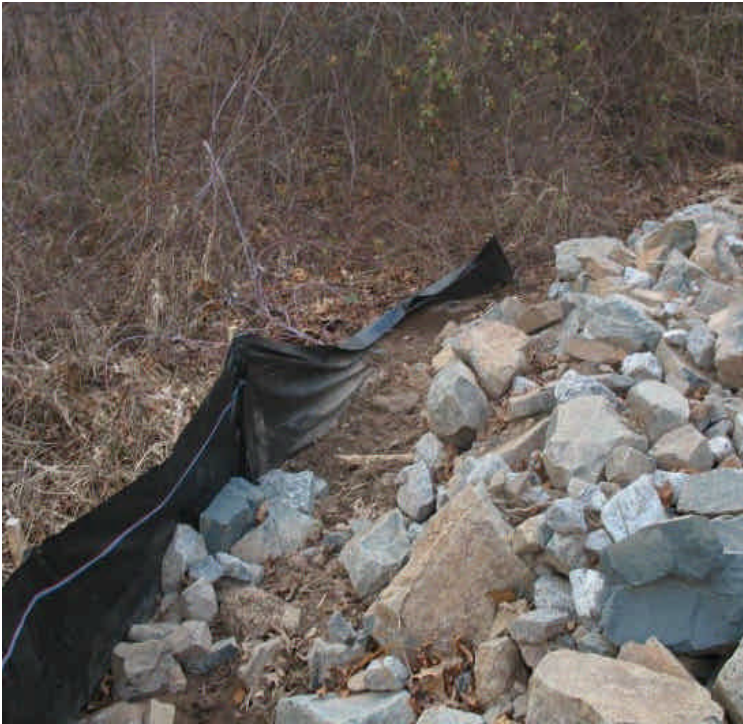
Riprap sediment trap and silt fence along the access road off Black Walnut Dr. Accumulated sediment should be removed and the silt fence repaired.

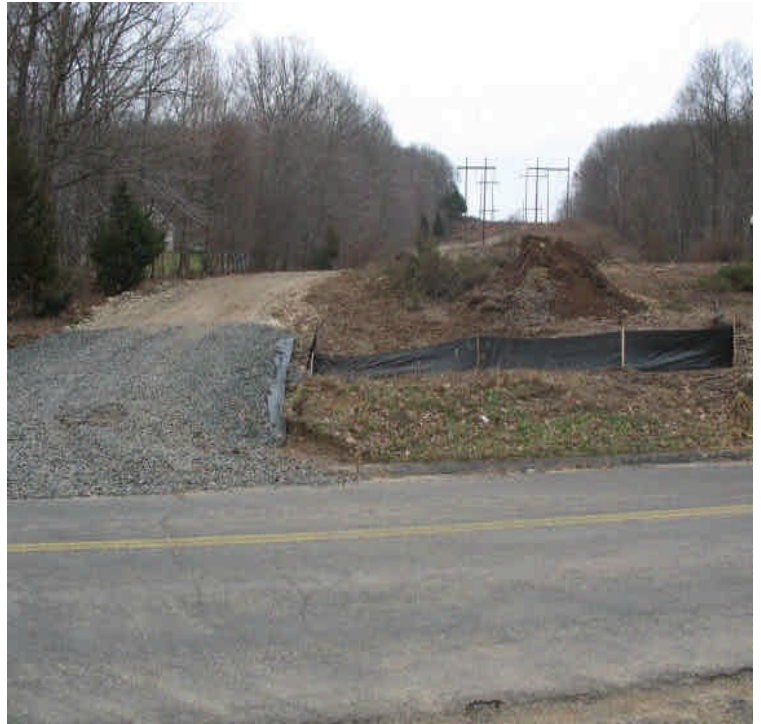
Silt fence, clearing, grading, and access road off Arbutus Street. Pull back stone from the roadway as needed.

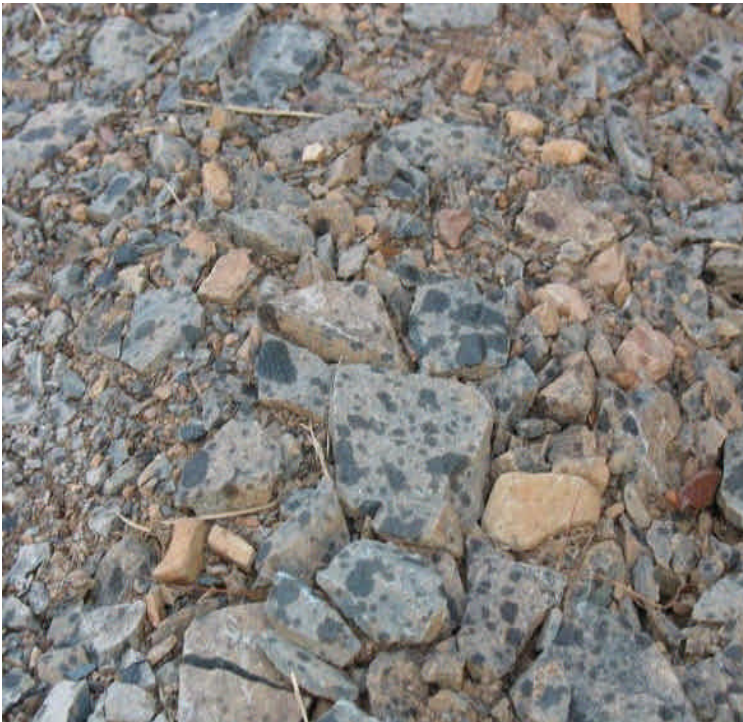
Small spill spray located on the access road off Black Walnut Dr. Spill size was non-reportable but clean up as feasible.

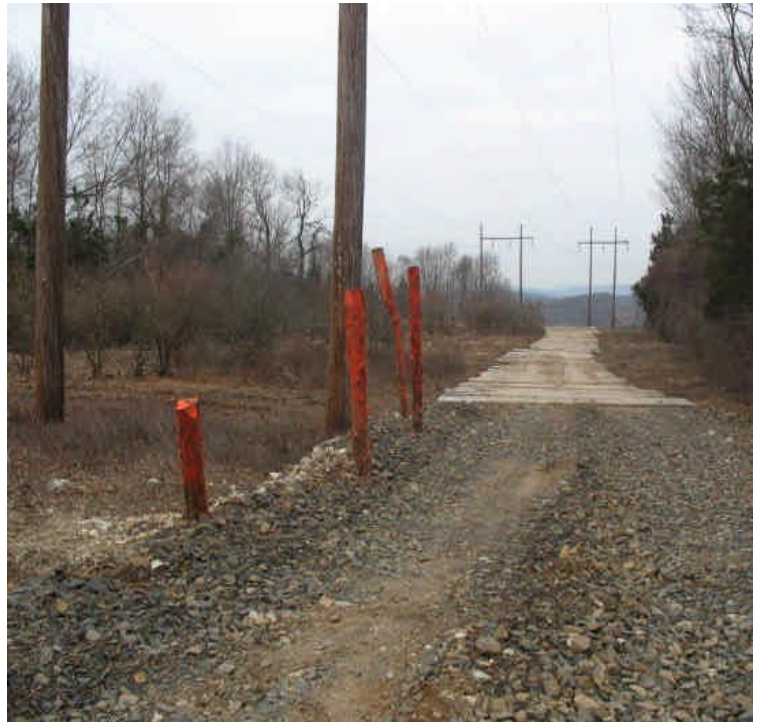
Non-jurisdictional wetland crossing area in the access ROW off Haddam Quarter Rd. Mats are in place and clean water was leaving the site.

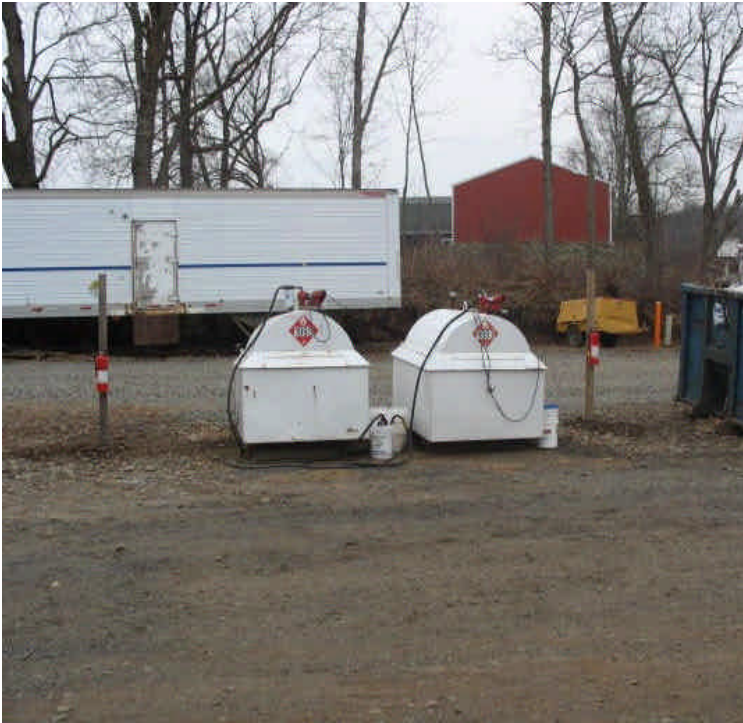
Nozzles for the fuel tank have been placed inside of 5-gallon buckets with spill controls at the contractor yard. Fire extinguishers were installed

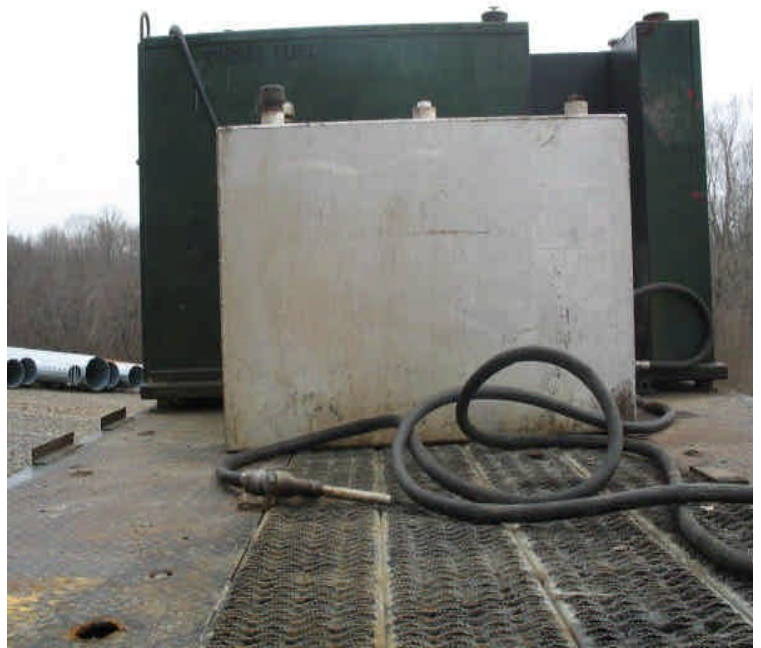
Truck with a portable refueling tank. Nozzle should be contained to prevent spilling. Ensure that spill kits are present on the vehicles.

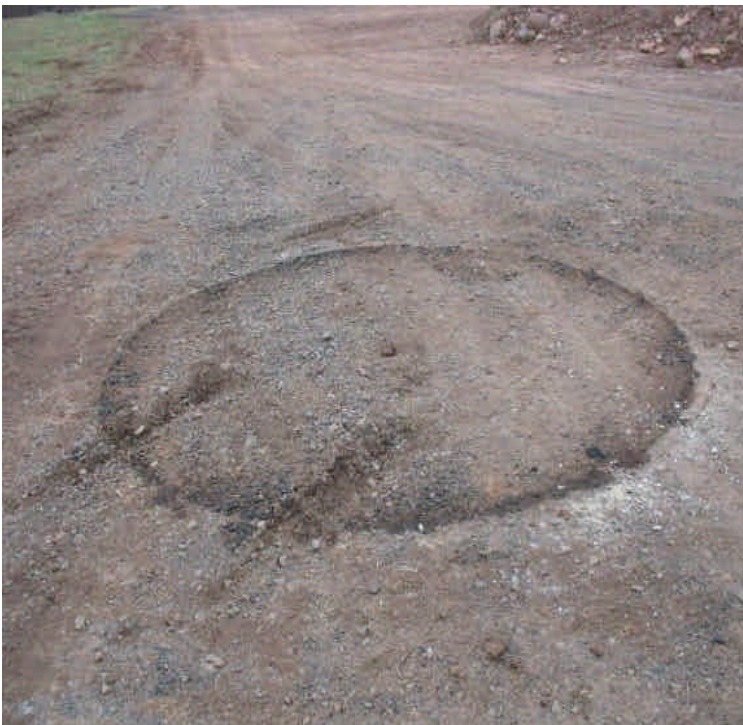
A stain was noted along the access road to the ROW north of Beseck SS. It is unclear whether this resulted from material storage or an equipment leak. Regardless, the size is non-reportable.

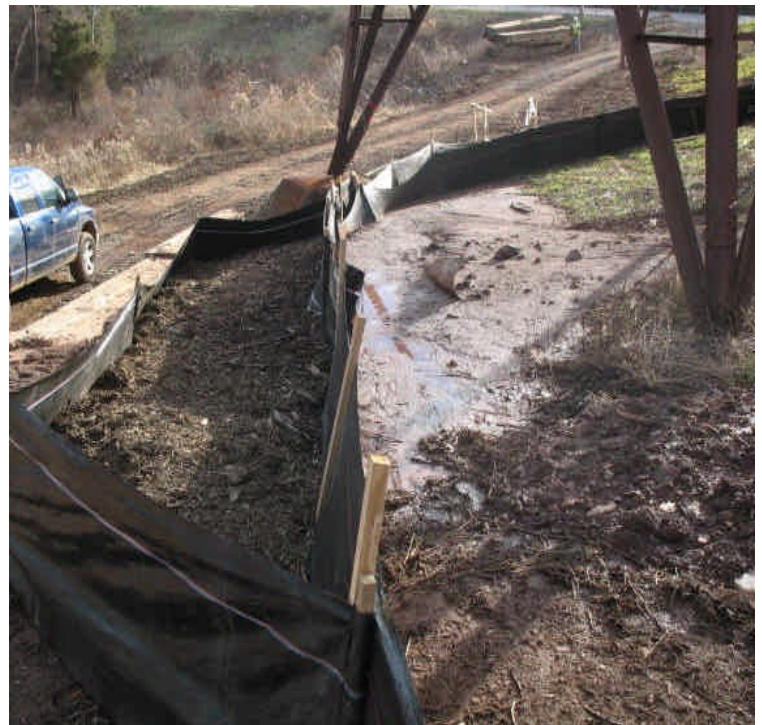
Silt fence/haybale barrier along the access road adjacent to Black Pond used for dewatering slurry. Slurry remains contained.

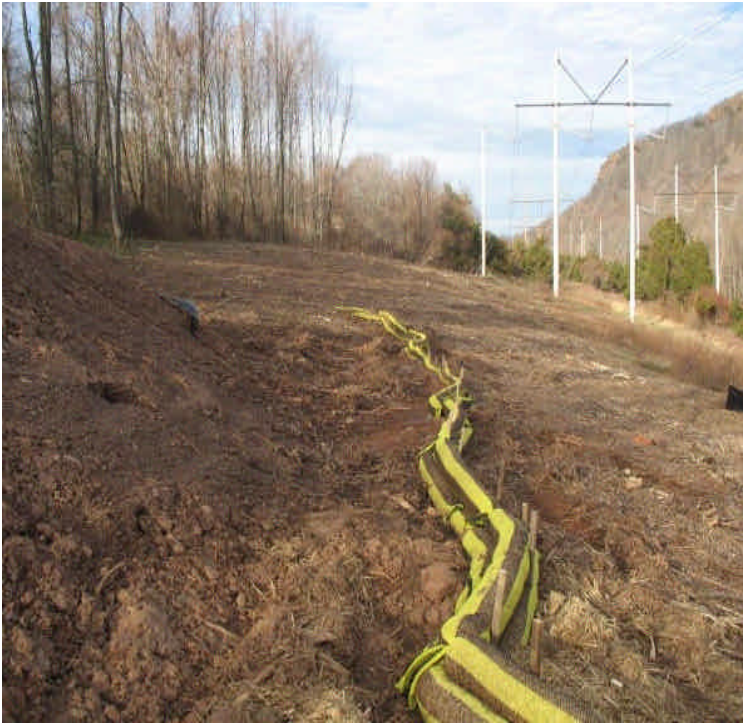
Bio-socks used to trap/filter slurry and sediment from dewatering efforts at Black Pond.

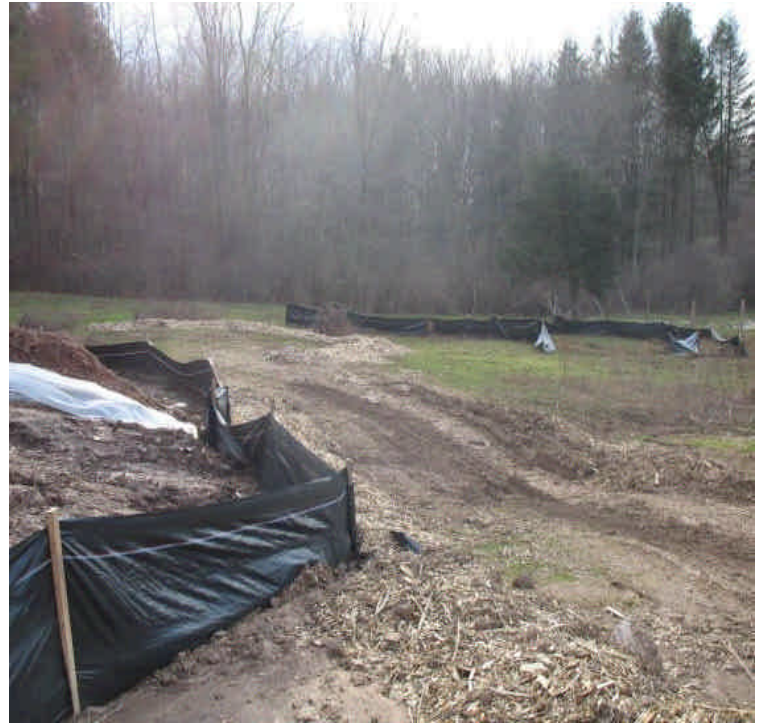
Slurry containment areas located in the ROW north of the contractor yard along Rte 17. Sediment is being removed and spread, and is mostly dry at this time.

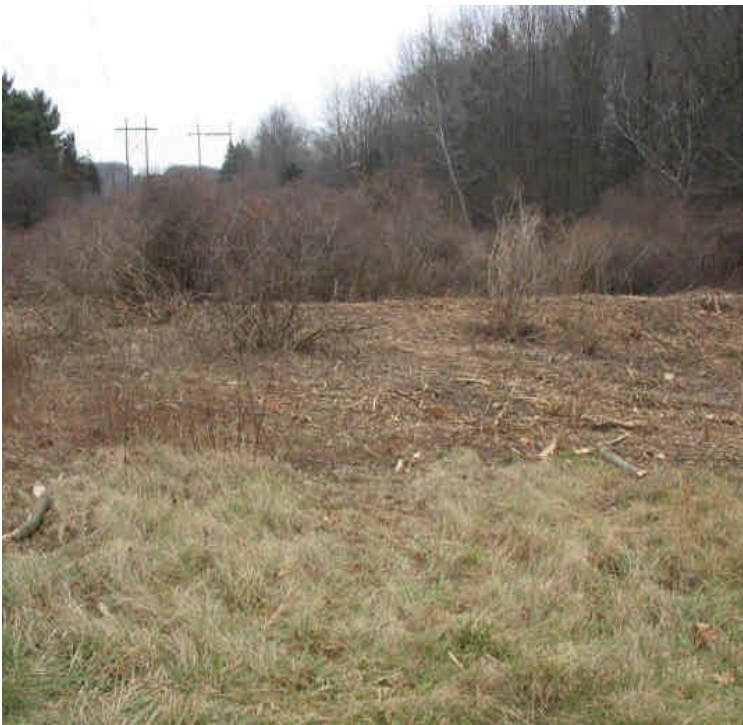
Previous buffer zone clearing off Little Lane, view from the wetland towards the upland. Monitor and add controls if needed; however, roots appear to be keeping soil stable.

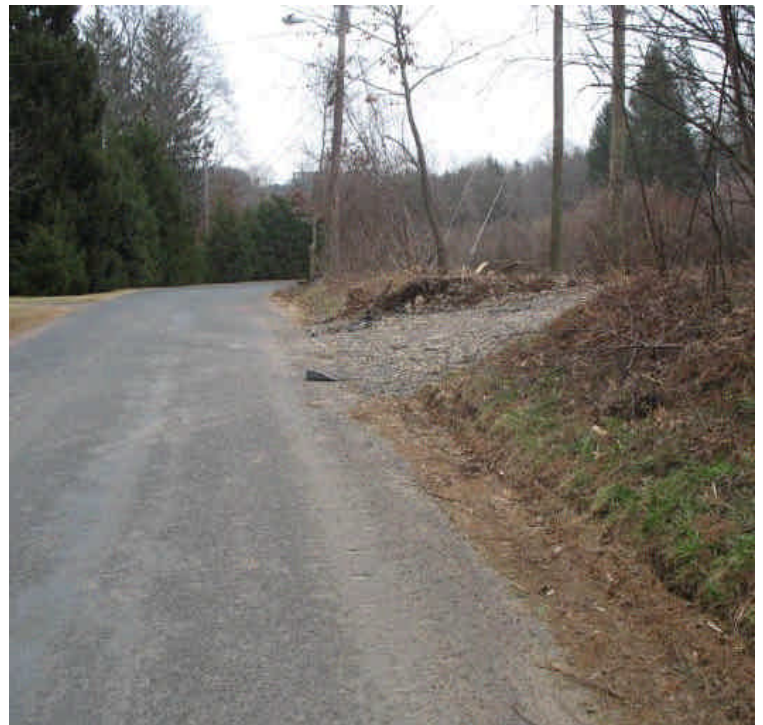
ROW entrance off Little Lane. No sediment tracking was noted.
