Docket No. 272 – Development and Management Plan Inspection

Segment 1a Inspection

Date: December 26, 2006

Location: Segment 1a – Scovill Rock Switching Station to Chestnut Junction, Oxbow Junction to Beseck Switching Station (excluding Royal Oak Bypass), Black Pond Junction to Beseck Switching Station

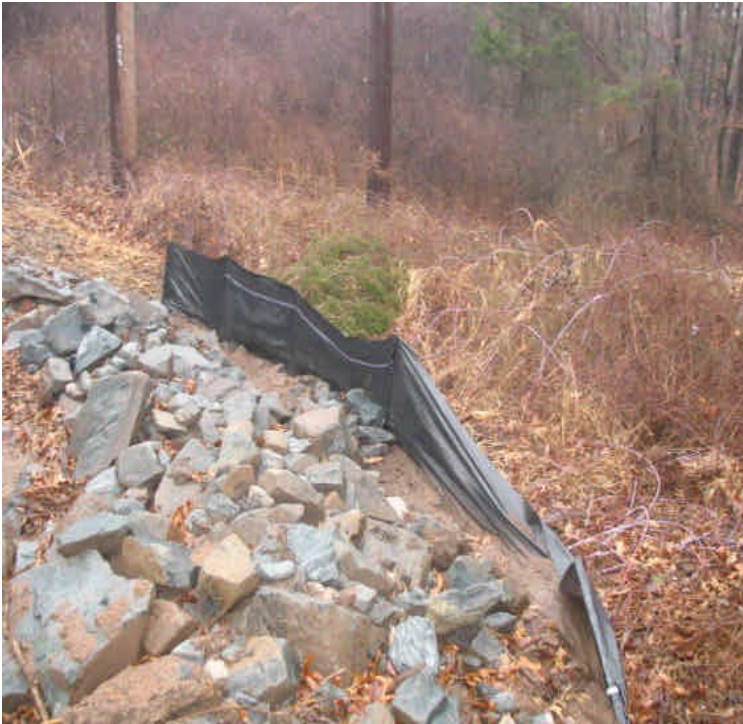
Riprap sediment trap and silt fence along the access road off Black Walnut Drive. Accumulated sediment should be removed and the silt fence maintained.

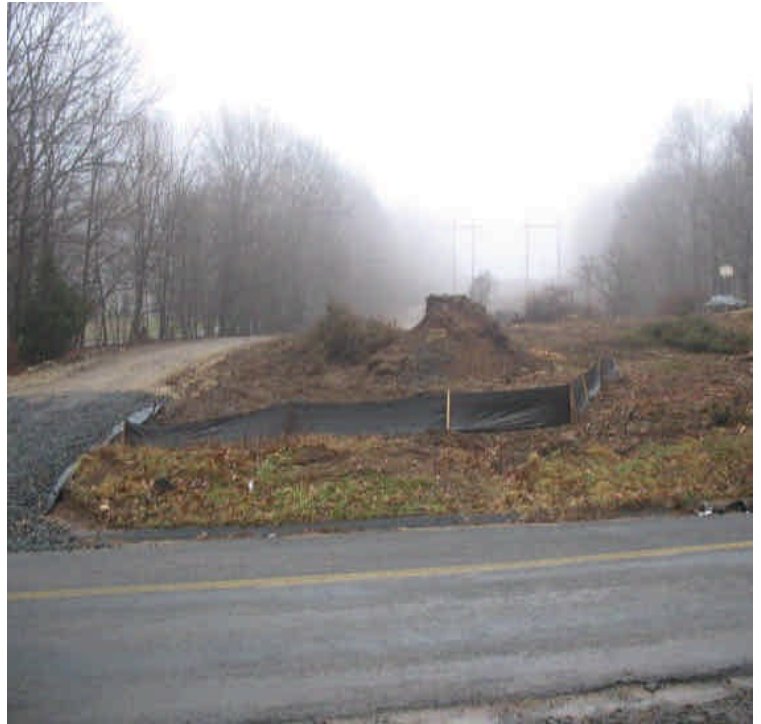
Silt fence, clearing, grading, and access road off Arbutus Street. Pull back stone from the roadway as needed.

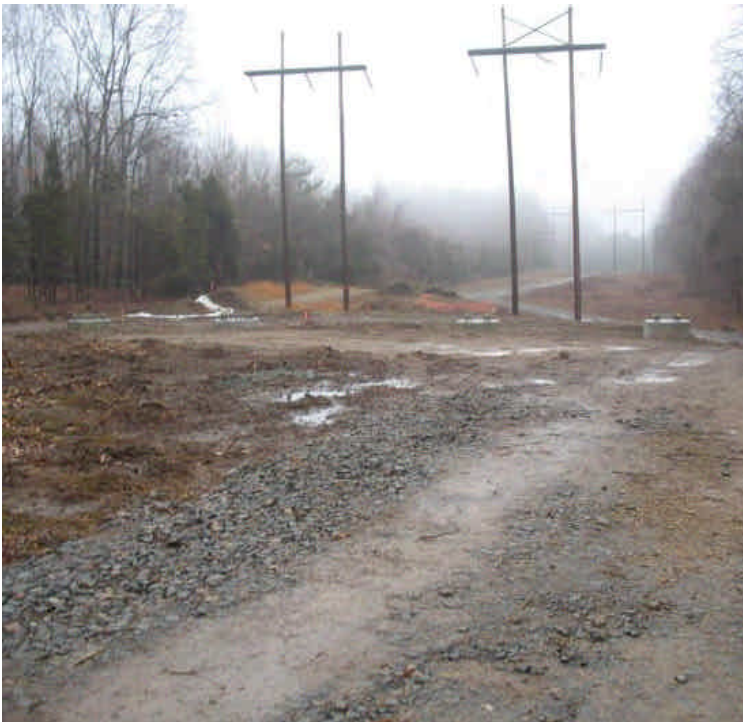
ROW access road and foundations in place off Black Walnut Dr.

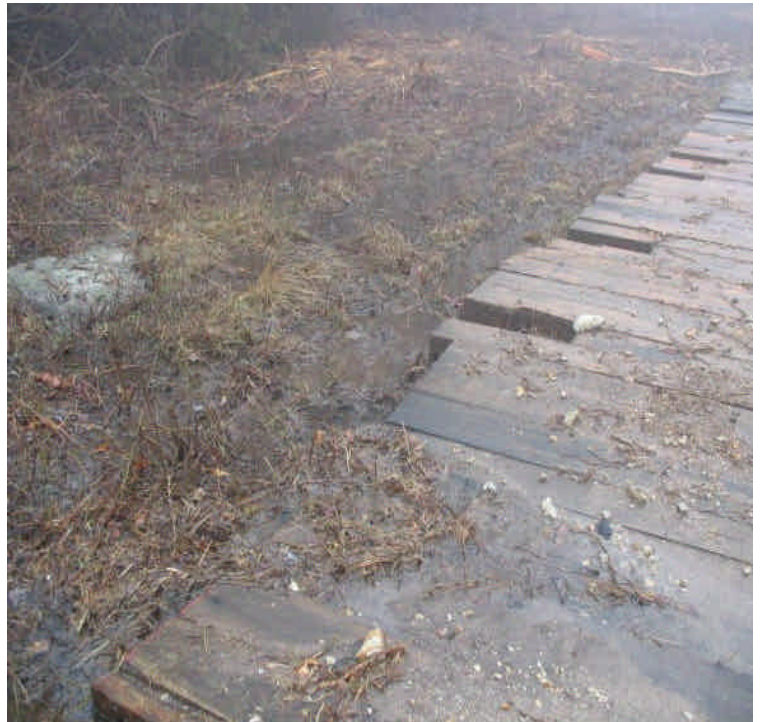
Non-jurisdictional wetland crossing area in the access ROW off Haddam Quarter Rd. Mats are in place and clean water was leaving the site. Reduce sediment tracking on the mat as feasible.

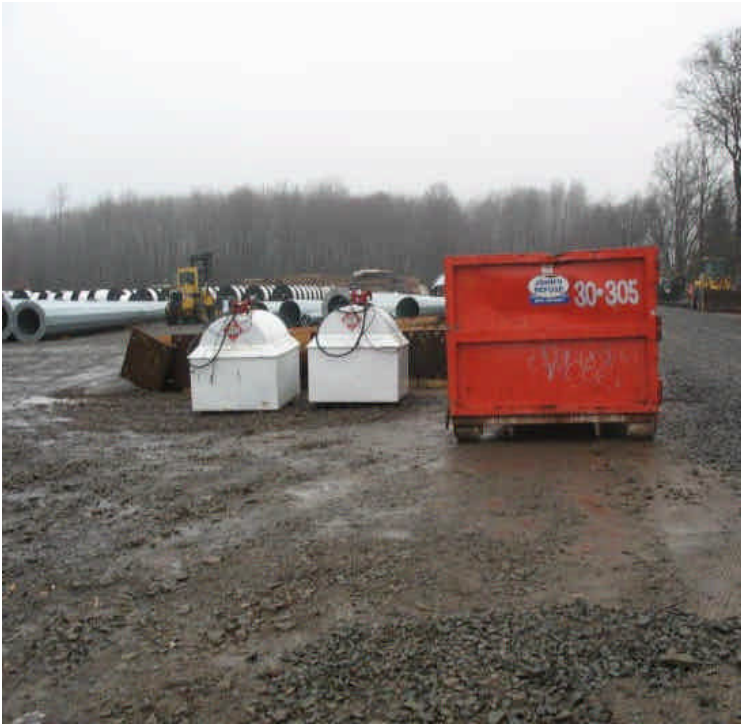
Fuel tanks and dumpster were moved farther from the wetland; controls for the fuel tank nozzles should be reinstalled.

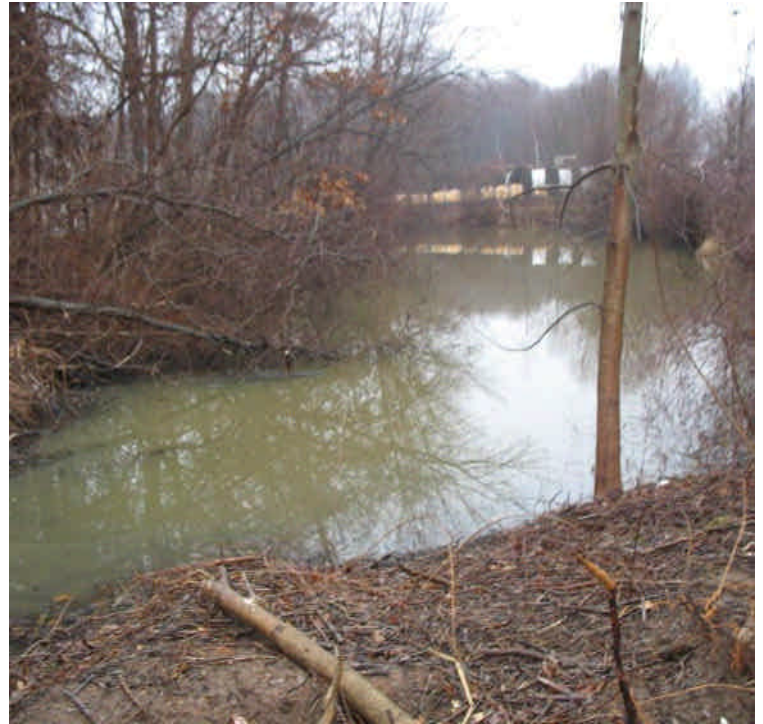
Turbidity in the pond adjacent to the contractor shipping and receiving yard has increased but a direct source is still not apparent.

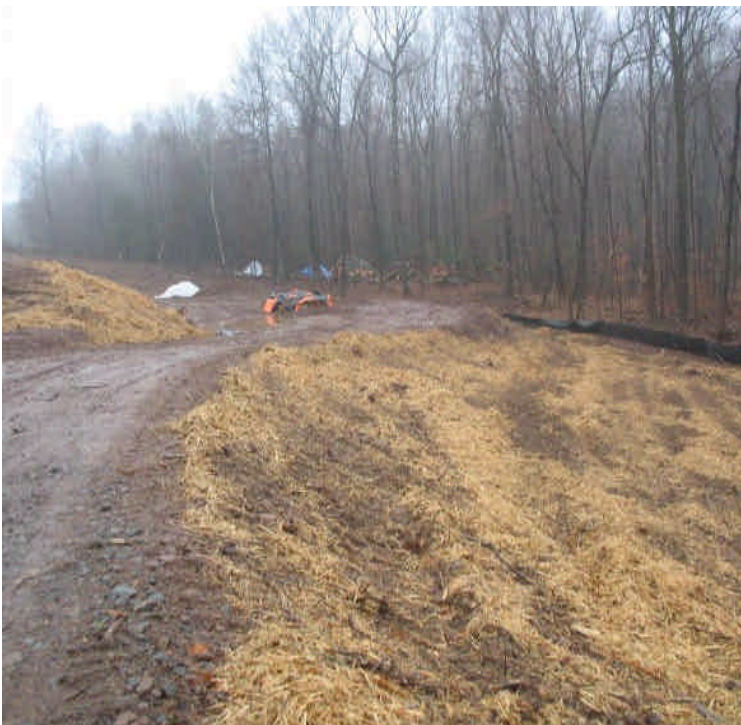
Foundations installed within the ROW north of Beseck SS. Controls are in place.

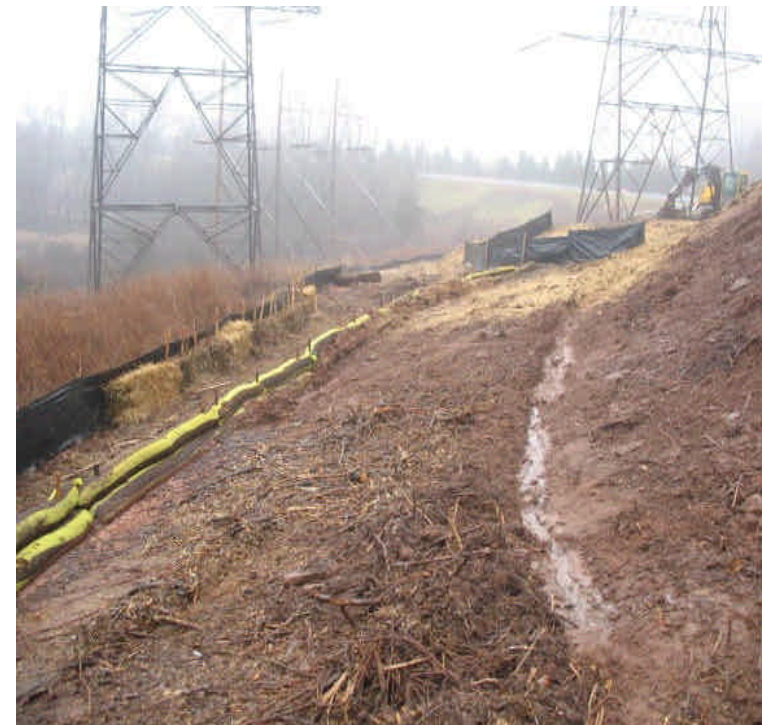
Silt fence/filter-sock barrier along the access road adjacent to Black Pond used for dewatering slurry. Slurry has been pulled back from the controls and spread around the site.

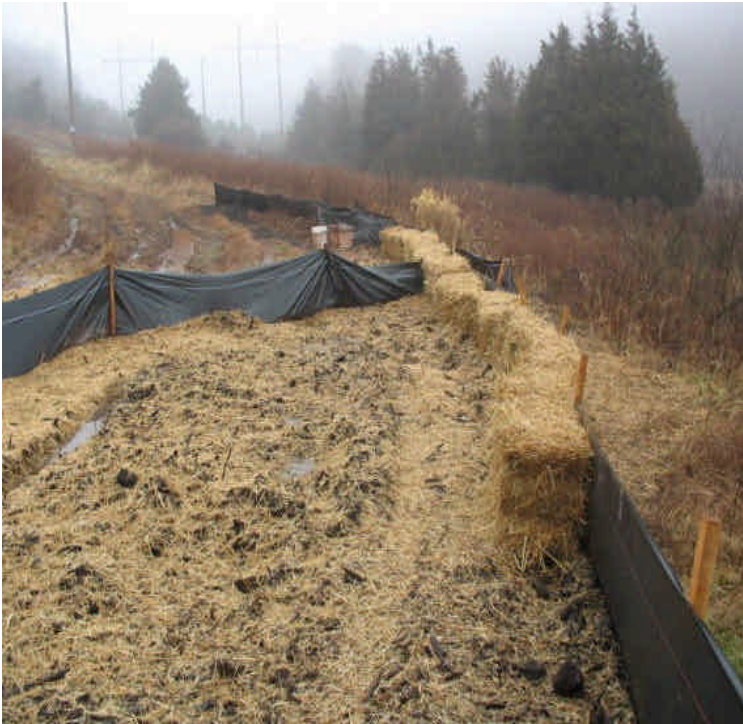
Slurry was pulled back from the edge of the silt fence at Black Pond and new haybales were installed. Mulch has been spread around the site for increased, temporary stabilization.

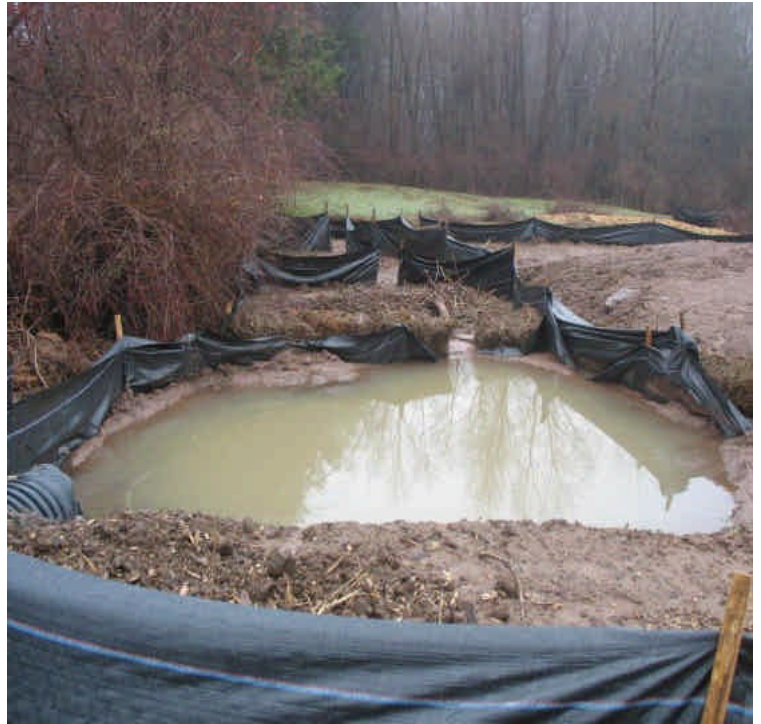
Slurry containment areas located in the ROW north of the contractor yard along Rte 17. Sediment was removed and stormwater contained.

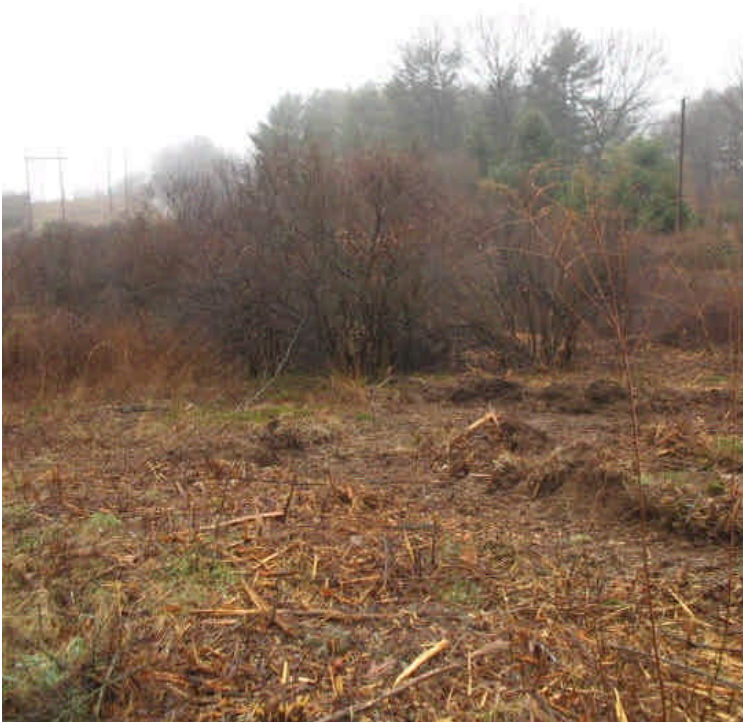
Previous clearing off Little Lane, view from the upland towards the wetland. Monitor and add controls if needed; however, roots appear to be keeping soil stable.

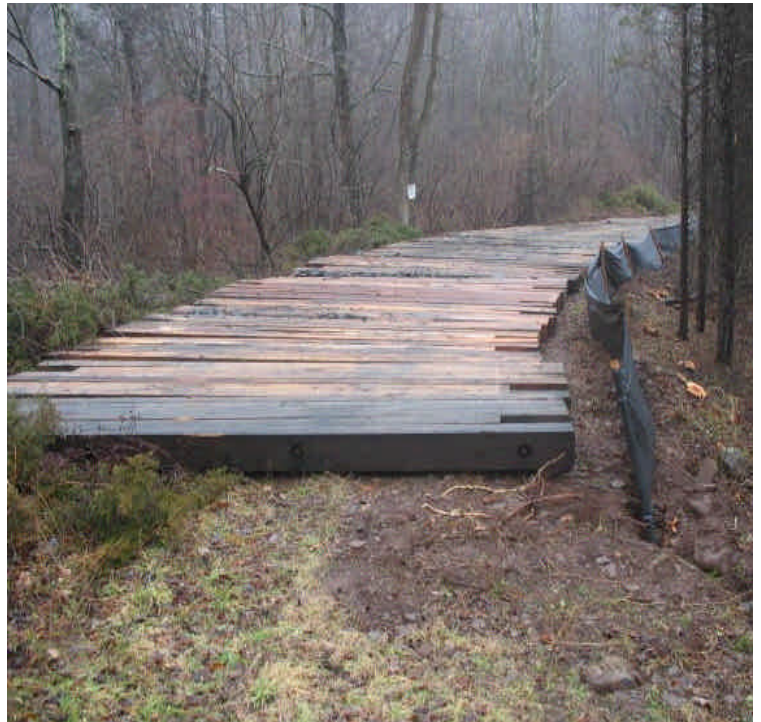
Silt fence and timber mat installation along an existing access road off Powder Hill Rd. The installation follows an existing road through a wetland and was determined to be maintenance by the contractor. Silt fence protects an existing pond adjacent to the access road.
