Docket No. 272 – Development and Management Plan Inspection

Segment 4a Underground Line

Date: December 6, 2006

Location: Singer Substation to Fairfield/Westport Town Line

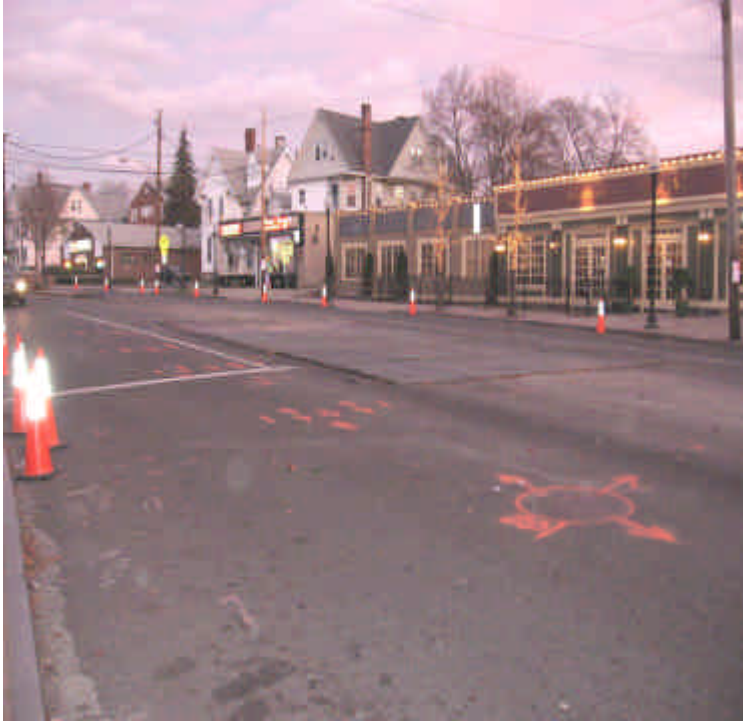
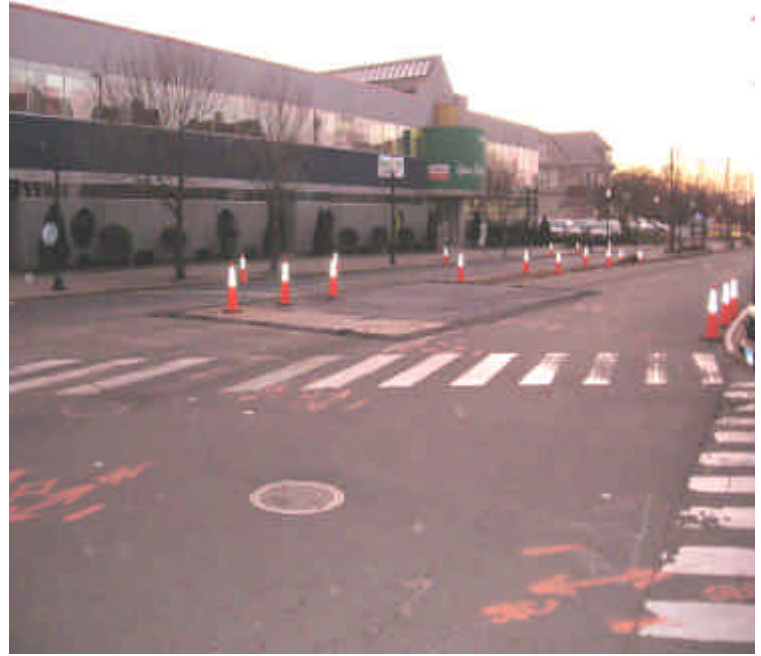
Vault #7540 installation activities on Rt. 1 near its intersection with Fox St. Photos were taken from the Fox St. intersection; Photo to the left was taken facing north, photo to the right was taken facing south.

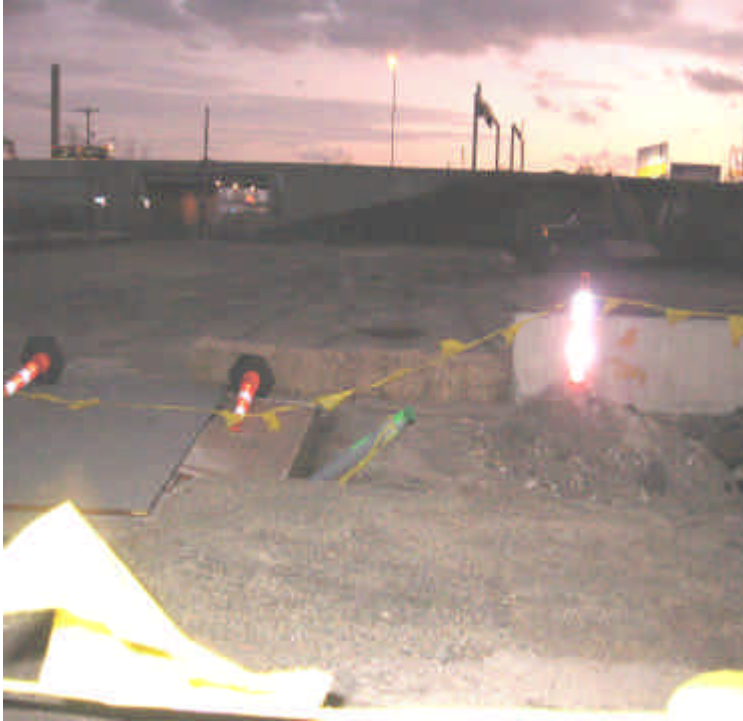
Photo taken from Railroad Ave. of trenching activities near its intersection with Bostwick Ave. Private storage yard with catch basin downgradient of activities is in background. A line of haybales have been placed between construction activities and catch basin to prevent sedimentation.

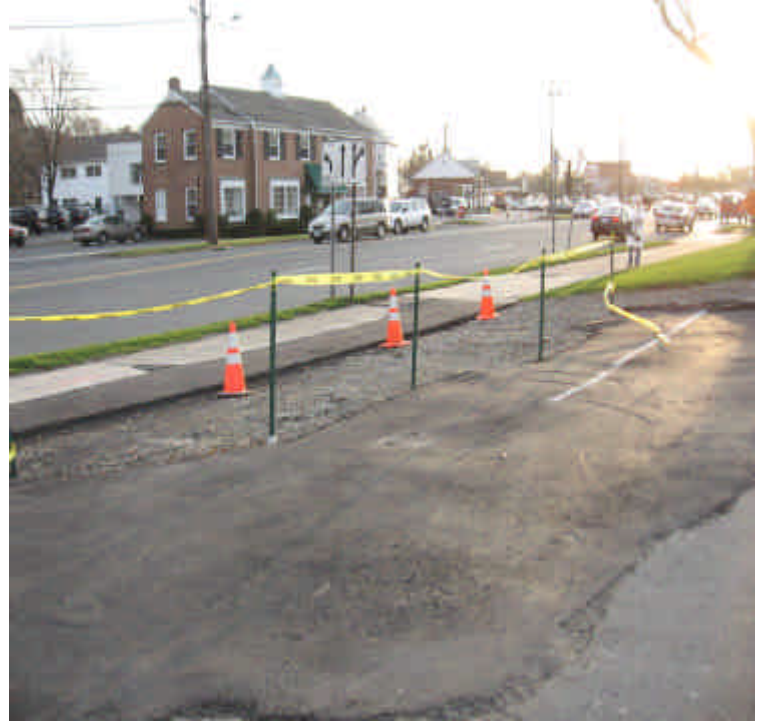
Photo of Vault #7536 location remains to be restored, but is temporarily stabilized.

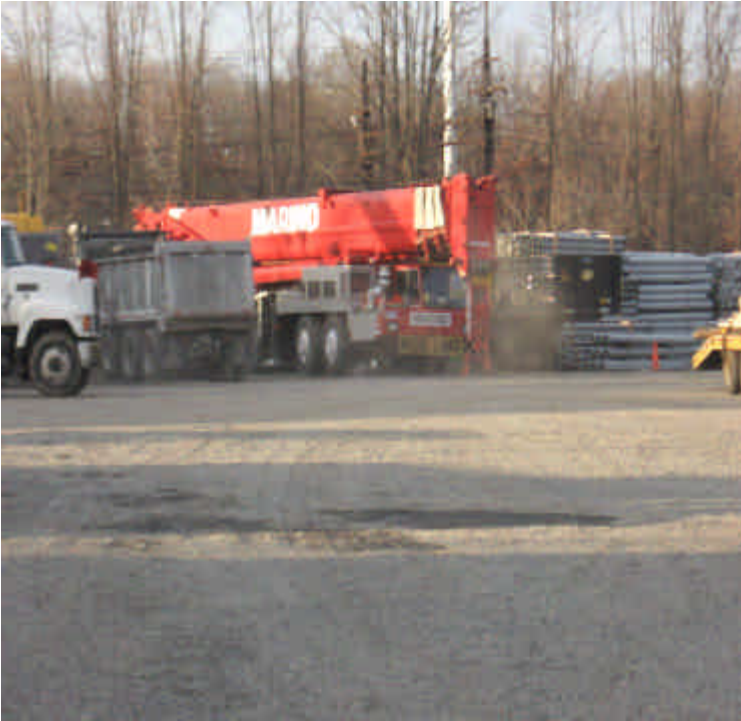
King's Highway Laydown Yard

Some airborne dust was noted in the yard during vehicle movement. Evaluate methods to control dust if necessary.

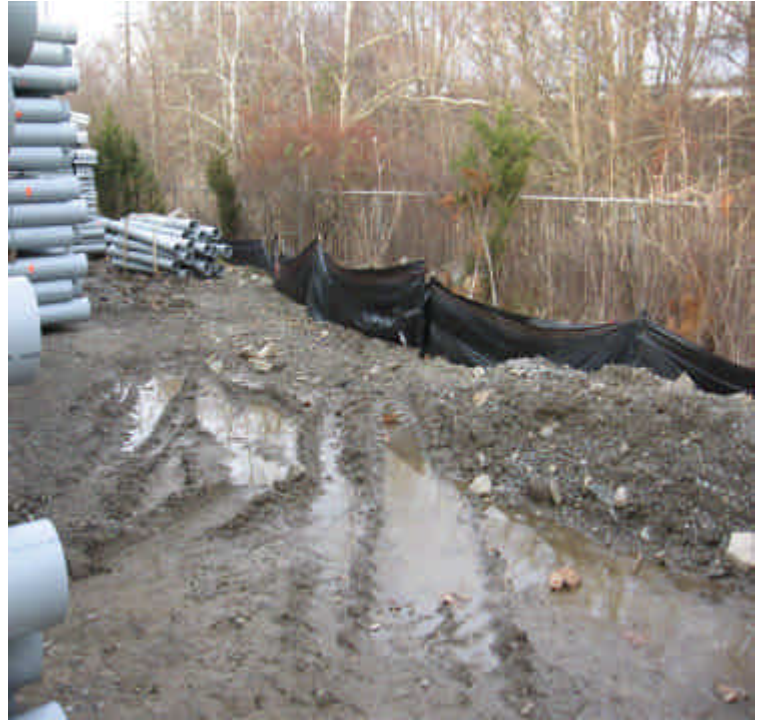
The portion of perimeter silt fence along the side of the yard adjacent to the sensitive area was repaired as recommended since the last inspection.

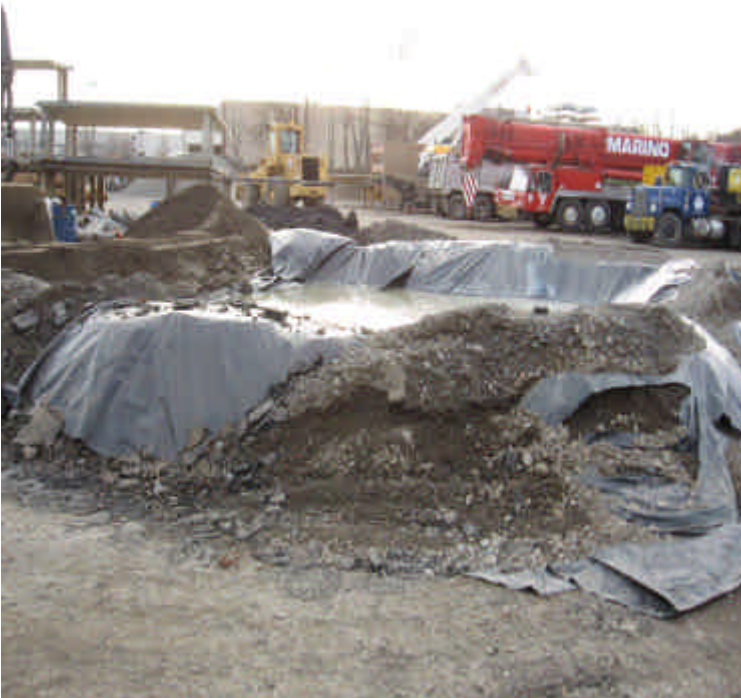
Newly constructed concrete washout basin that is properly lined with fabric and has additional storage capacity.

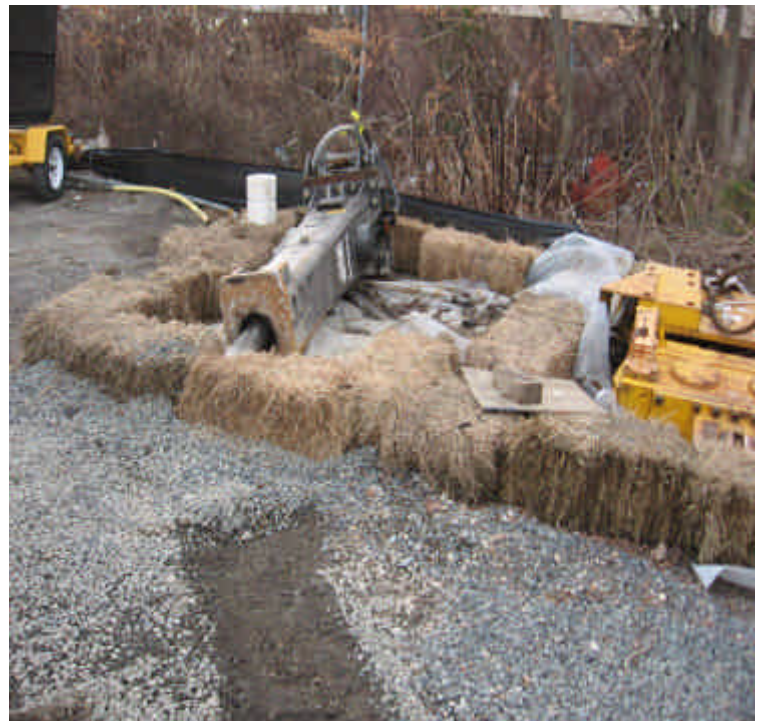
Equipment attachment storage area has now been fully enclosed with controls as recommended.
