Docket No. 272 – Development and Management Plan Inspection

Segment 4b Underground Line

Date: December 6, 2006

Location: Fairfield/Westport Town Line to Westport Avenue in Norwalk

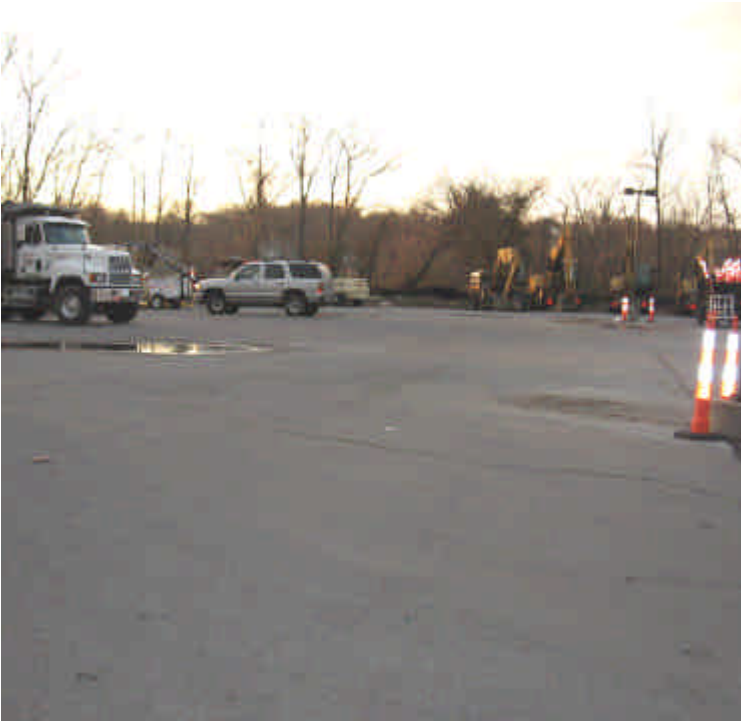
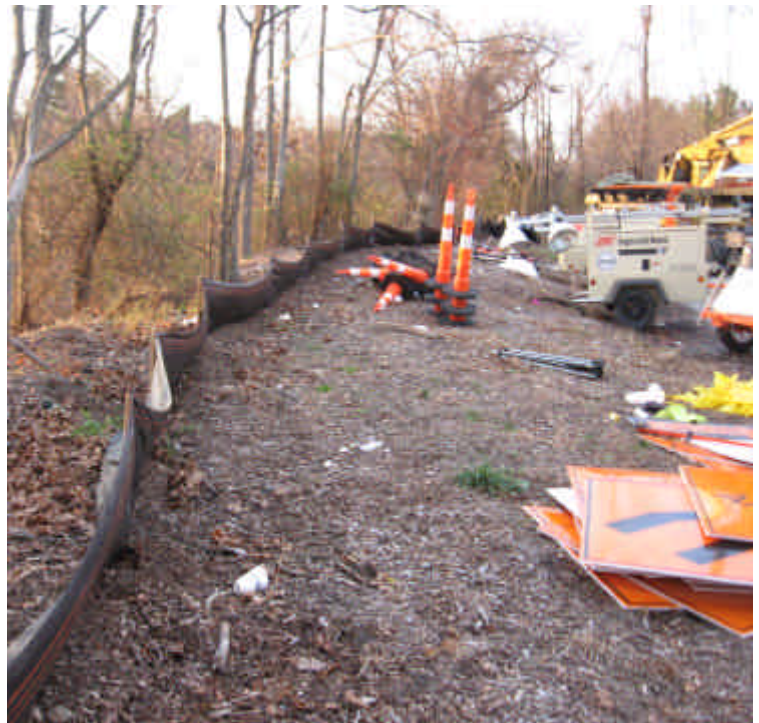
Both photos are of the new laydown yard in Westport on Imperial Ave. The yard is located immediately adjacent to the Saugatuck River on the southwest, west, and north sides. Erosion controls are in place around the perimeter of the yard, adjacent to the river.

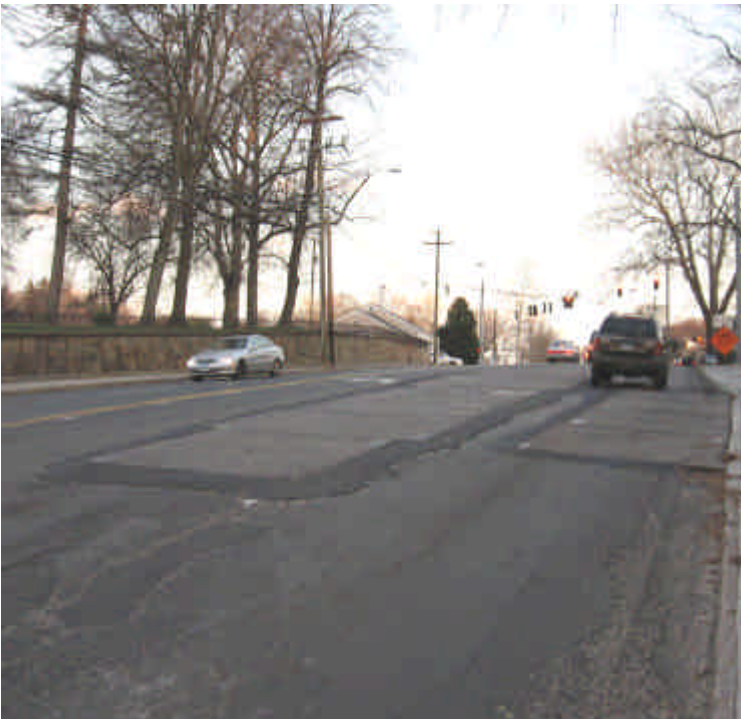
Photo taken on Rt 1 looking towards N. Compo Rd. at the trenching activities.

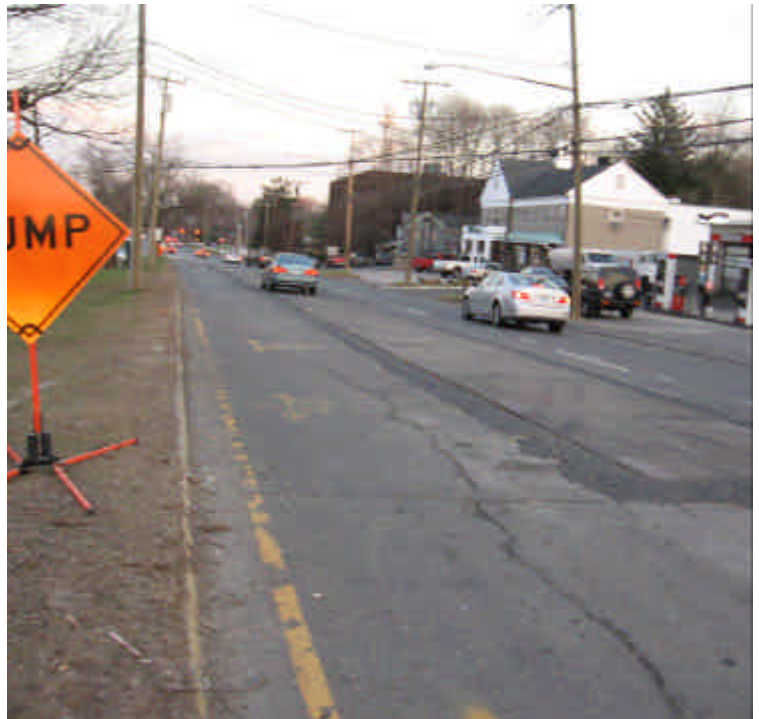
Photo of trenching activities on Rt. 1 near its intersection with Long Lots Rd.

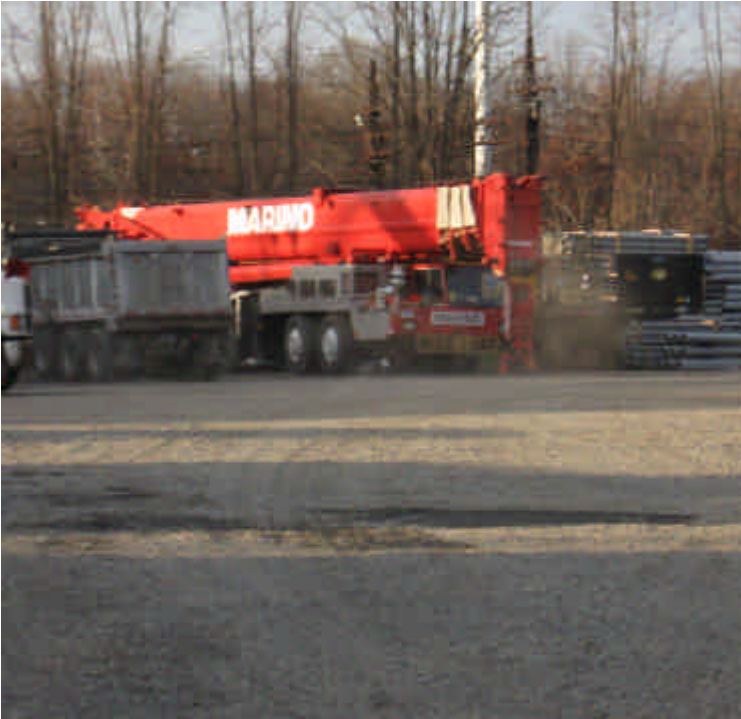
King's Highway Laydown Yard

Some airborne dust was noted in the yard during vehicle movement. Evaluate methods to control dust if necessary since the last inspection.

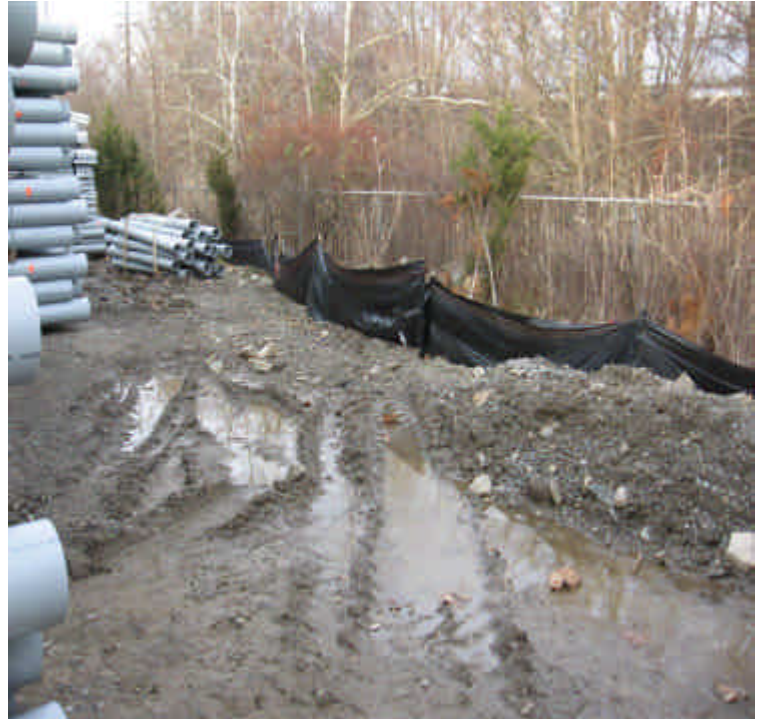
The portion of perimeter silt fence along the side of the yard adjacent to the sensitive area was repaired as recommended

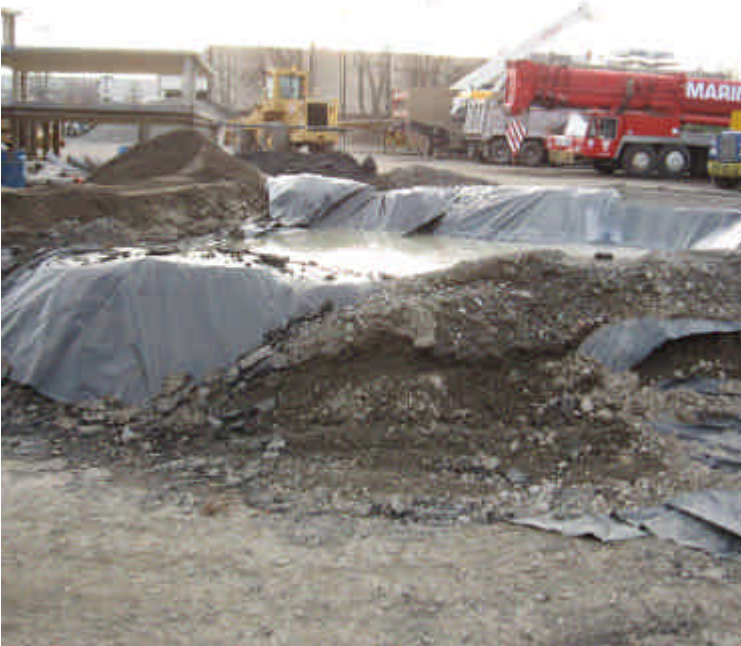
Newly constructed concrete washout basin that is properly lined with fabric and has additional storage capacity.

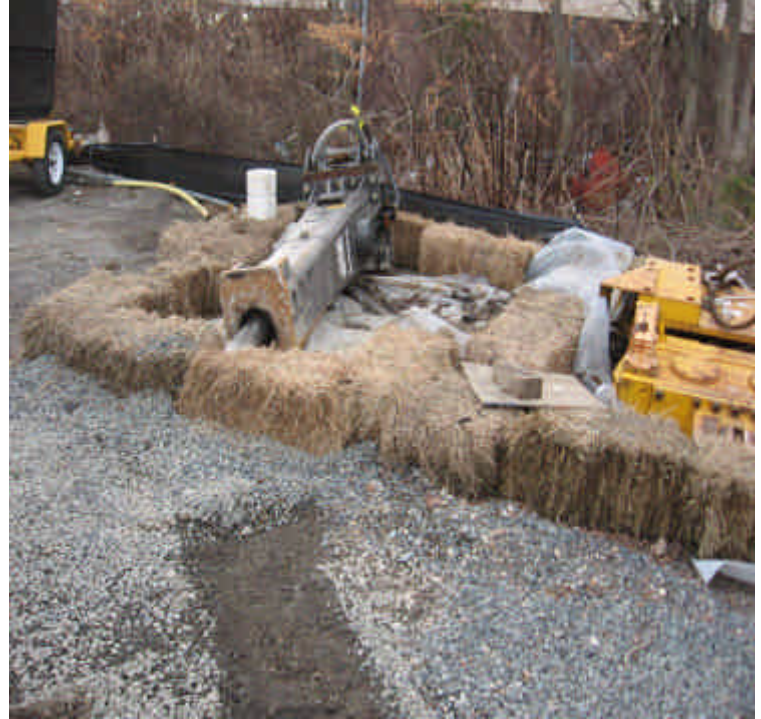
Equipment attachment storage area has now been fully enclosed with controls as recommended.
