Docket No. 272 – Development and Management Plan Inspection

Beseck Switching Station Inspection

Date: February 6, 2007

Location: Beseck Switching Station

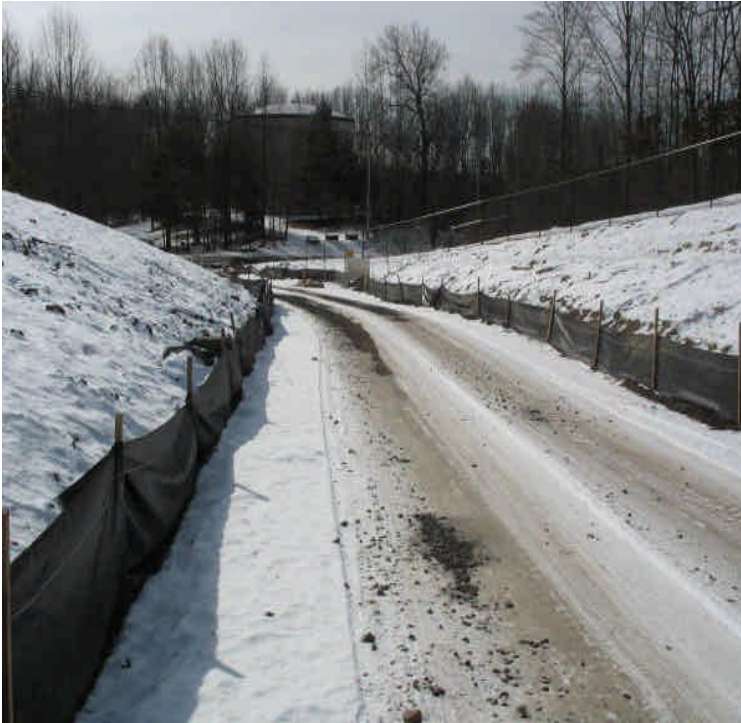
Site entrance off Carpenter Lane is at final grade; erosion controls are intact along the driveway. Monitor carefully for run-off.

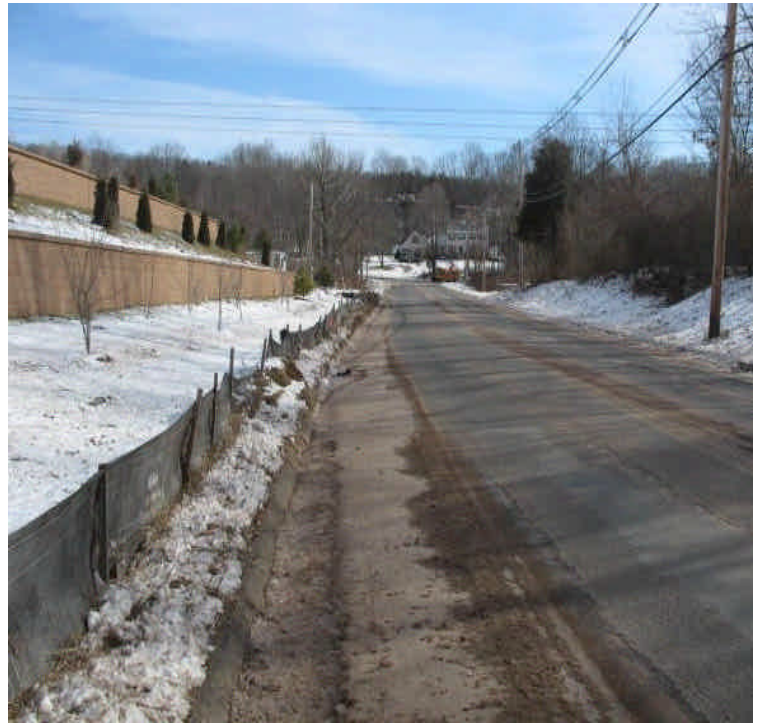
View of Carpenter Lane and retaining walls. Sand accumulation was noted along the gutters from town plows and sanders but is not a result of the project. Gutter buddies were removed from the catch basins during plowing but liners are in place.

Catch basin liners along Carpenter Lane were in good shape. The torn liner across the roadway has been replaced. Town plowing and sanding of the roadways required removal of gutter buddies	Continue to monitor and maintain liners and controls. Restore gutter buddies when feasible. 2/6/07	The torn CB liner was replaced. Needs regular attention

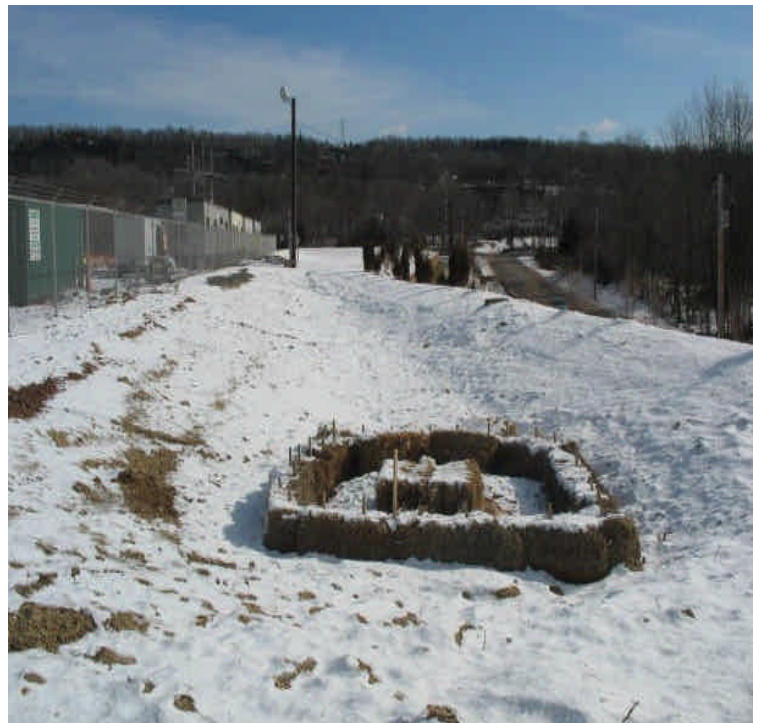
Surface areas on site are temporarily stabilized with tackified hydroseed and as a result of freezing temperatures. Haybales are in place at the inlet and no run-off was noted this week.

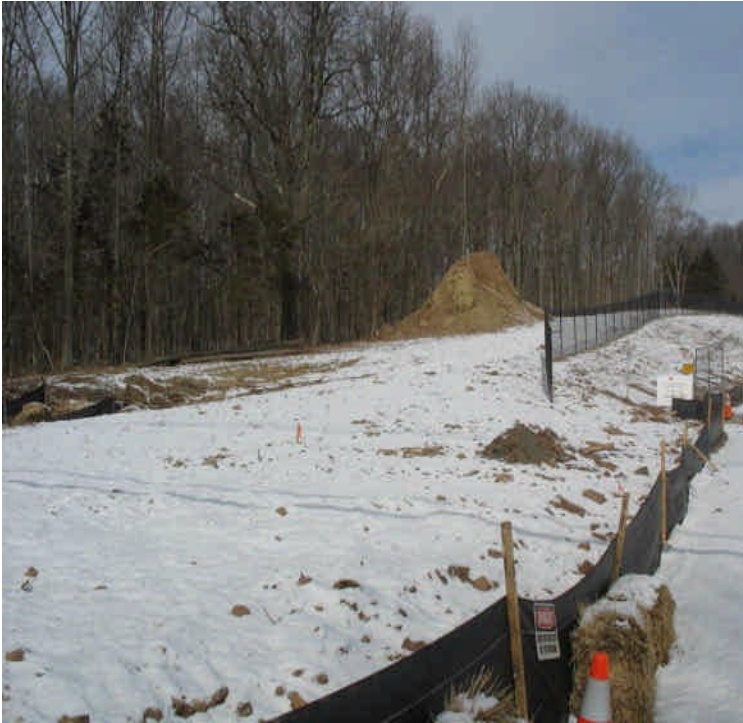
Haybales were placed across the old Zolnik driveway. The remaining stockpile and exposed surfaces are temporarily stabilized with hydro-seed and as a result of freezing temperatures.

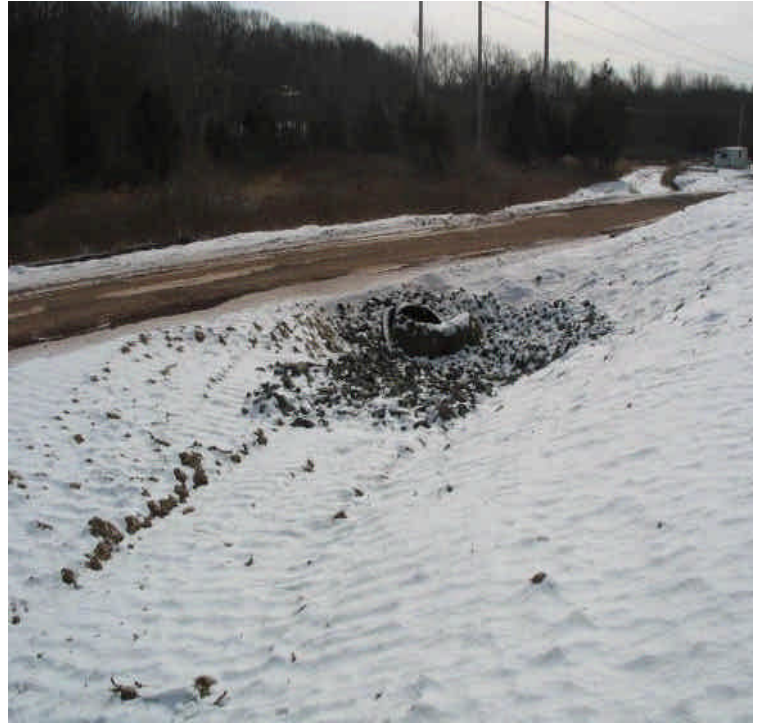
View of the culvert under the new access road. A minor amount of sediment was noted but appears well contained within the trap. Beseck and Seg. 1A contractors are jointly sharing the access road.

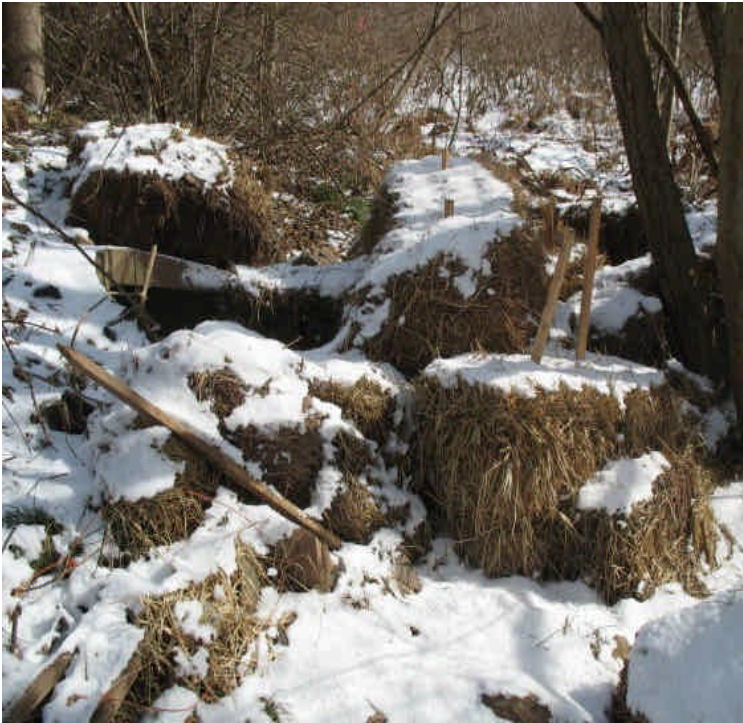
<p>The storm water outlet pipe at the wetland across Carpenter Lane has several layers of haybales in place to help filter turbid water. Ice was observed within the culvert outlet but sedimentation was not apparent. In general, sediment from the site is very fine and difficult to filter but increased efforts on site appear to have helped. 2/6/07</p>	<p>Haybales should be monitored and replaced as needed at the storm drain outlet. Stormwater should continue to be contained and filtered before leaving the site. Always closely monitor dewatering activities. See dewatering section. 2/6/07</p>	<p>The quality of stormwater remains improved.</p>
<p>Inland Wetland and Watercourse encroachment and mitigation</p>	<p>Turbid water within the wetland and outlet across Carpenter Lane appears to have settled out of the water column but ice cover made evaluation difficult. Ice was also observed at the outlet pipe so flow was not apparent. Sediment is extremely fine and difficult to remove or</p>	<p>Several areas have sediment accumulation. Sediment should be removed from the outlet and adjacent areas when water levels recede 12/26/06- 2/6/07. It will be evaluated whether the accumulation justifies the minor disturbance required to remove it. 1/23-2/6/07</p>	<p>Ice cover/frozen conditions have helped to temporarily stabilize the area.</p> <p>Continue to evaluate</p>

Sediment appears to have settled out at the storm drain outlet across Carpenter Lane. Ice was observed in the culvert but sedimentation was not apparent. The additional efforts on site appear to be effective at reducing sediment. Continue to monitor.

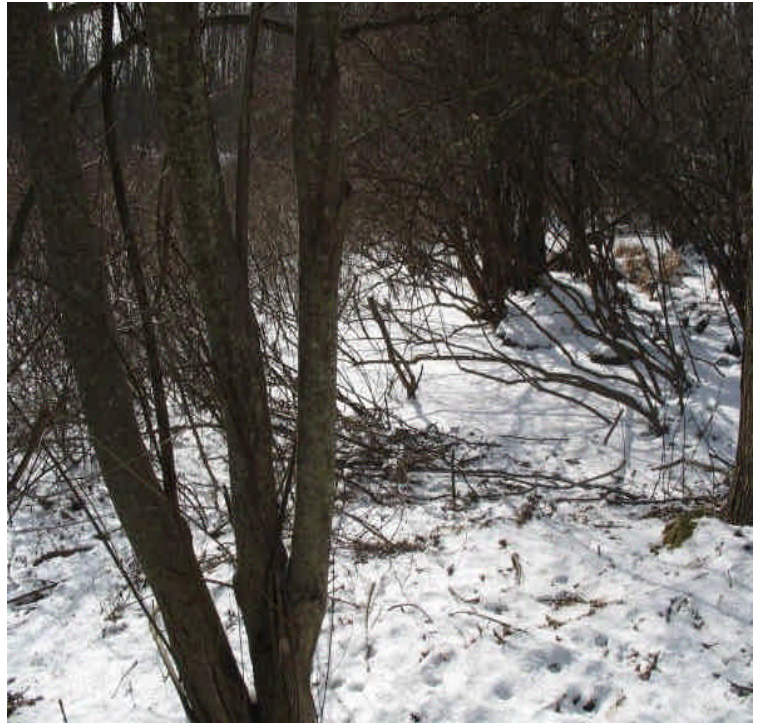
Snow and ice cover made observation difficult in the wetlands across Carpenter Lane. Sediment removal may still be necessary once the water level subsides. It will be evaluated whether the amount of accumulation justifies the minor disturbance to remove it.
