**Docket No. 272 – Development and Management Plan Inspection**

**Beseck Switching Station Inspection**

**Date:** February 27, 2007

**Location:** Beseck Switching Station

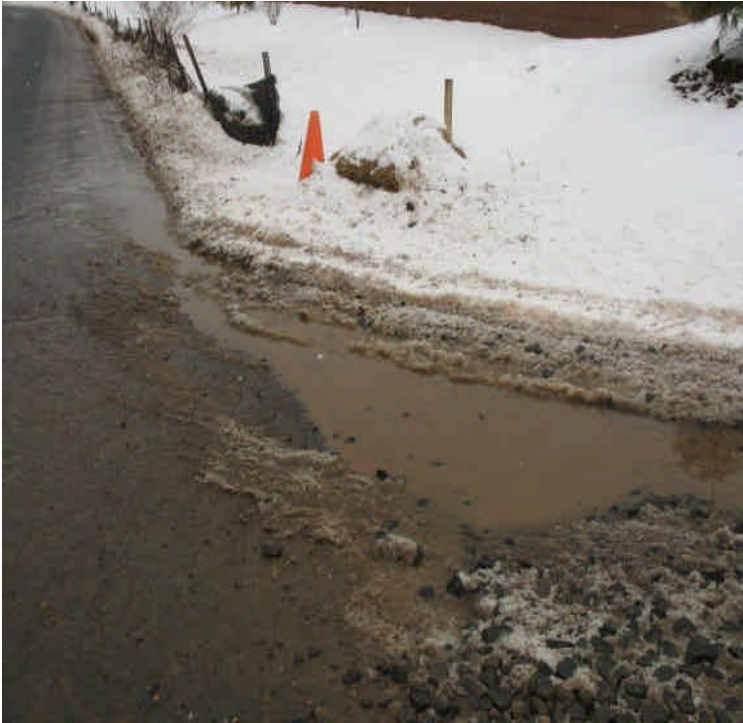
**Site entrance/exit off Carpenter Lane is at final grade; erosion controls are intact along the driveway. Minor amounts of turbid run-off were noted reaching the roadway.**

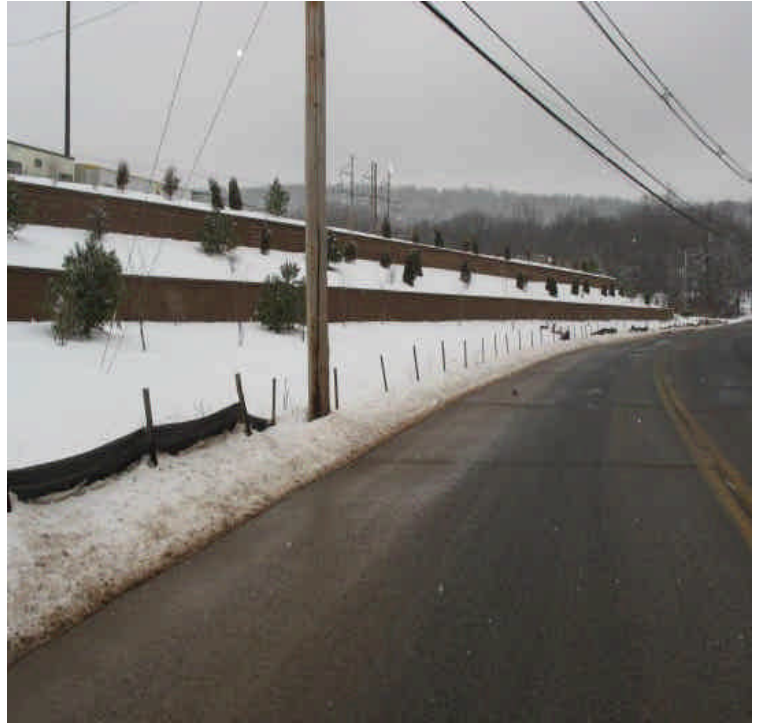
**View of Carpenter Lane and retaining walls. Sand accumulation was noted along the gutters from town sanders but is not a result of the project. However, catch basins controls could use maintenance.**

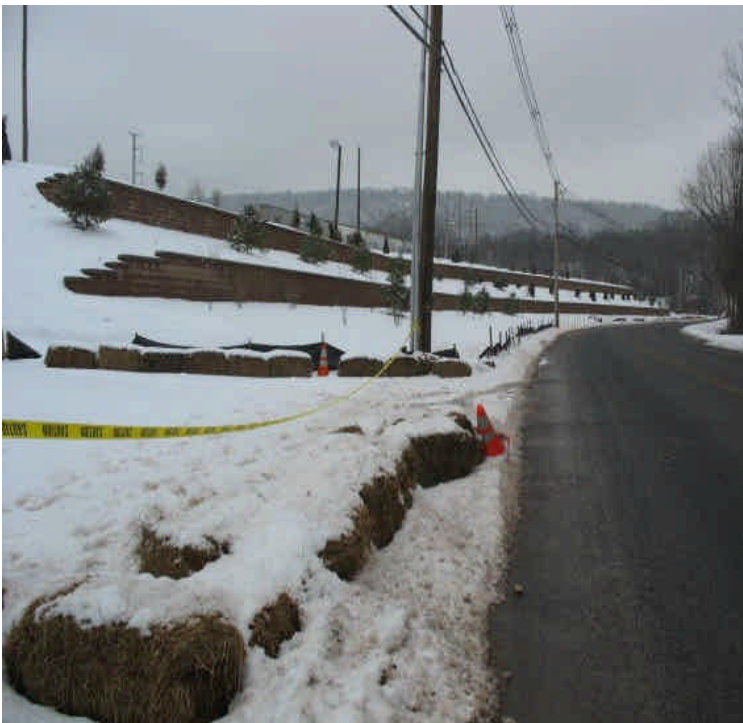
**Haybales were placed across the closed site entrance (west side) in an effort to reduce turbid run-off from the site. A small detention area was also constructed. Snow cover also helps to stabilize the area; continue to monitor during thaw periods.**

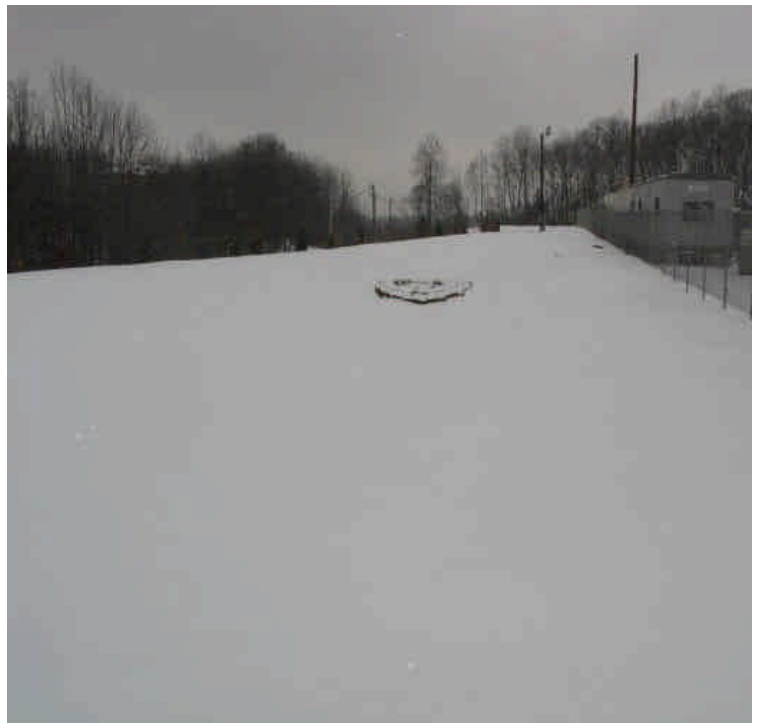
**Surface areas on site are temporarily stabilized with snow cover. Haybales and controls remain in place at the inlet of the detention basin.**

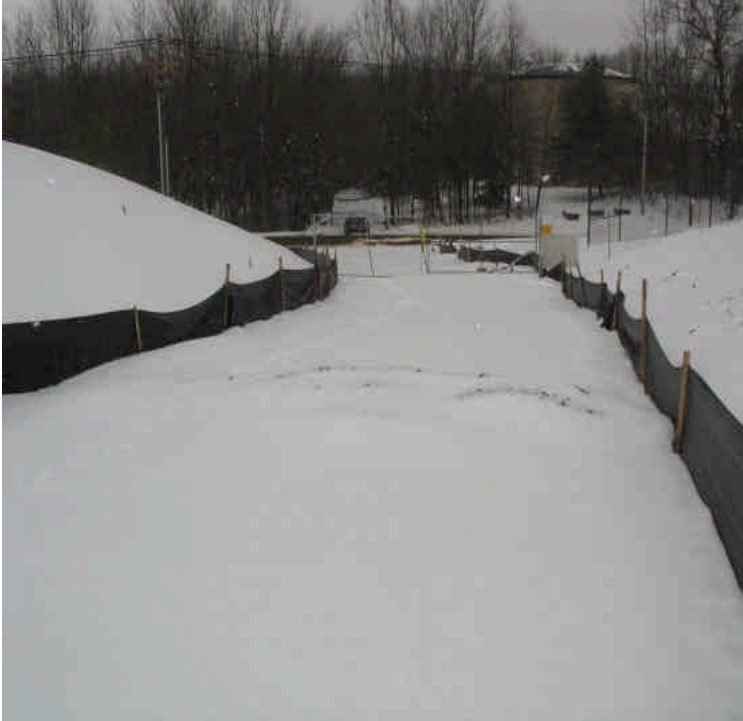
**Another view of the closed site entrance where a water bar was installed in an effort to divert turbid run-off from leaving the site.**

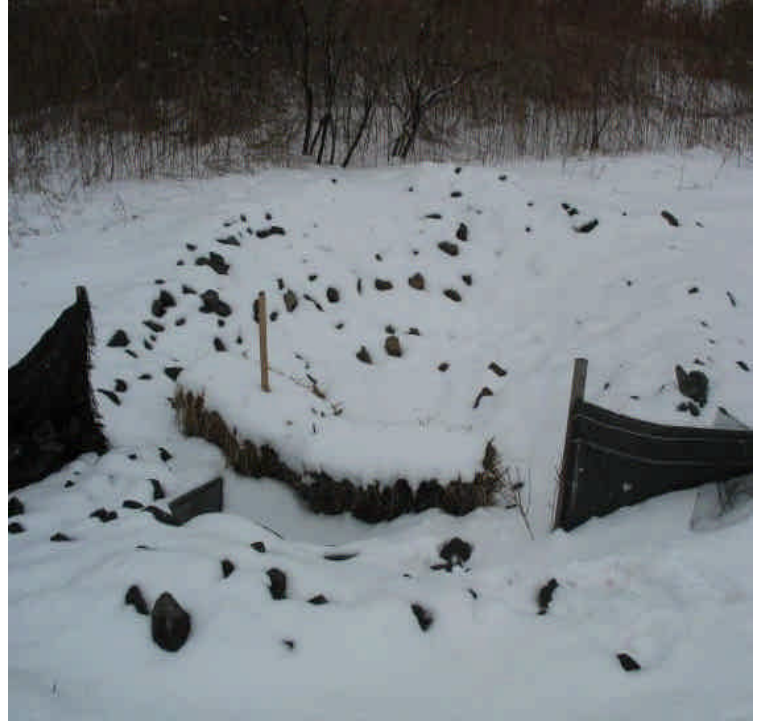
**View of the culvert under the new access road. Turbid water from last week has since filtered out of the trap. Sediment appears contained within the trap.**

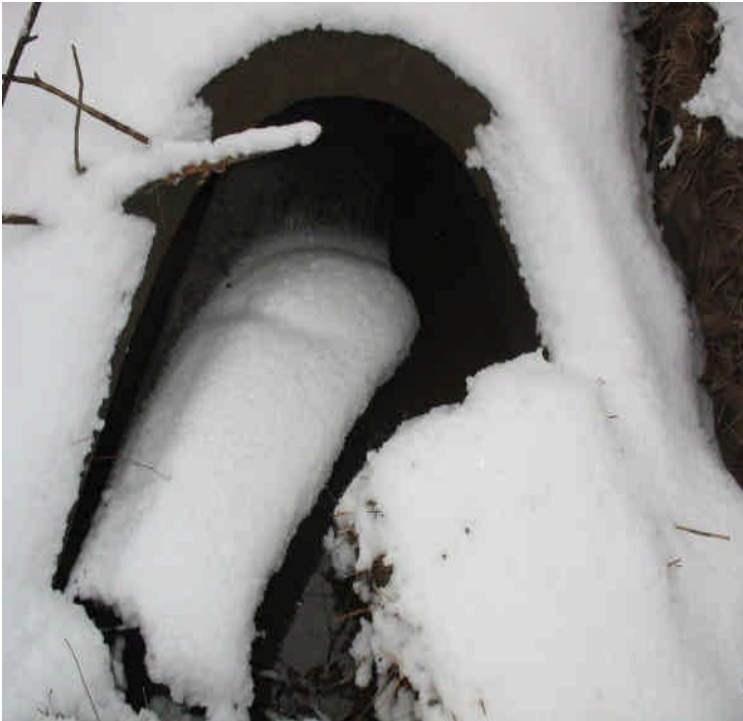
**Storm drain outlet across Carpenter Lane has clear water flowing through the haybales. Ice and snow cover were observed in the culvert and wetlands. The majority of sediment appears to be retained onsite.**

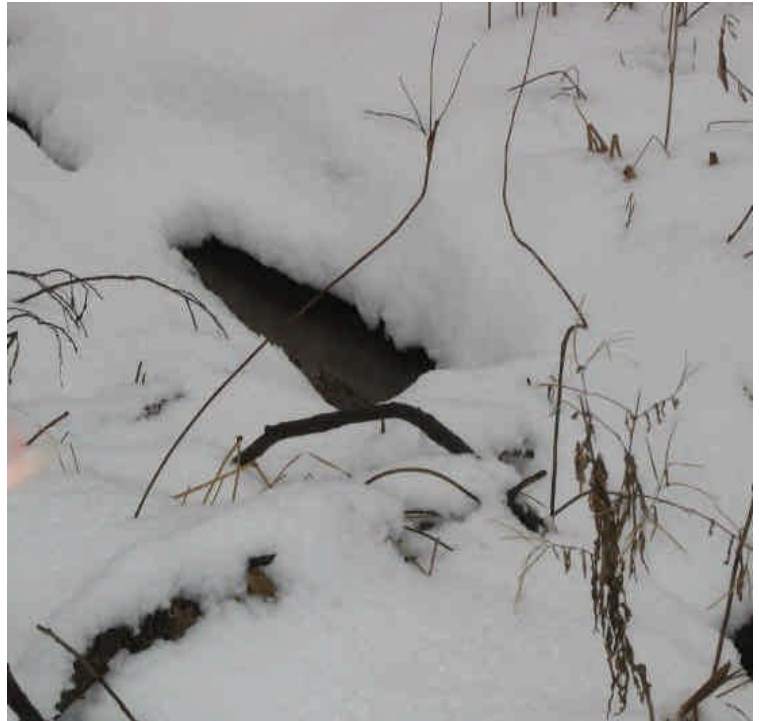
**Snow and ice cover made observation difficult in the wetlands across Carpenter Lane. Clear water was observed leaving the haybales and entering the wetlands. Evaluate whether the amount of sediment accumulation justifies the minor disturbance needed to remove it, once the water subsides.**
