Docket No. 272 – Development and Management Plan Inspection

Scovill Rock Switching Station Inspection

Date: February 20, 2007

Location: Scovill Rock Switching Station

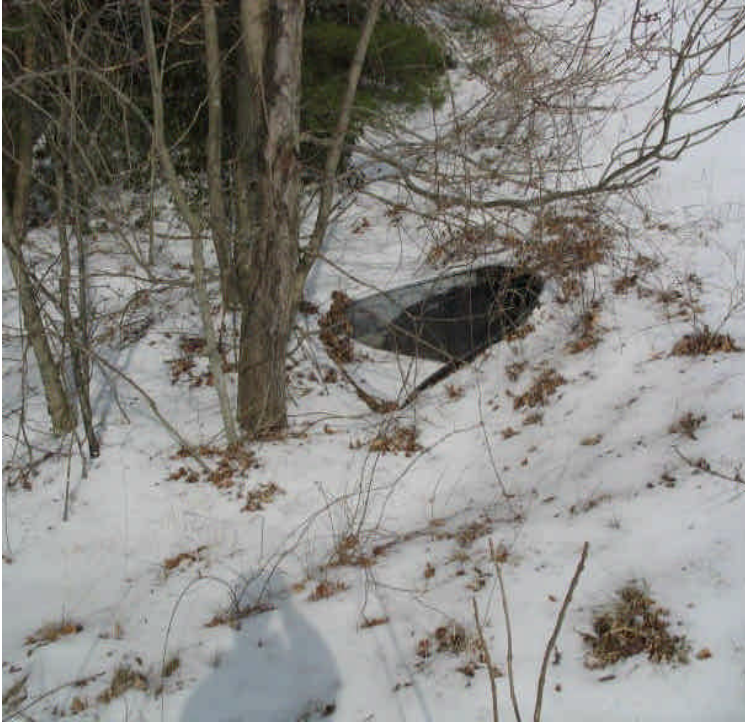
| Areas of Inspection | Observation | Recommended Action | Corrected Action |
|---|--|--|---|
| | No sedimentation issues have been observed at the culvert under the access driveway. 2/20/07 | Closely monitor any work done near the culvert. 2/20/07 | NA |

View of the culvert under the access drive. No sediment issues have been observed.

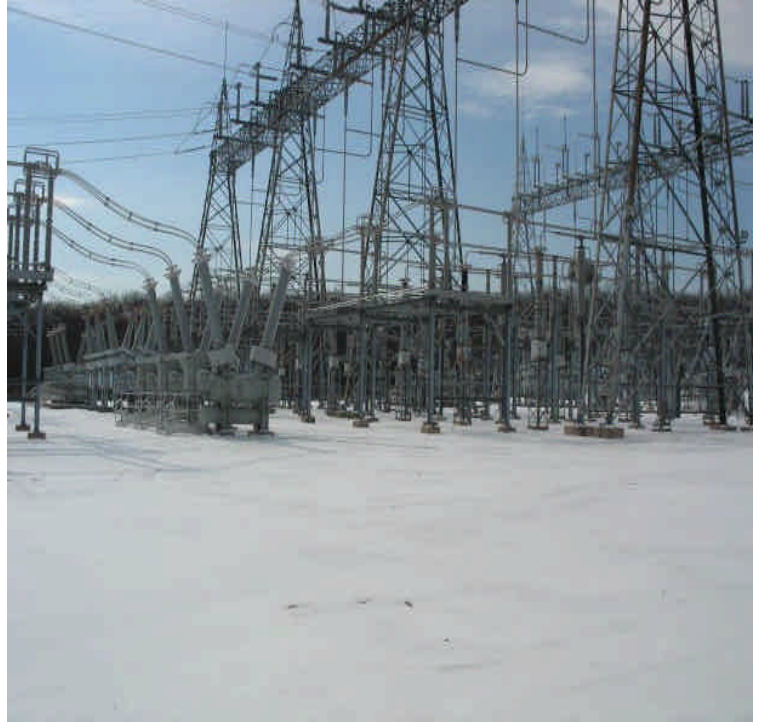
| Areas of Inspection | Observation | Recommended Action | Corrected Action |
|---|--|--|---|
| Foundation and site construction | Structural and foundation work appears complete. 2/20/07 | None 2/20/07 | NA |

The site is stable and civil and structural work in the yard appears to be complete.

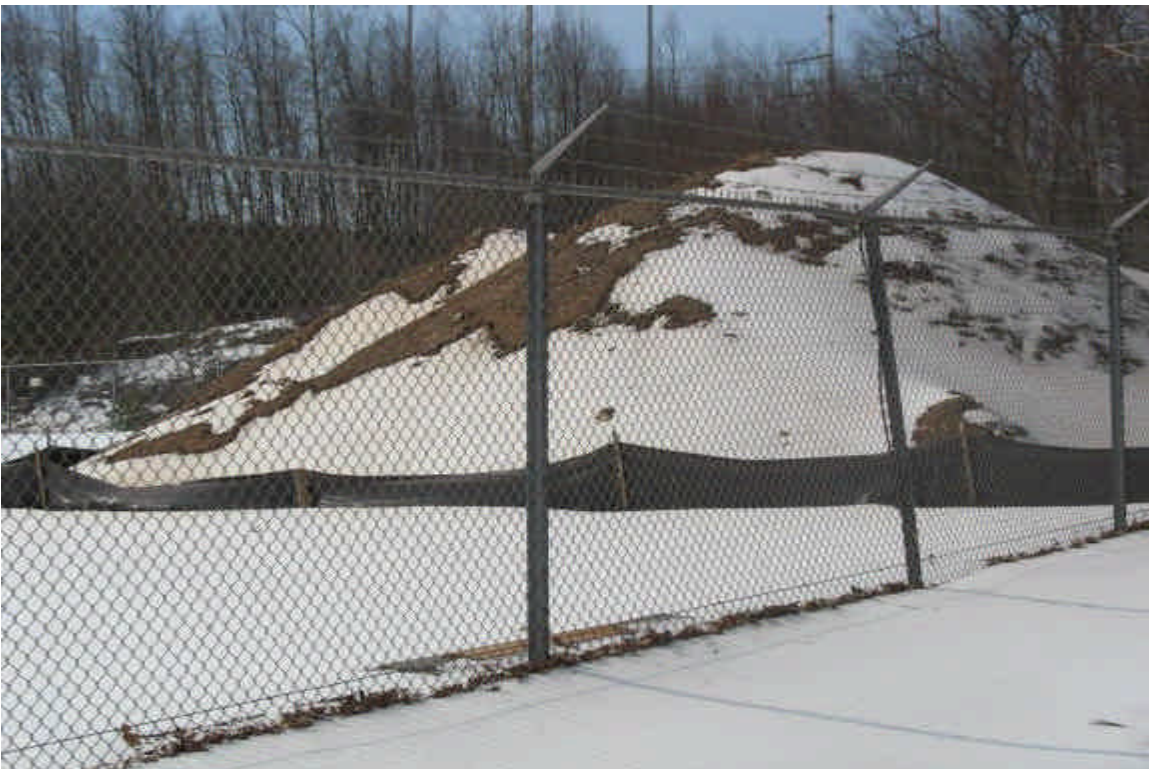
| Areas of Inspection | Observation | Recommended Action | Corrected Action |
|---|--|--|---|
| | One stockpile remains in the yard, surrounded by intact silt fence and a flat crushed stone surface. It | Once soil analysis is complete, remove soil and dispose of properly. Soils are contained within | NA |

| Areas of Inspection | Observation | Recommended Action | Corrected Action |
|---|---|--|---|
| Erosion and sediment controls (continued) | will be removed after soil analysis. 11/7/06-2/20/07 | the yard. 11/21/06-2/20/07 Surrounding land is level and sediment issues are not likely. | NA |

Soil stockpile to be removed with controls in place. No sediment issues have been observed.
