Docket No. 272 – Development and Management Plan Inspection

Scovill Rock Switching Station Inspection

Date: February 26, 2007

Location: Scovill Rock Switching Station

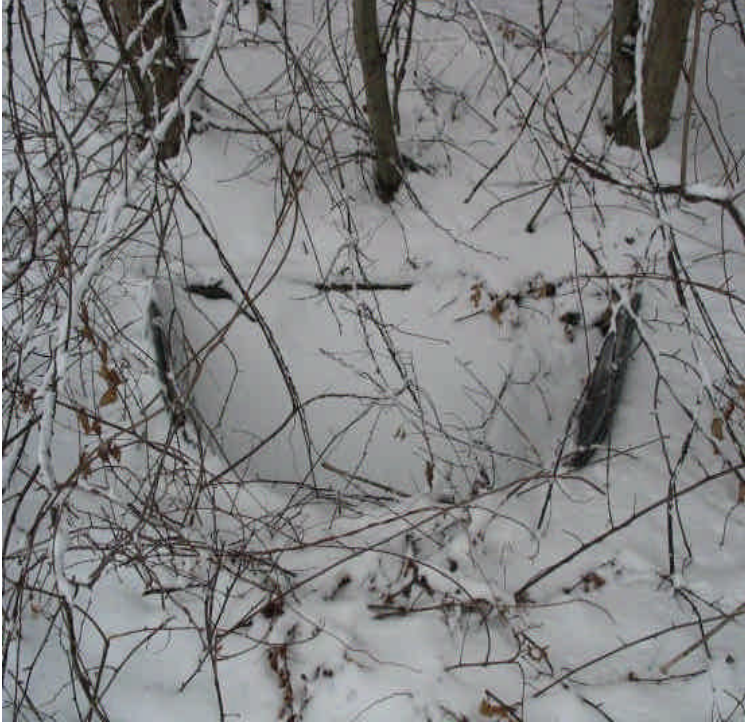
View of the culvert under the access drive. No sediment issues have been observed. Heavy snow cover is present.

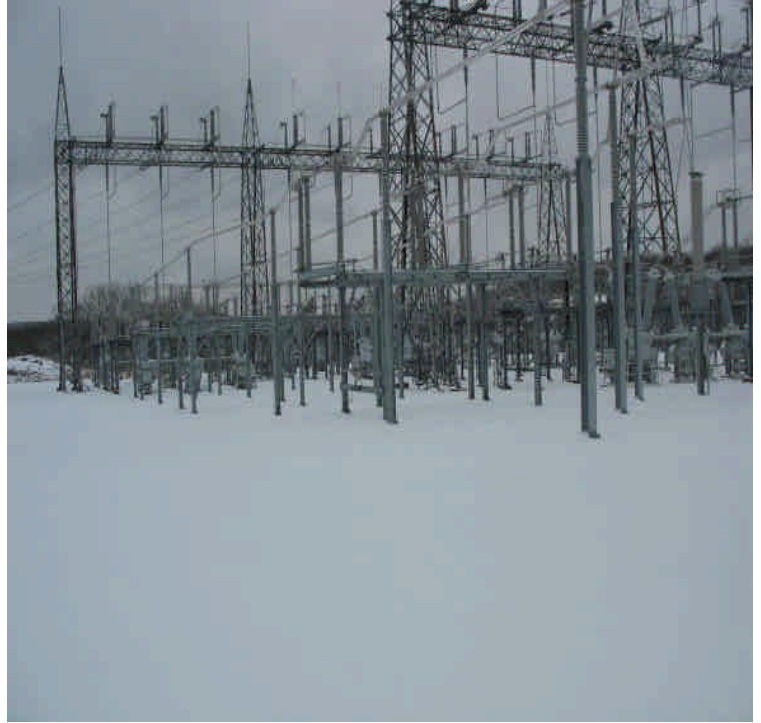
The site is stable and civil and structural work in the yard appears to be complete.

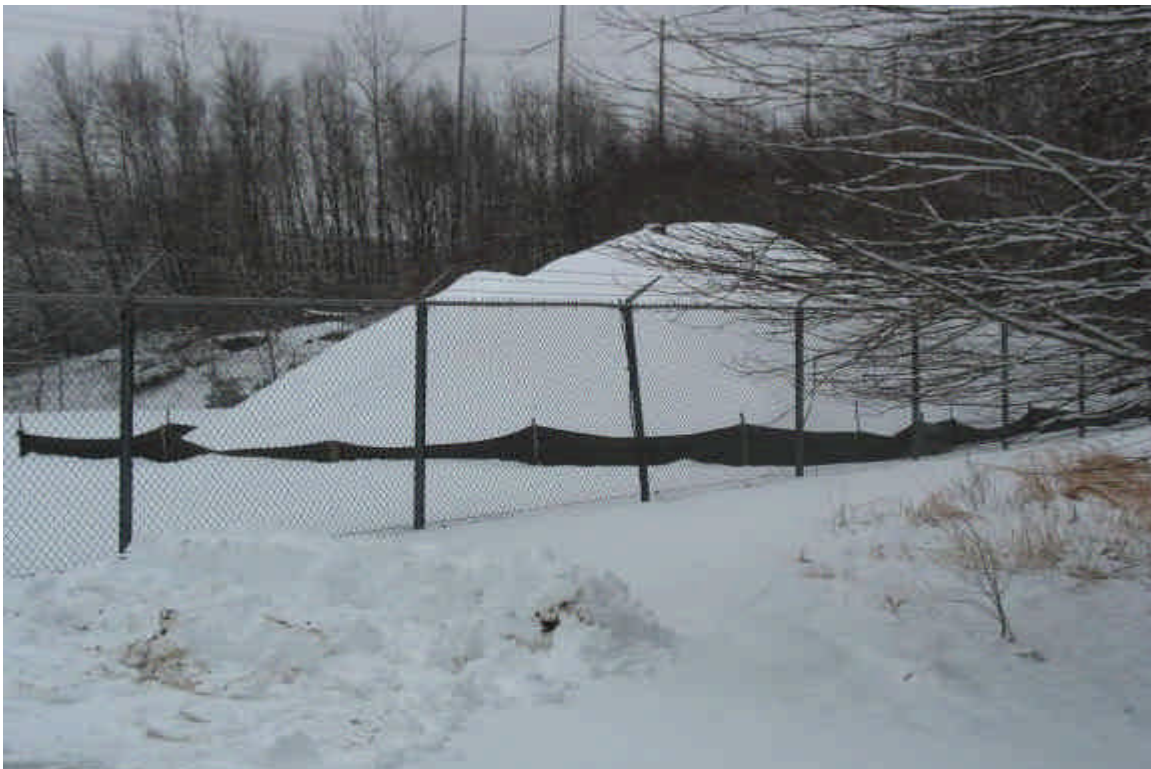
One stockpile remains in the yard, surrounded by intact silt fence and a flat crushed stone surface. It	Once soil analysis is complete, remove soil and dispose of properly. Soils are contained within	NA

Soil stockpile to be removed. Controls are intact and sediment issues have not been observed.
