Docket No. 272 – Development and Management Plan Inspection

Segment 1a Inspection

Date: February 20, 2007

Location: Segment 1a – Scovill Rock Switching Station to Chestnut Junction, Oxbow Junction to Beseck Switching Station (excluding Royal Oak Bypass), and Black Pond Junction to Beseck Switching Station

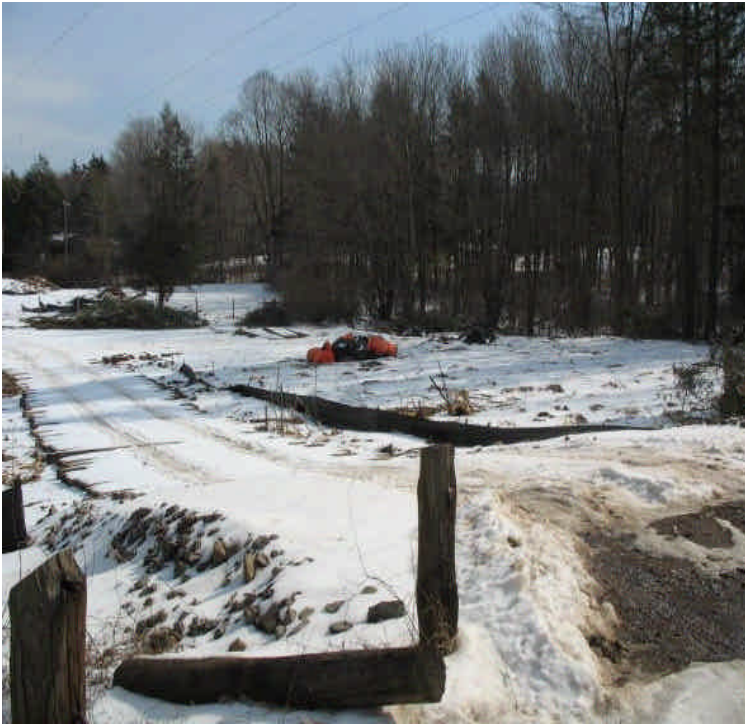
Foundations installed last week along ROW between Little Lane and Route 17.

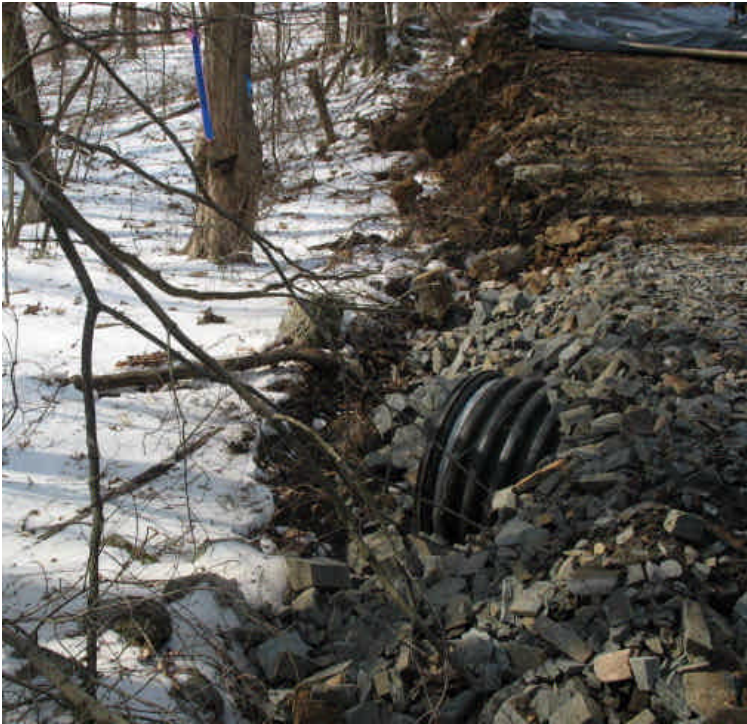
<p>Black Walnut Dr.</p>	<p>Access road was being extended east across a small wetland and stream. A culvert was being installed and a slope was being graded to lessen the incline to the next staging area. 2/20/07</p>	<p>Ensure that water bars and or silt fence (or similar controls) are installed at the base of slope here as required by the D&M. 2/20/07</p>	<p>NA at this time (add controls with remainder of work)</p>
<p>Black Pond, Little Lane, Contractor Receiving Yard, Rt. 17, Powder Hill Rd.</p>	<p>Access roads and stone tracking pads are in place at the ROW entrance. Associated roadways were free of project related sediment at this time. 2/20/07</p>	<p>Sweep the roadways and refresh stone as needed. Clean existing controls in CBs as necessary. 2/20/07</p>	<p>NA</p>
<p>Little Lane</p>	<p>Access road connecting Little Ln. to Rte. 17 was in place. Access includes timber mats and a (temporary) culvert to cross a section of wetlands and small stream. Access road construction continues west of Little Ln. 2/20/07</p>	<p>Monitor activities and add controls, as needed. Culverts are temporary and are will be restored at the completion of work. 2/20/07</p>	<p>NA</p>

Close-up view of culvert installation off Black Walnut Dr. Ensure water bars and/or silt fence are installed along the access road base of slope to protect wetlands.

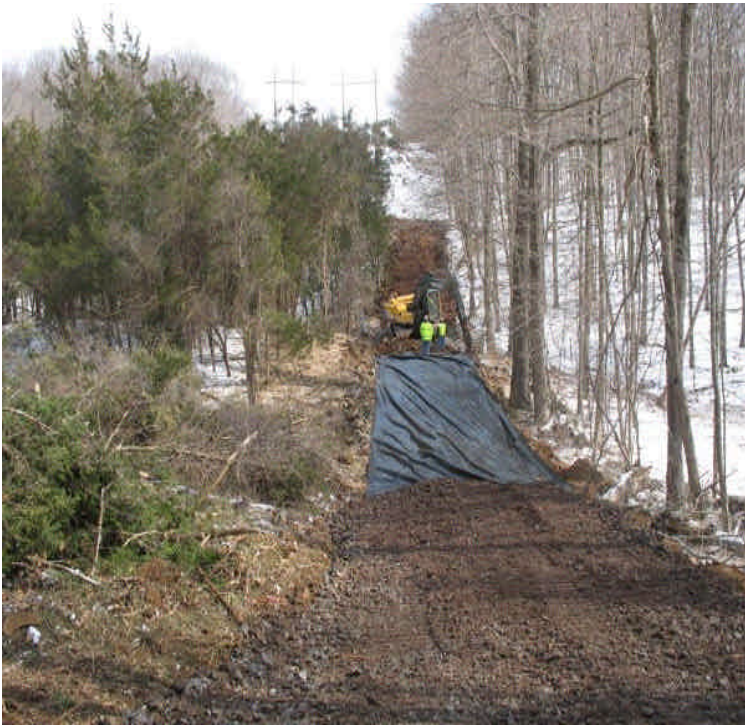
Additional view of access road and culvert installation off Black Walnut Dr.

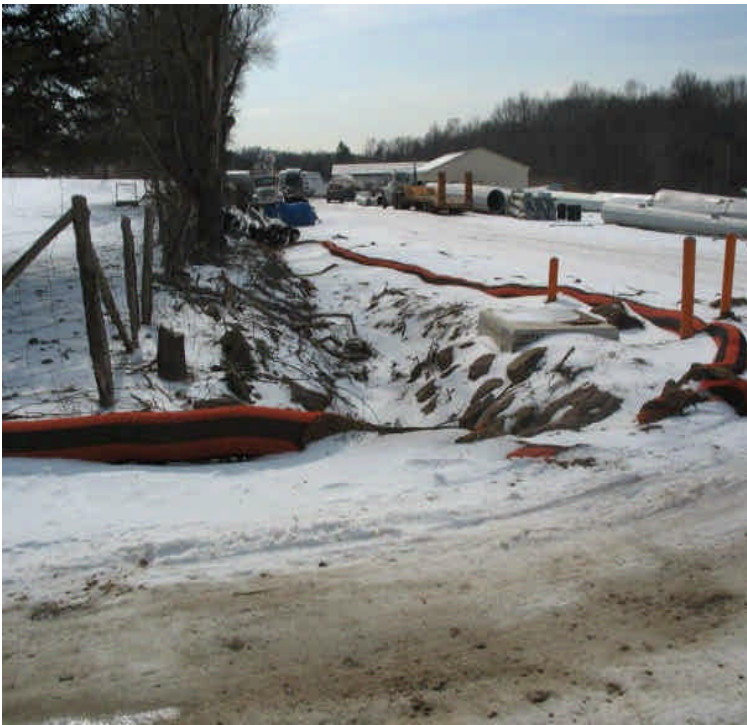
Areas of Inspection	Observation	Recommended Action	Corrected Action
<p>Contractor Receiving Yard and Storage Area</p>	<p>been run over along the access drive. 2/12-2/20/07</p> <p>The silt fence and fiber rolls at the perimeter of the yard and along drainage areas/swales appear to be holding up following a period of thaw this week. No sediment was noted leaving the site. 2/20/07</p>	<p>fiber roll. 2/12-2/20/07</p> <p>Continue to add, maintain, and monitor controls as necessary. 2/20/07</p>	<p>feasible.</p> <p>NA at this time.</p>
<p>North of Contractor Yard Along Rte. 17 and Little Lane</p>	<p>Timber mats and a culvert are in place at the wetlands and stream crossing. Silt fence are in place along the mats and access pads where needed moving west along Little Ln. 2/20/07</p>	<p>Monitor and maintain controls, adjust as needed. 2/20/07</p>	<p>NA</p>
<p>Durham Rd.</p>	<p>Wetland crossings were in place in this section of ROW. 2/20/07</p>	<p>Erosion controls may be needed along the edges of the new access road if sedimentation is noted Monitor surrounding wetlands closely. 2/20/07</p>	<p>Needs to be monitored</p>

Silt fence, fiber rolls, and hay mulch are in place as a buffer for wetlands around the perimeter of the contractor receiving yard. Replace the section of filter sock that was run over.

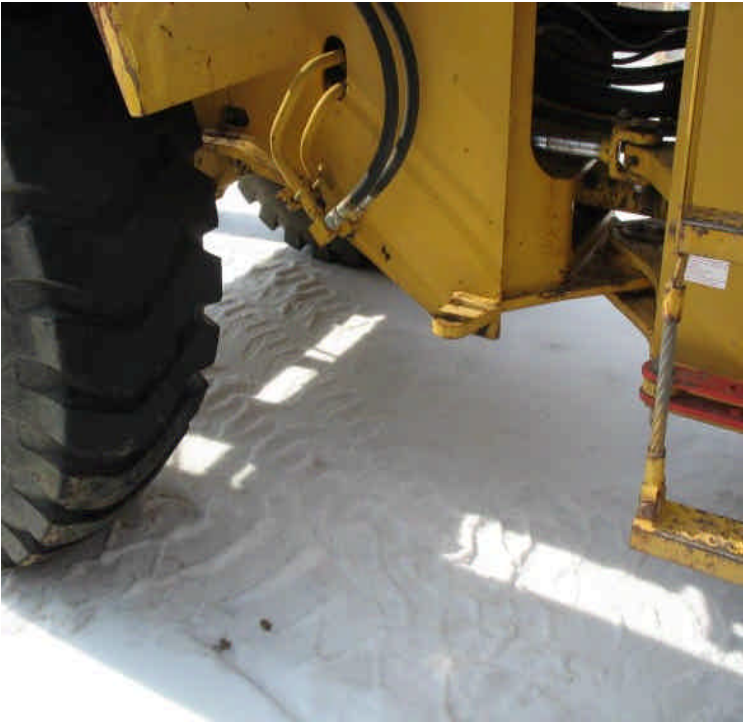
Areas of Inspection	Observation	Recommended Action	Corrected Action
<p>Contractor Receiving Yard and Staging Area</p>	<p>components, equipment, etc.) are being stored here, well away from any wetland resource areas.</p> <p>Materials are being stored and structures staged in this area. Fuel tanks are in place on their stone spill control pad. Fire extinguishers and spill kits are located near the fuel tanks. 2/20/07</p> <p>All fuel nozzles on site were controlled. 2/20/07</p> <p>The forklift was repaired this week and it was not observed to be leaking. 2/20/07</p> <p>Several drip stains were still noted on the stone pad at the refueling tanks. 1/22/07-2/20/07</p>	<p>materials away from resource areas.</p> <p>Always use spill control materials when working on equipment and during refueling. Continue to locate hazardous materials and equipment away from wetlands inlets such as culverts and CBs. when possible 2/20/07</p> <p>Make sure all fuel nozzles are being properly stored after every use. 2/20/07</p> <p>If necessary, pick up any larger areas of soil where old drip stains are noted. 2/20/07</p> <p>Spill controls should always be used when equipment is leaking during refueling and equipment maintenance. 1/22-2/20/07</p>	<p>A stone pad is in place for spill control</p> <p>Nozzles were controlled</p> <p>The forklift was repaired and a leak was no longer noted.</p> <p>Contractors are looking into solutions here.</p>

The leaking forklift in the contractor receiving yard has been repaired.

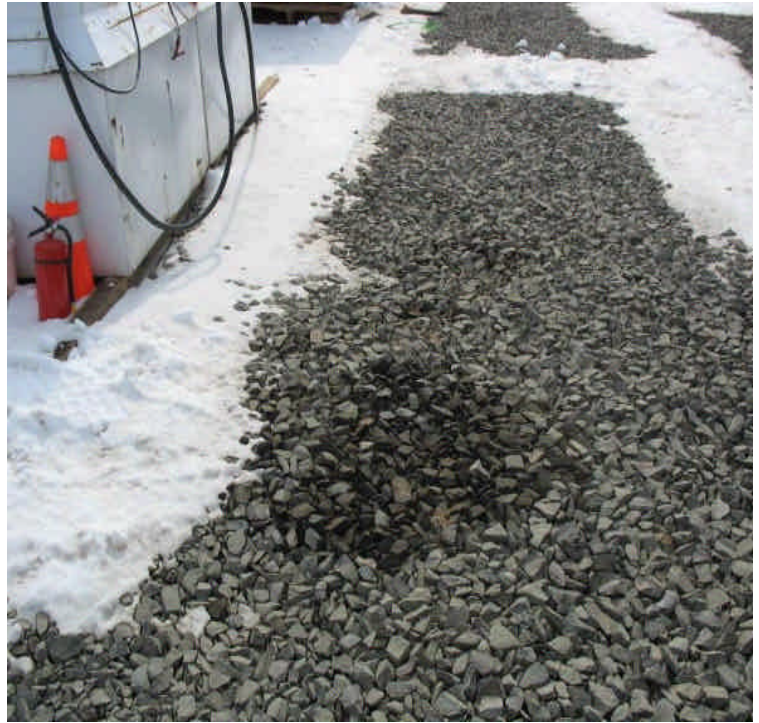
The fuel storage tanks remain in place on the stone spill pad and nozzles are contained. Small drip stains are noted and are contained to the stone.

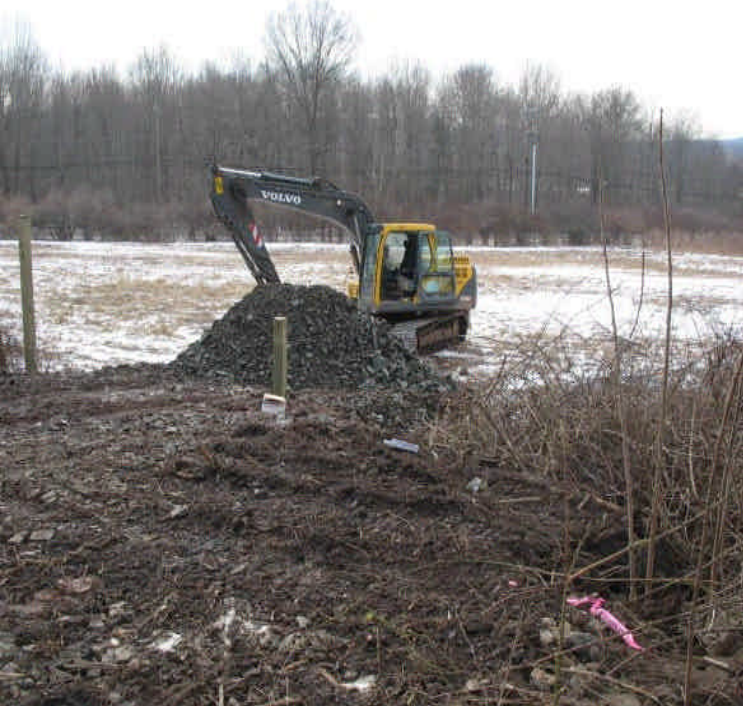
New access road construction off Durham Rd.

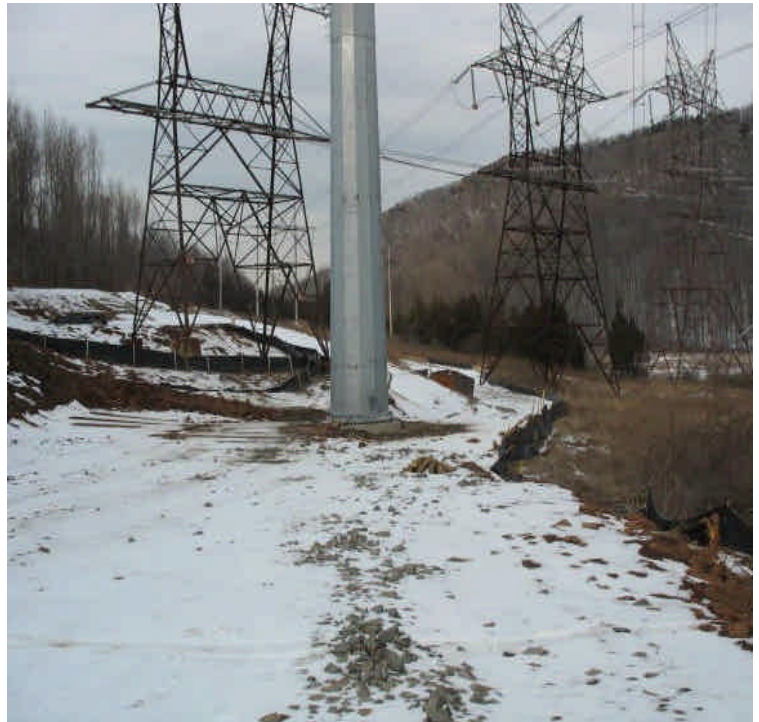
View of mono-pole and controls at Black Pond. Controls are intact and look good.

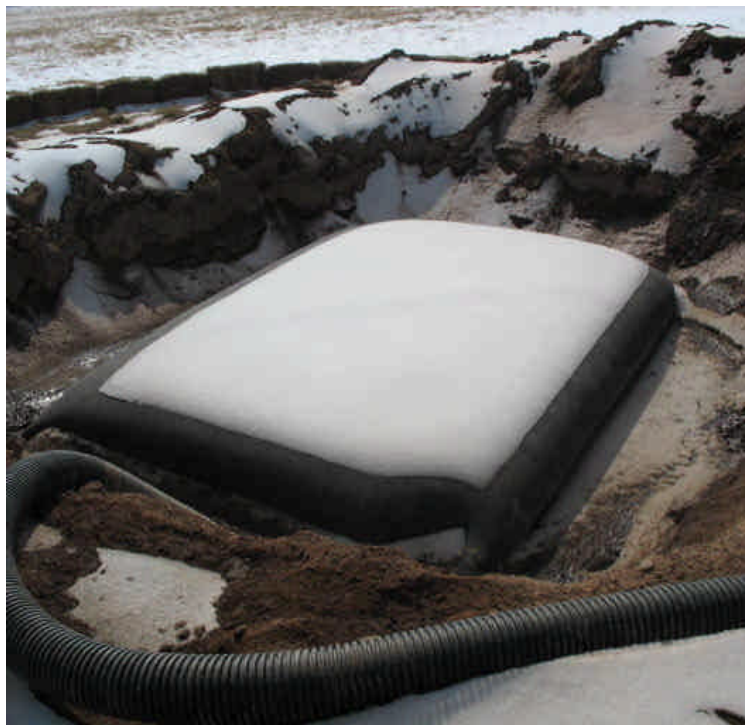
Filter bag and containment basins are in place for dewatering foundation work. Controls are in good shape.

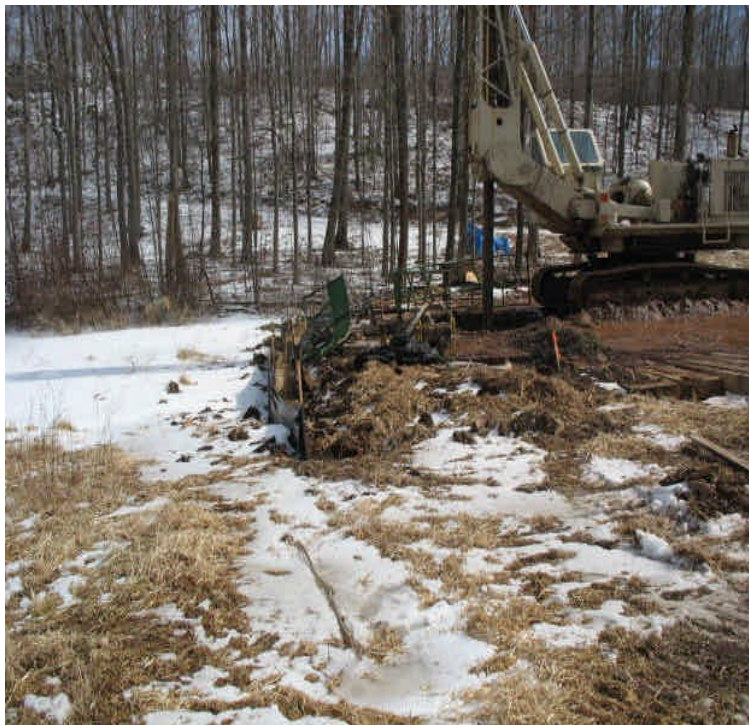
Foundation drilling along the ROW north of the Beseck SS. Controls were in place to prevent sediment from entering the wetlands but any dewatering should be monitored carefully here.

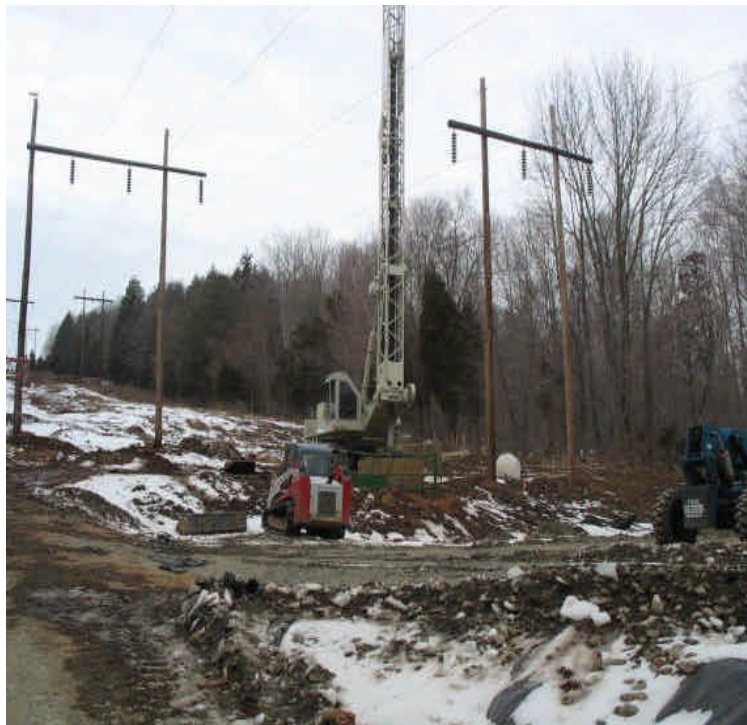
Foundation drilling west of Powder Hill Rd. No active dewatering was noted during the inspection. Controls were in place downgradient. Ensure soils remain contained or temporarily stabilized along these slopes during thaw and snow melt.
