Docket No. 272 – Development and Management Plan Inspection

Segment 1a Inspection

Date: February 26, 2007

Location: Segment 1a – Scovill Rock Switching Station to Chestnut Junction, Oxbow Junction to Beseck Switching Station (excluding Royal Oak Bypass), and Black Pond Junction to Beseck Switching Station

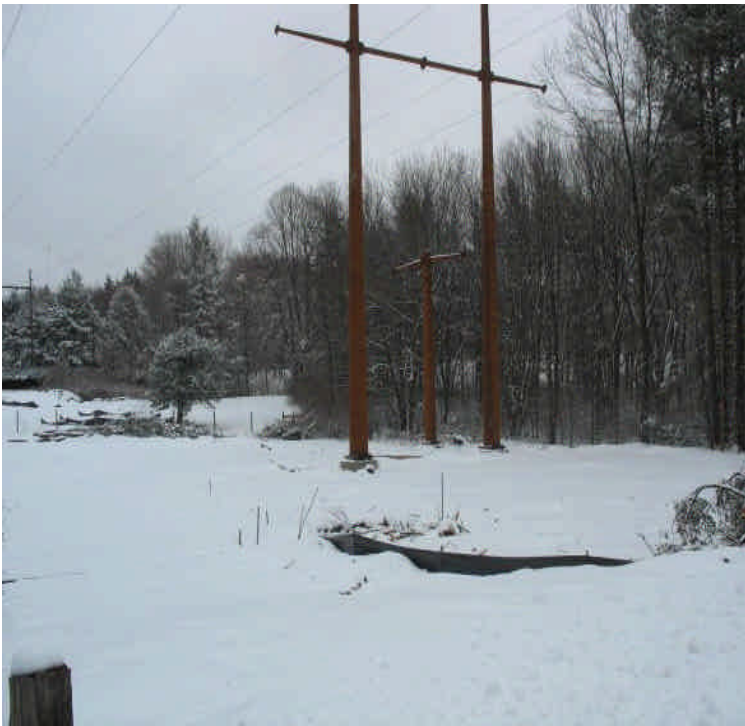
Foundations and poles installed along ROW between Little Lane and Route 17.

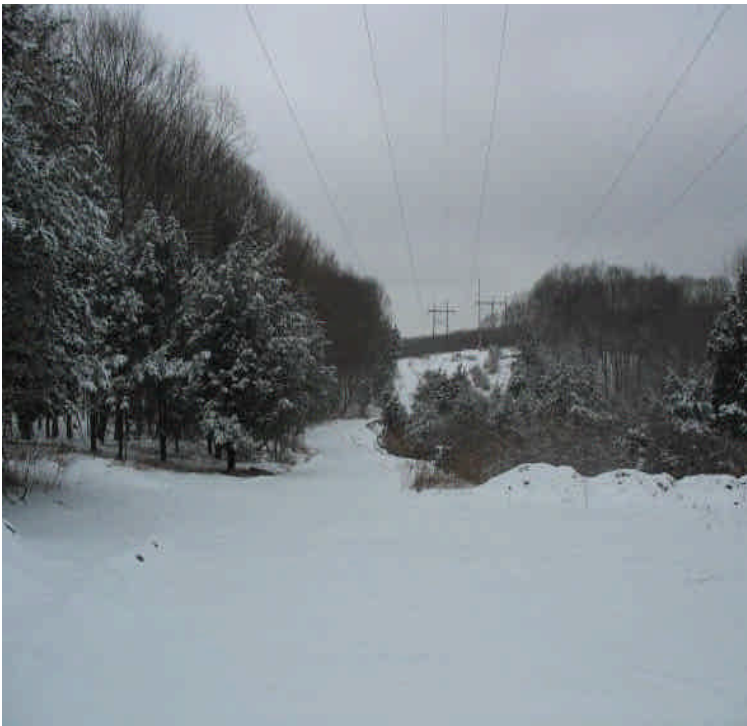
Timber mats in place for access west of Arbutus Street. No run-off was noted during the inspection.

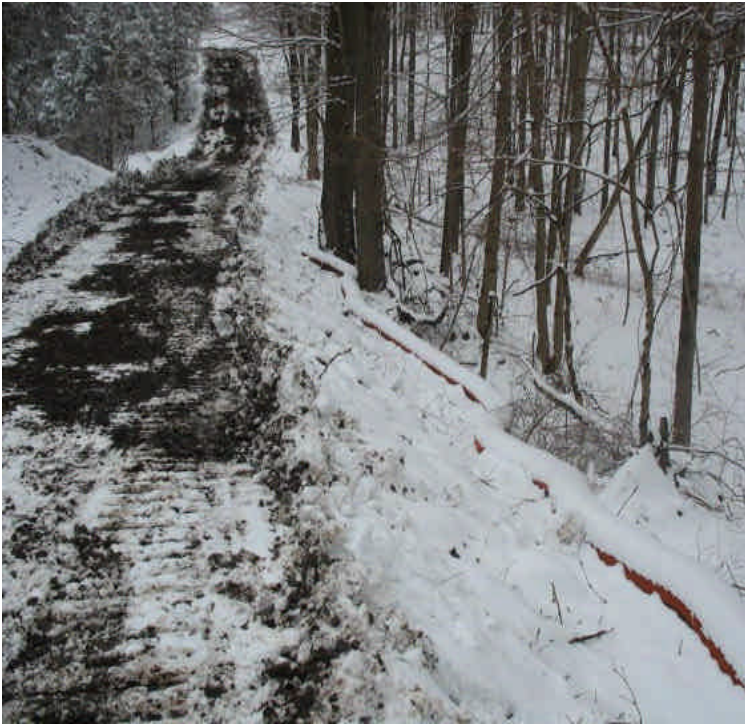
View of access road and culvert in place off Black Walnut Dr. Filter socks were installed along the base of slope of the access road. Continue to monitor to ensure filter socks are controlling run-off appropriately

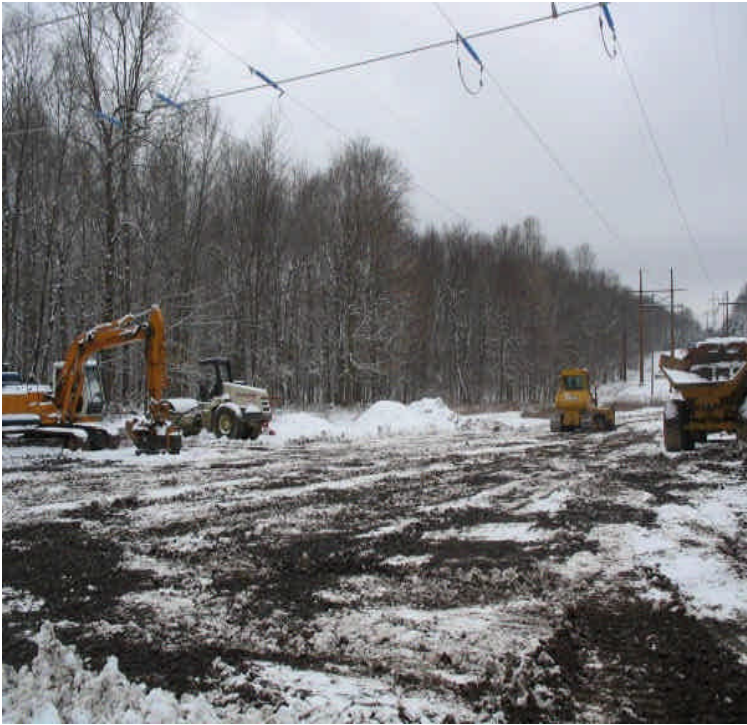
View of parking and staging area off Black Walnut Dr.

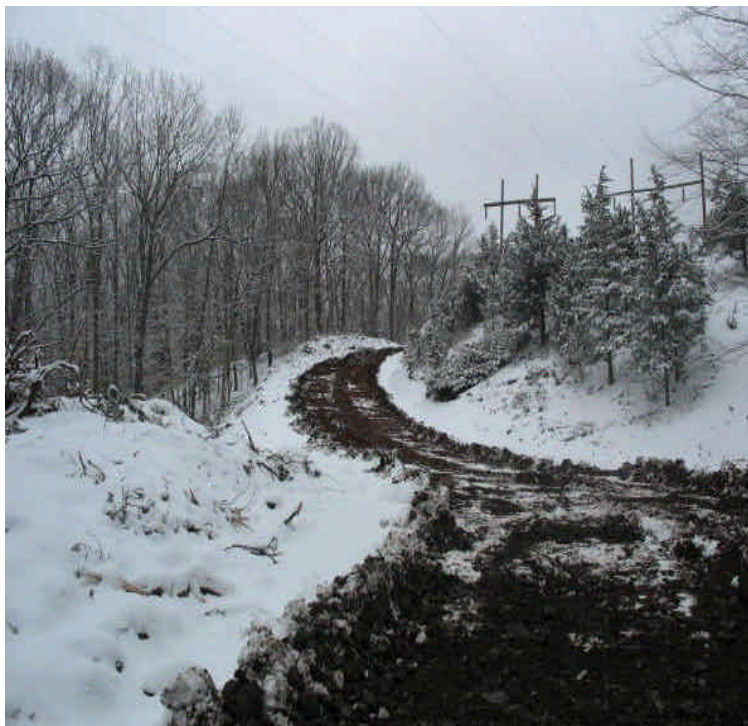
New access road off Black Walnut Dr. Access is installed in this section to reach poles locations to the east and avoid crossing Ball Brook and associated habitat.

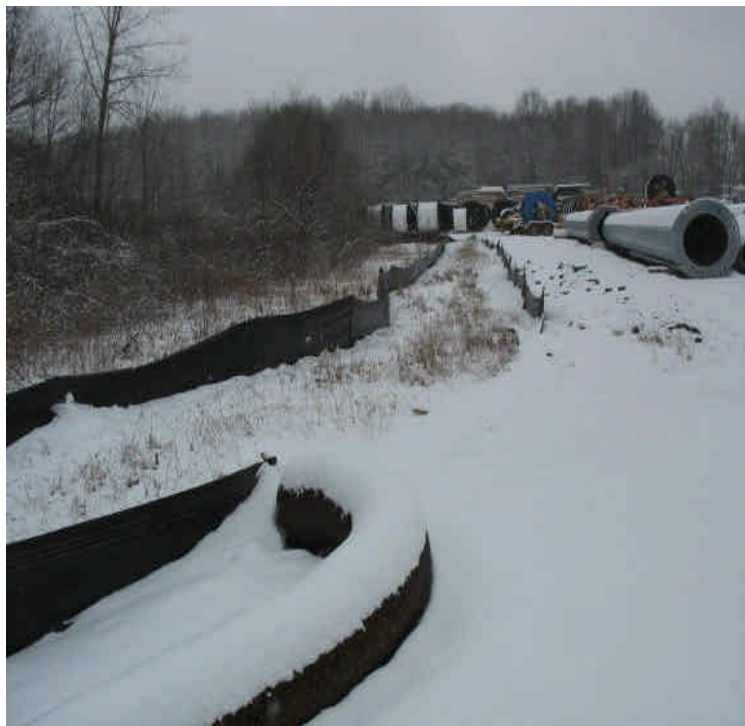
Silt fence, fiber rolls, and hay mulch are in place as a buffer for wetlands around the perimeter of the contractor receiving yard. Replace fallen sections of silt fence and filter sock that was run over.

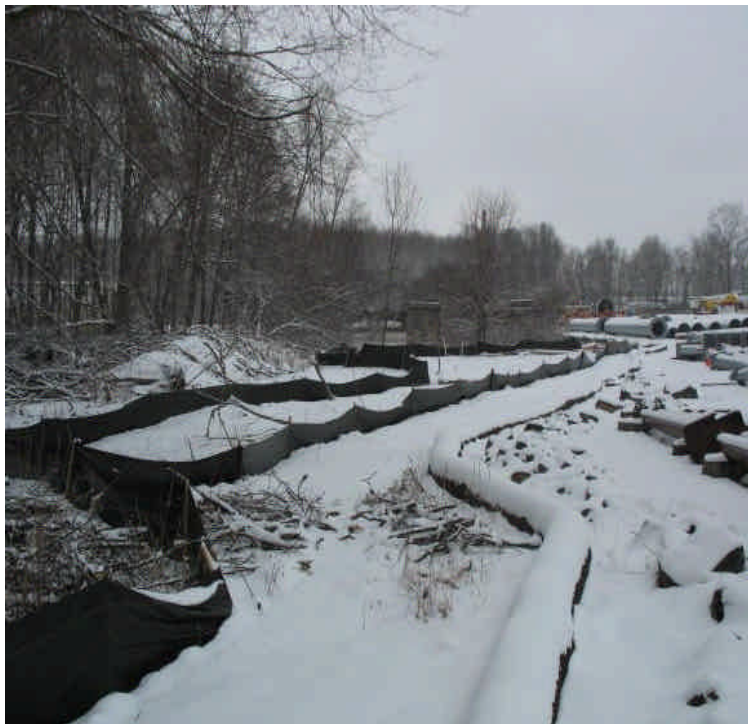
Additional controls remain in place adjacent to wetlands to filter/contain turbid run-off leaving the site.

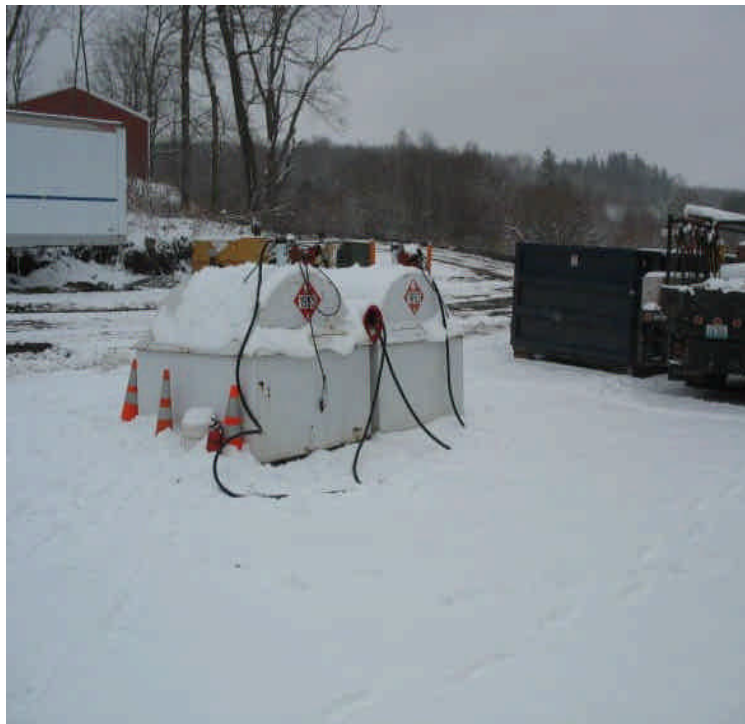
The fuel storage tanks remain in place on the stone spill pad and nozzles are contained. Small drip stains are noted and are contained to the stone.

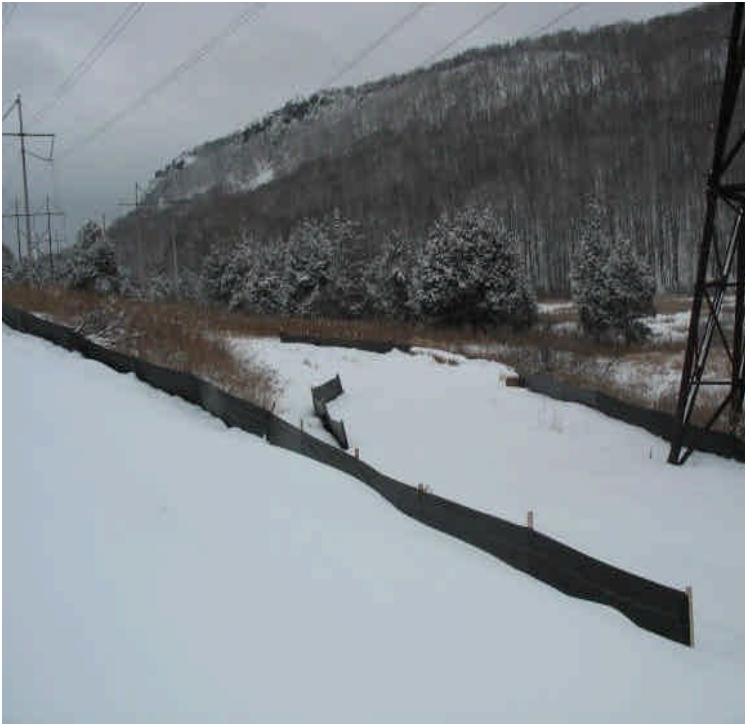
Controls are stable off Black Pond.

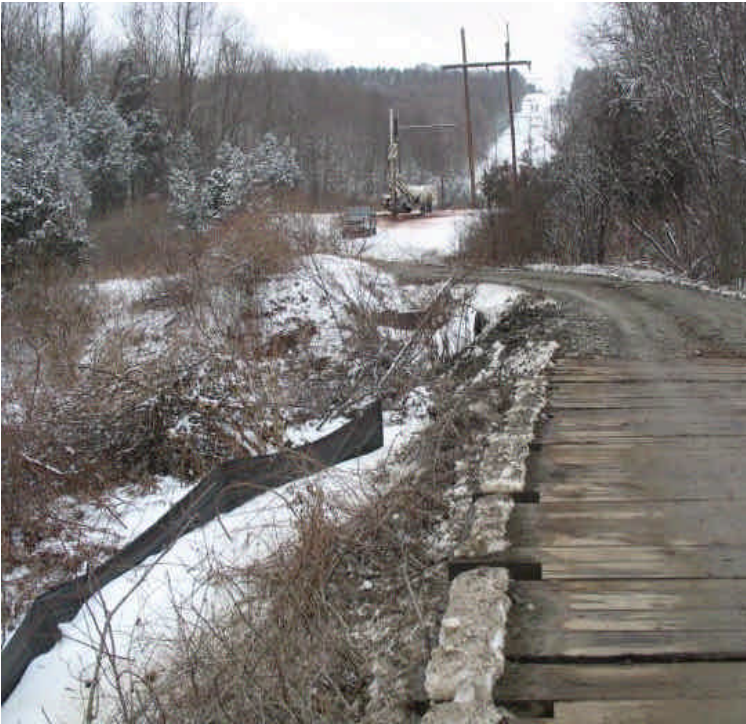
**Wetland crossing off Powder Hill Road. No sediment observed
Coming from the stone crossing**

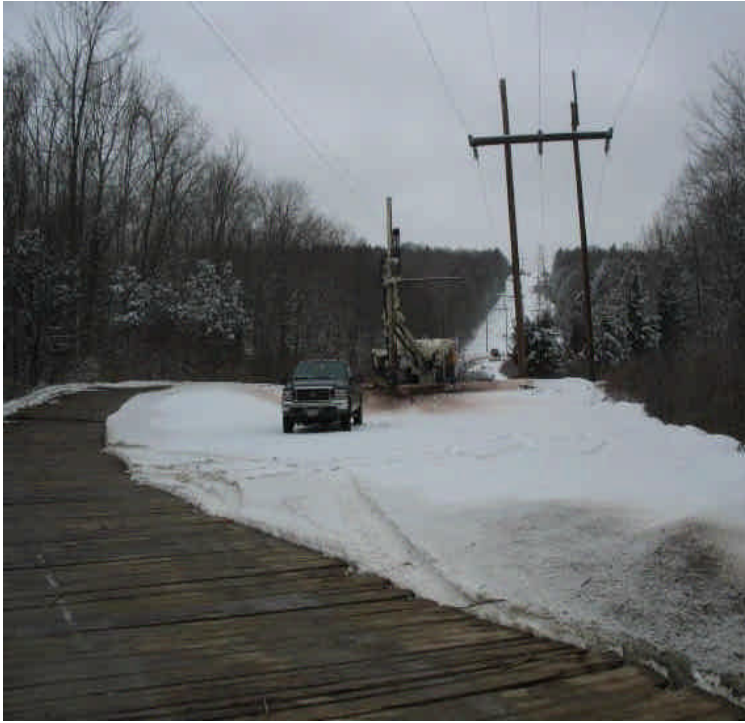
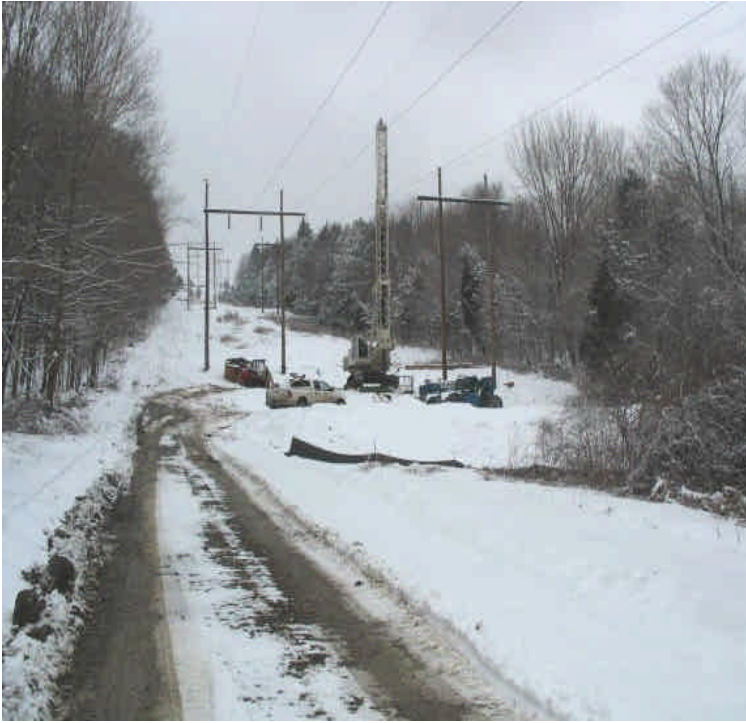
Both photos show foundation drilling west of Powder Hill Rd. No active dewatering was noted during the inspection. Controls were in place downgradient.

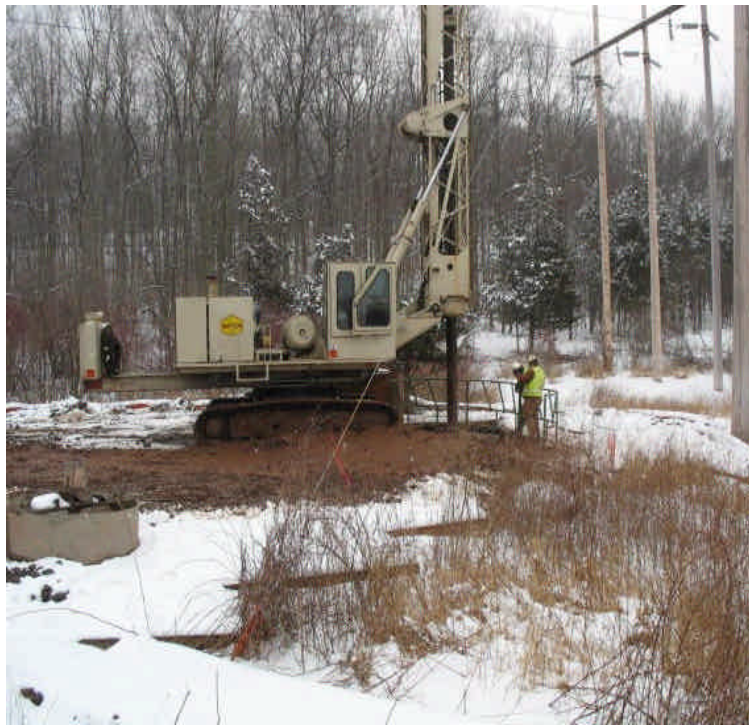
Foundation drilling along the ROW east of Beseck SS. Controls were in place to prevent sediment from entering the wetlands.

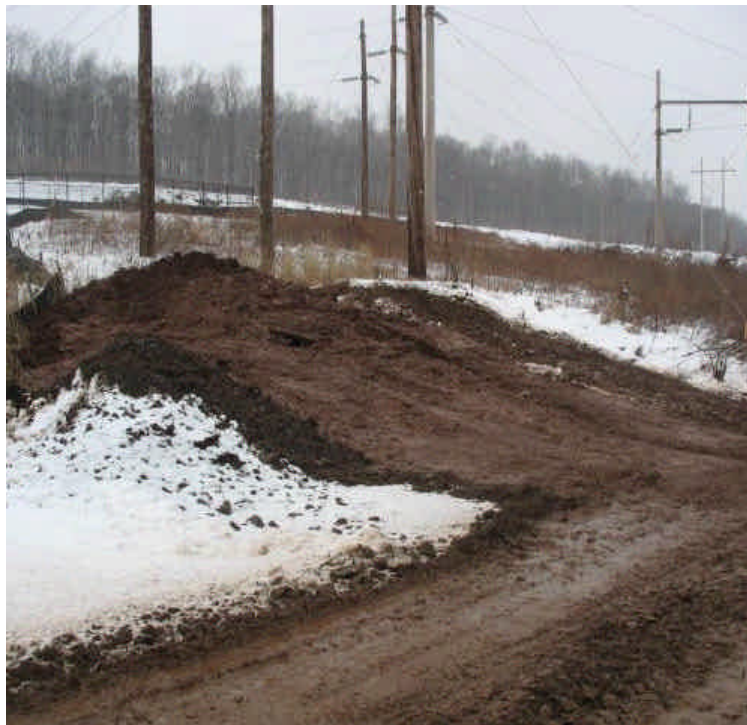
Slurry from foundation drilling in the wetland was being trucked and placed on a slope upgradient. Stabilize soils or install controls as necessary to prevent sedimentation from migrating

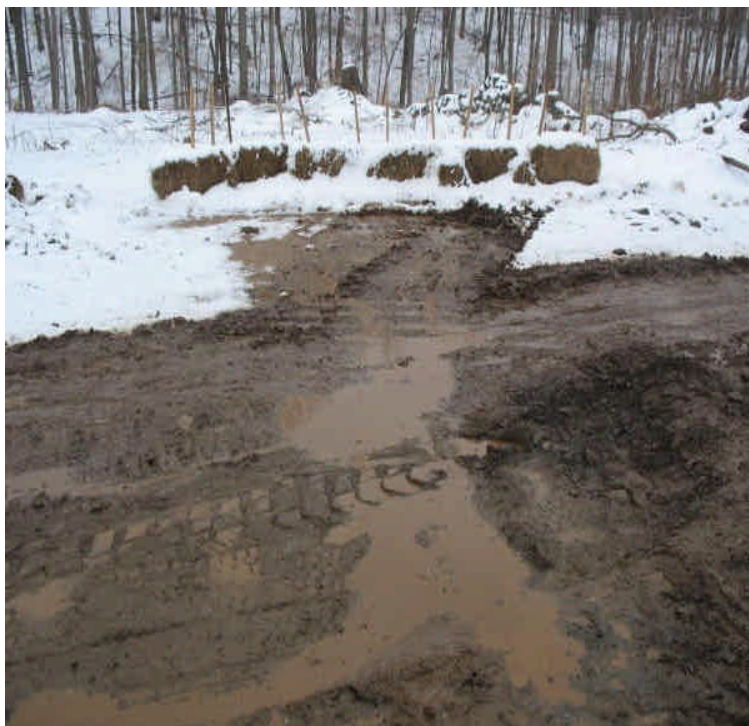
Water bars were installed along the access road north of Beseck SS. Turbid water is diverted off the road and towards haybales installed to filter sediment.

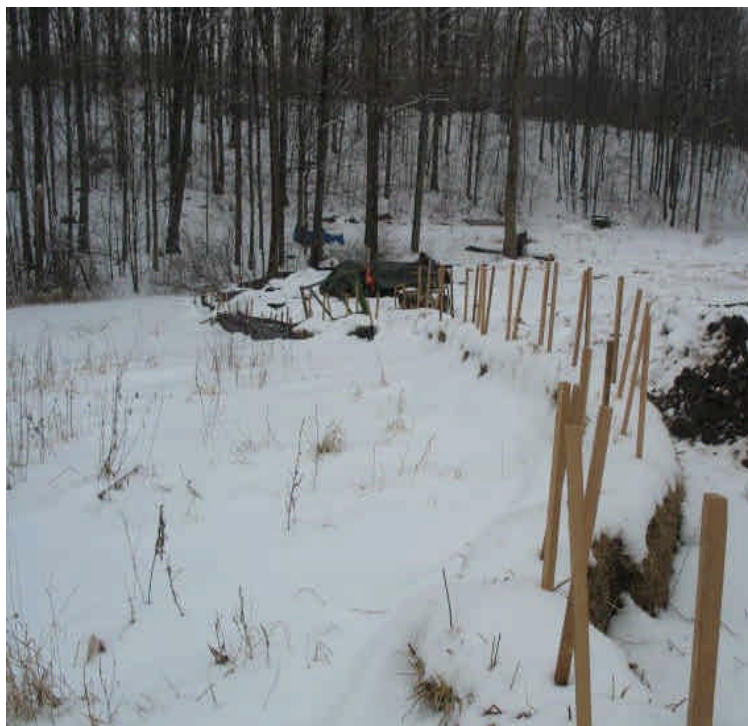
Controls were left in place after drilling the foundation adjacent to to the pond, north of Beseck SS.
