Docket No. 272 – Development and Management Plan Inspection

Segment 2a Inspection

Date: February 6, 2007

Location: Segment 2a – Beseck Switching Station to Cheshire/Hamden Town Line

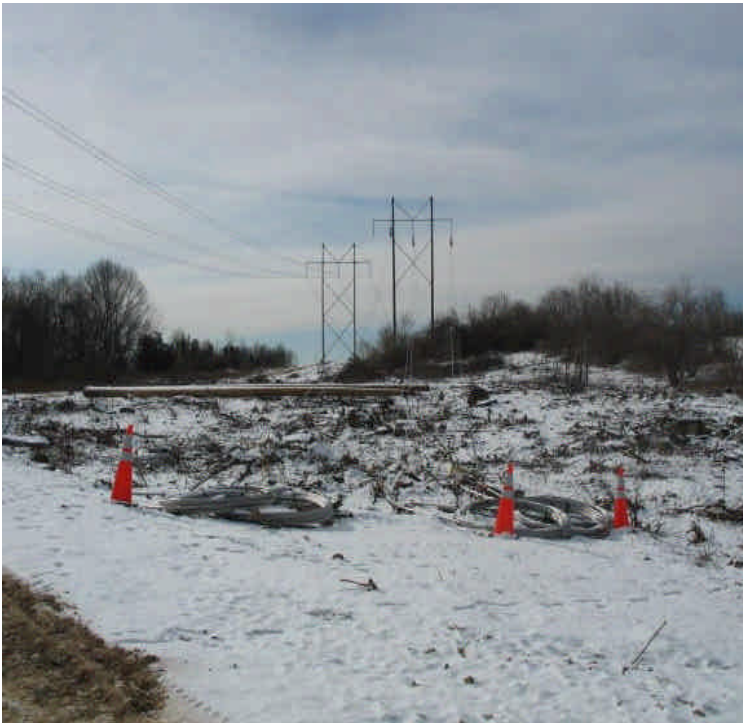
View of poles installed and wires pulled off High Hill Road.

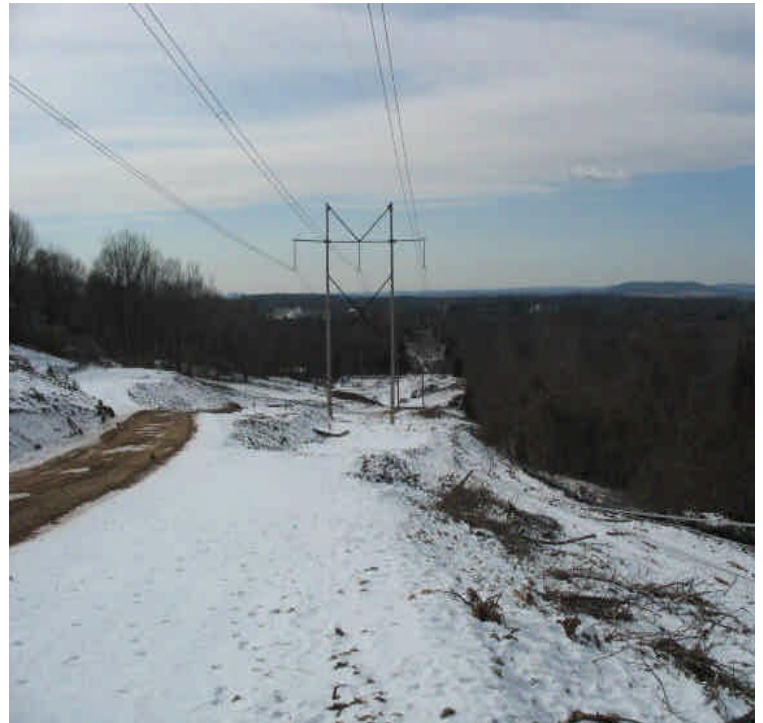
View of the staging areas. Temporary stabilization measures (mulch) are added as needed.

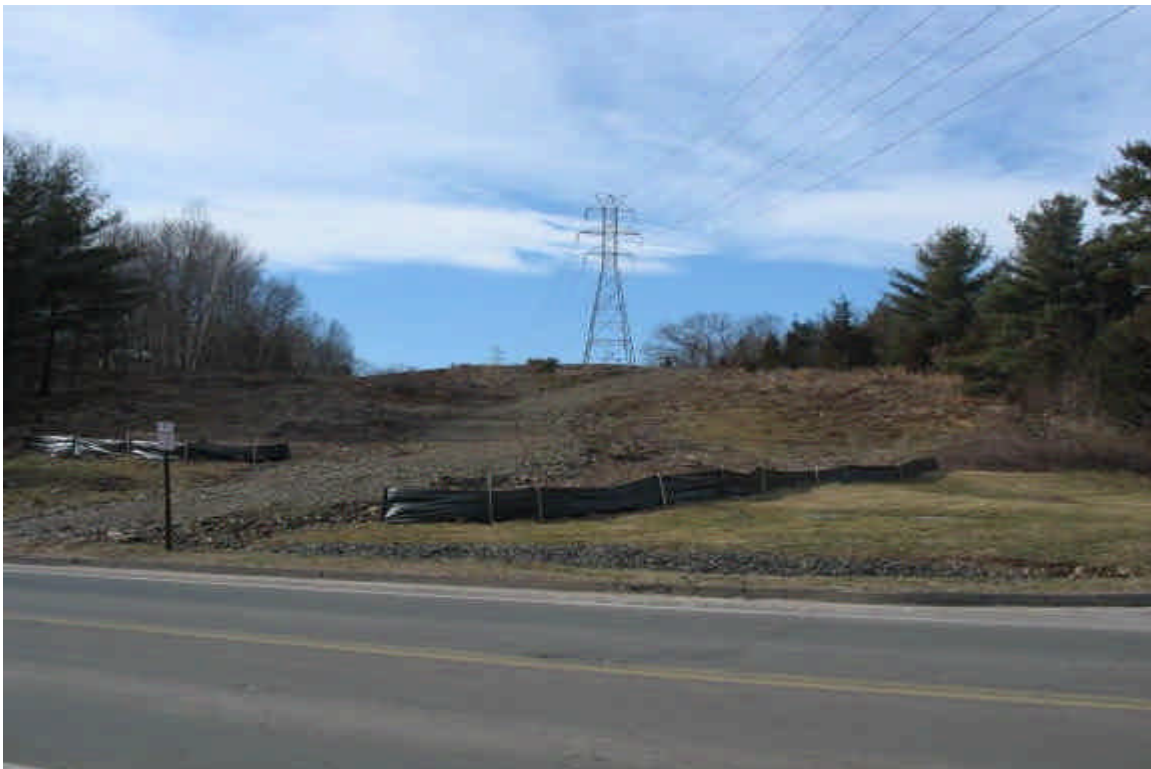
Silt fence remains intact along South Turnpike. Continue to monitor the slope for erosion, issues with run-off were not observed at this time.

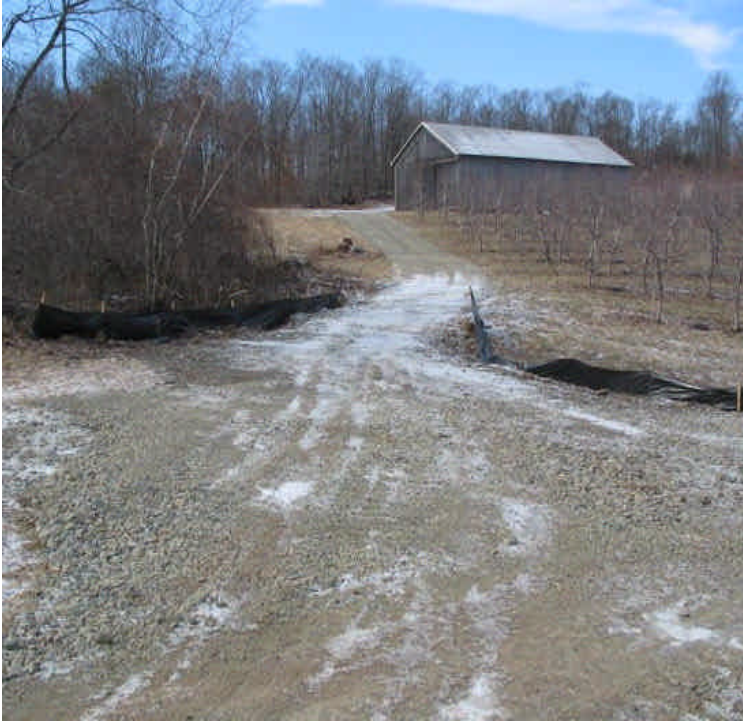
Silt fence remains intact along the access road adjacent to wetlands within the apple orchard off Mansion Rd.

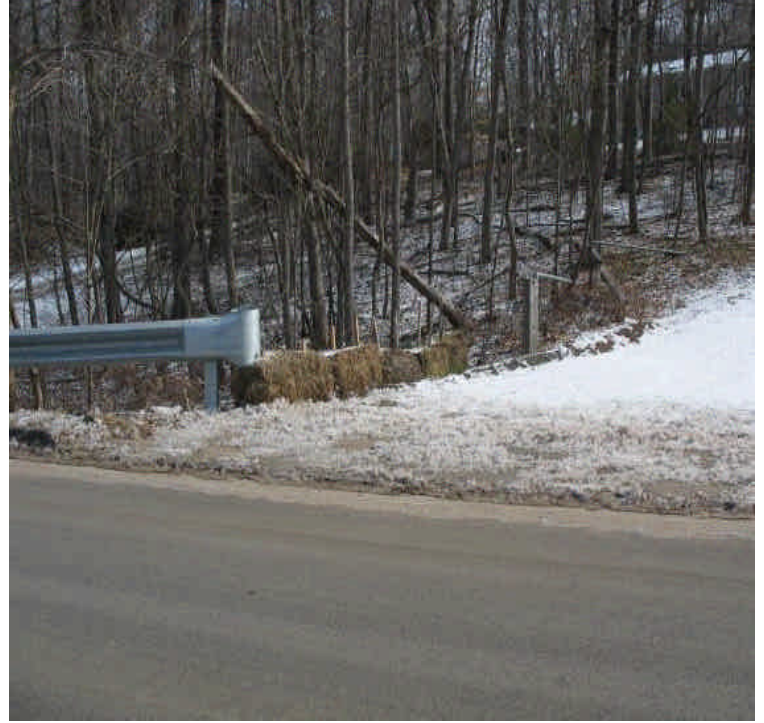
Silt fence removed at the ROW access off Mansion Rd. No erosion issues noted.

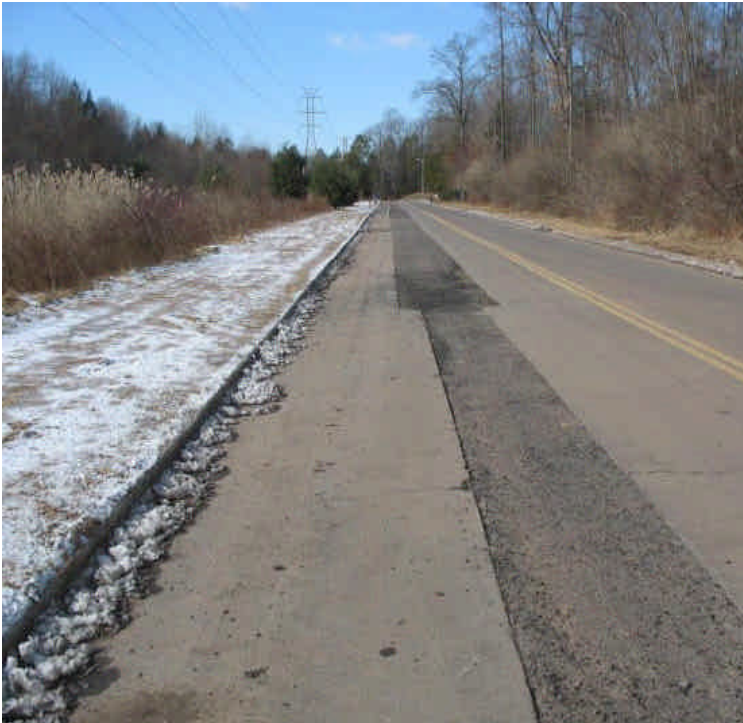
View of completed trench for the underground 115kv work on Old Farms Rd. Sweep up remaining asphalt/pebbles where work is complete. Cold weather appears to exacerbate the asphalt patch "crumbling".

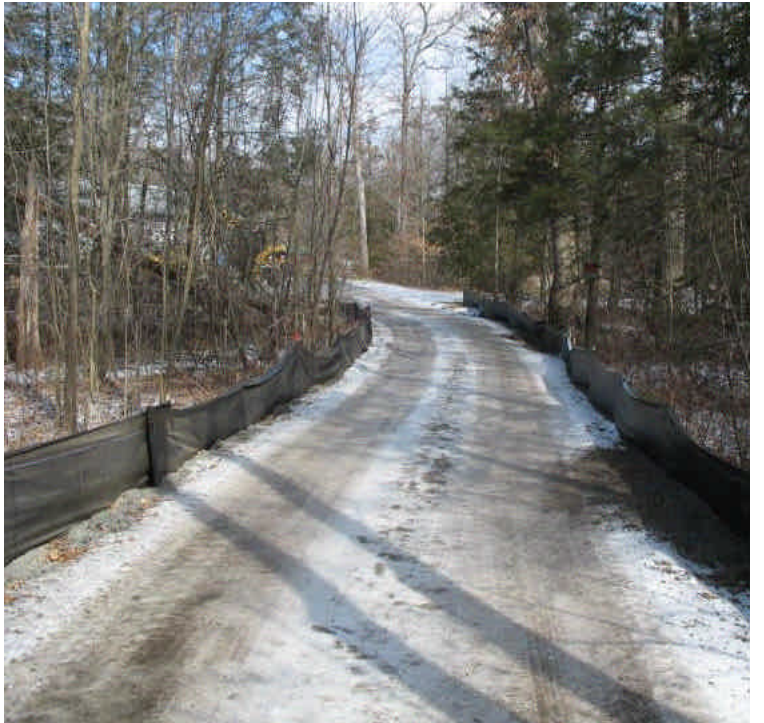
View of Old Farms Rd. equipment storage area entrance.
