Docket No. 272 – Development and Management Plan Inspection

Segment 2a Inspection

Date: February 21, 2007

Location: Segment 2a – Beseck Switching Station to Cheshire/Hamden Town Line

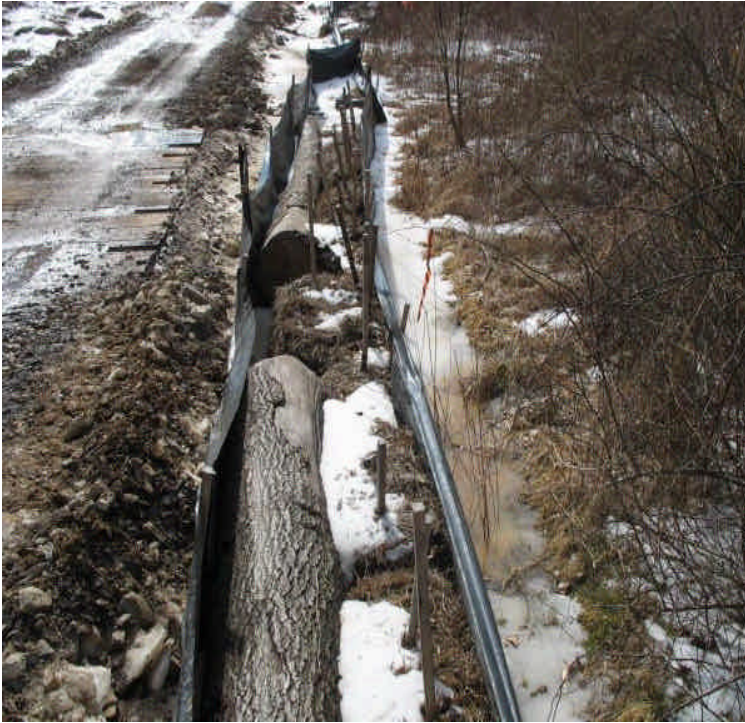
Some turbid run-off was observed flowing under or through controls in the ROW off High Hill Road.

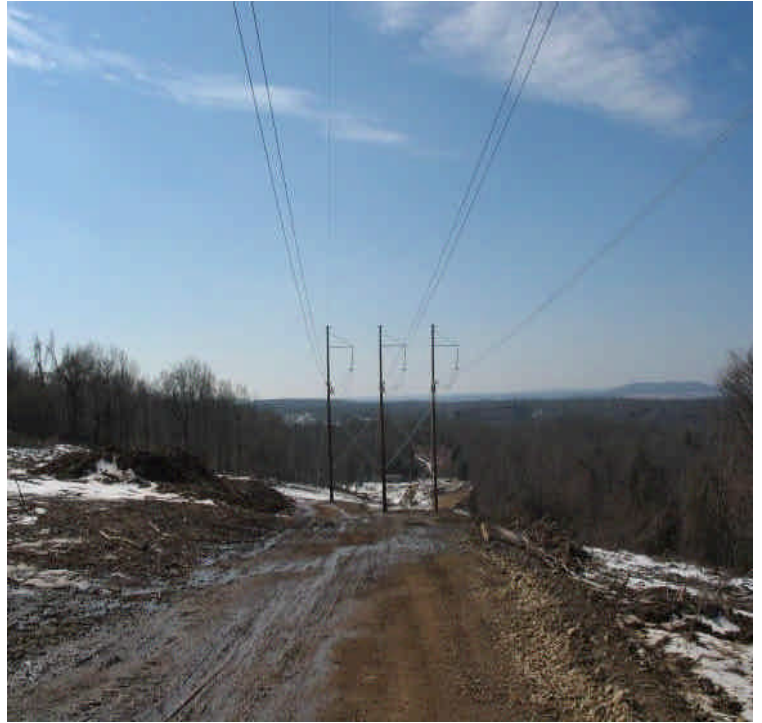
View of the staging areas. Poles/line installation complete in this location.

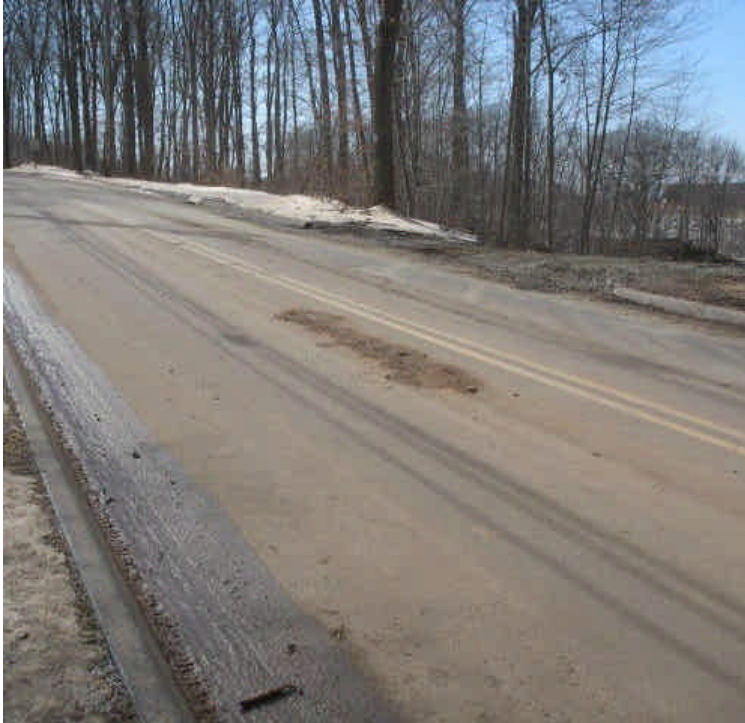
Some sediment tracking and accumulation was noted along High Hill Rd. Sweep roadway and remove sediment.

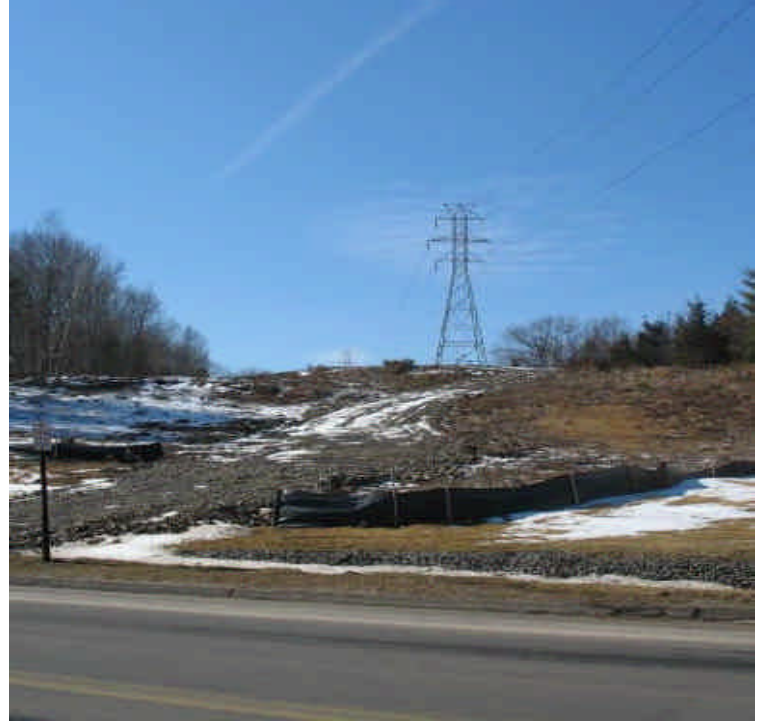
Silt fence remains intact along South Turnpike. Continue to monitor the slope for erosion, issues with run-off were not observed at this time.

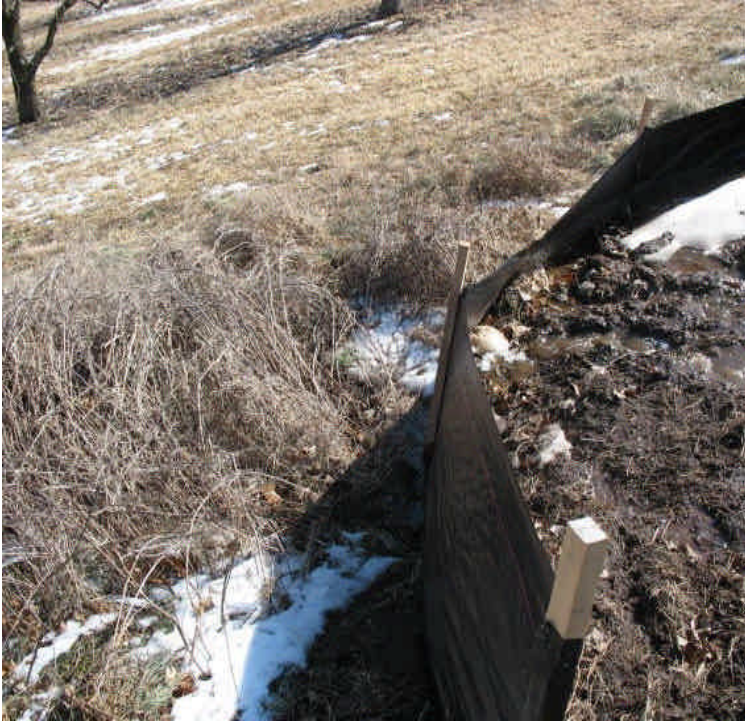
Small sections of silt fence were appropriately placed along the access road at points of run-off. This section within the apple orchard off Mansion Rd. was observed filtering run-off effectively.

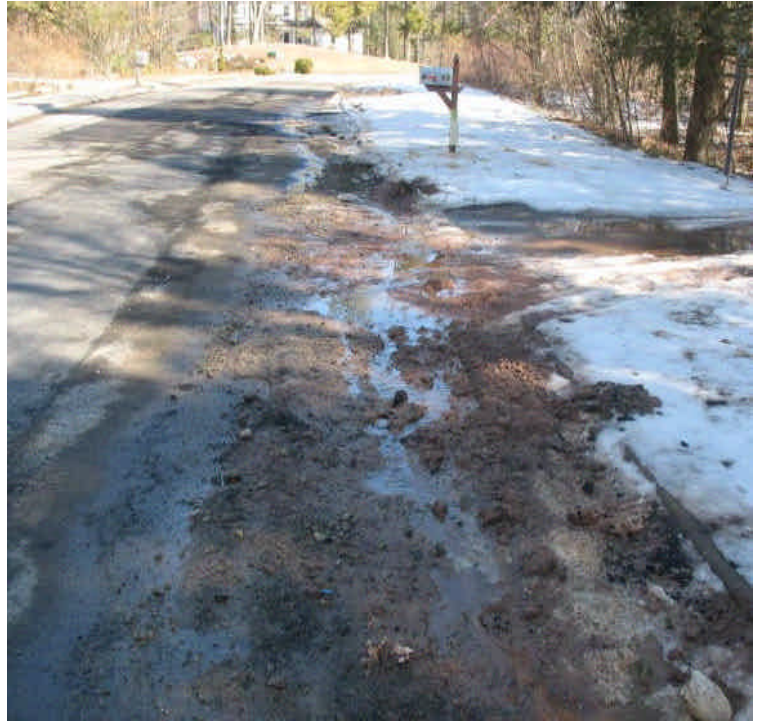
View of sediment accumulation along the gutter near a catch basin along Old Farms Rd. Gutter buddies were not in place, likely due to town plowing. Sweep by hand if the street sweeper cannot reach this

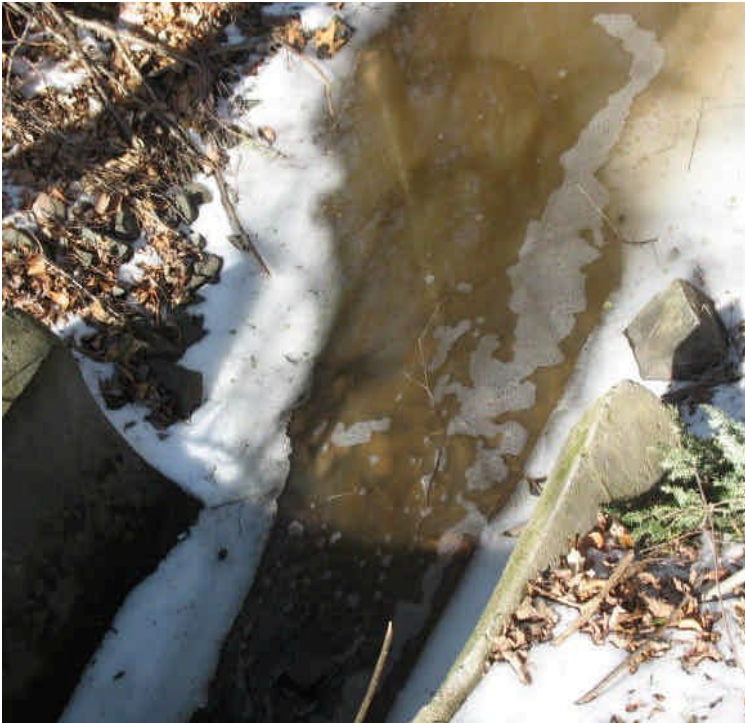
Turbid run-off was flowing into the CBs along Old Farms Rd. and was observed entering the adjacent wetlands. Liners were in place but gutter buddies had been removed and needs to be restored.

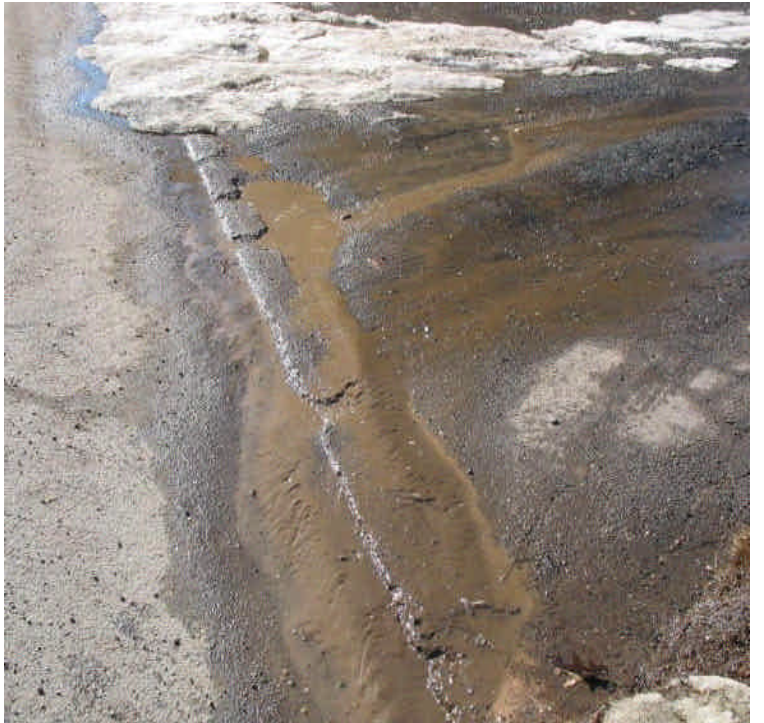
With the thaw, turbid run-off was again flowing from the low saturated area, filled by the access road installation. Run-off was reaching Old Farms Rd and entering a CB that did not have a gutter buddy in place.
