Docket No. 272 – Development and Management Plan Inspection

Segment 3 Underground Line

Date: February 1, 2007

Location: East Devon Substation to the Housatonic River Crossing

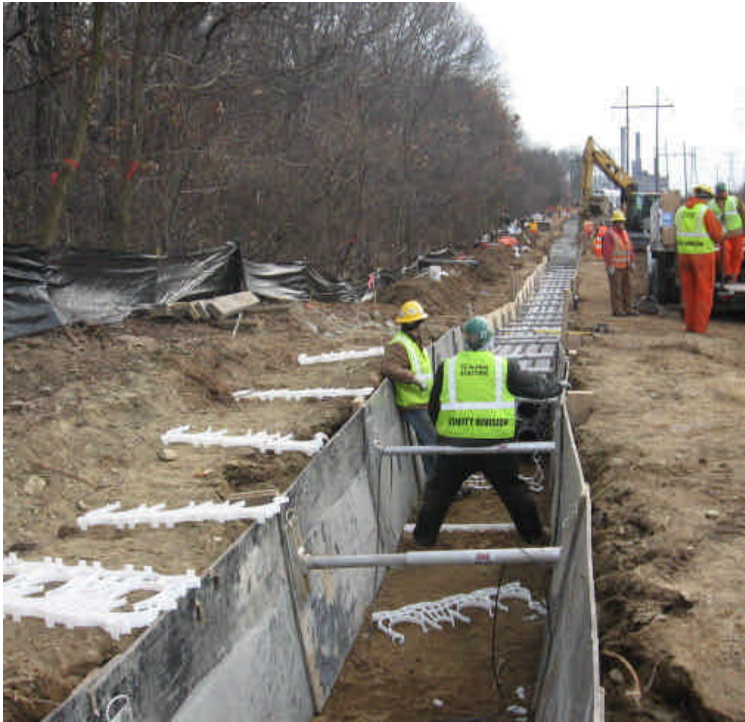
Trenching activities near station #1072. Vegetation has been cleared to accommodate the installation of the utilities.

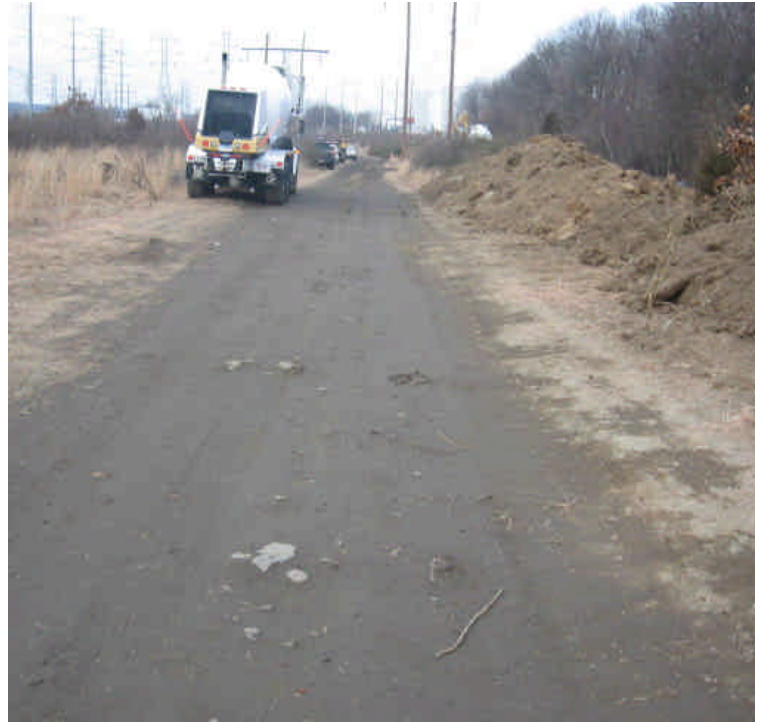
Construction access road has been watered down for dust control.

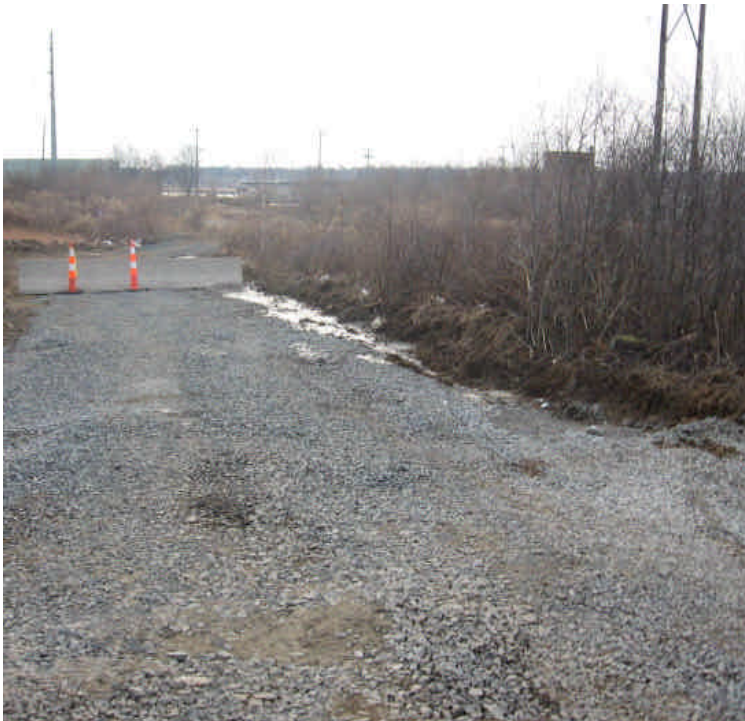
Spills and Material Storage	Reserve spill cleanup materials/kits were observed in the storage yard. Spill kits were also noted on site adjacent to vault #7 construction activities. 2/1/07 An uncontained concrete washout was noted along the edge of the access road, away from trenching activities. 1/16-2/1/07	Continue to bring spill kits to active work sites. 2/1/07 This concrete should be removed and disposed of properly. Remind drivers to continue to washout in designated locations. Temporary basins had been constructed in other locations. 2/1/07	Spill kits were on site (proactively). Needs attention.
Additional Observations	None 2/1/07	None 2/1/07	NA

The uncontained concrete washout remains along the access road near station #1055. The concrete should be removed and properly disposed of.

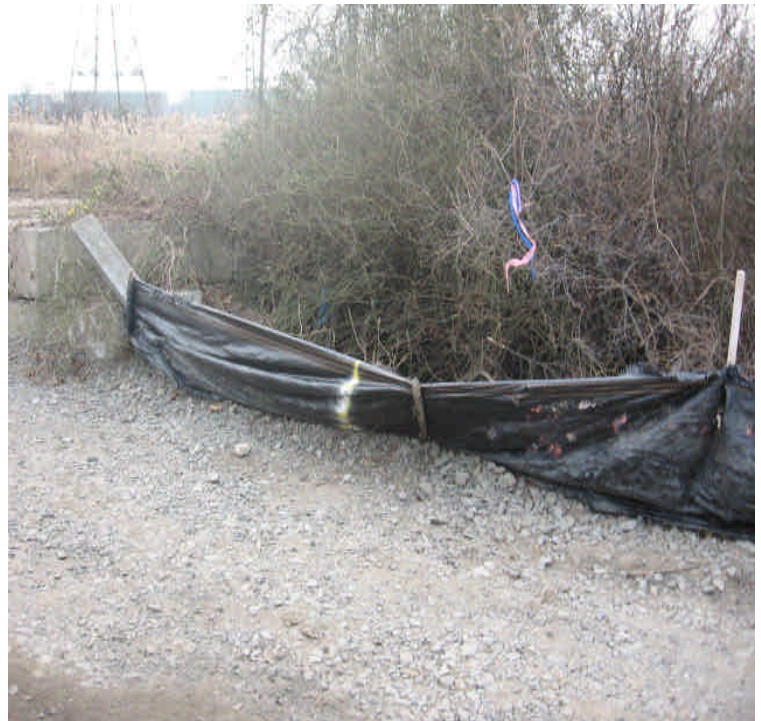
Ensure that the silt fence near station #1052 is toed-in and maintained as necessary.

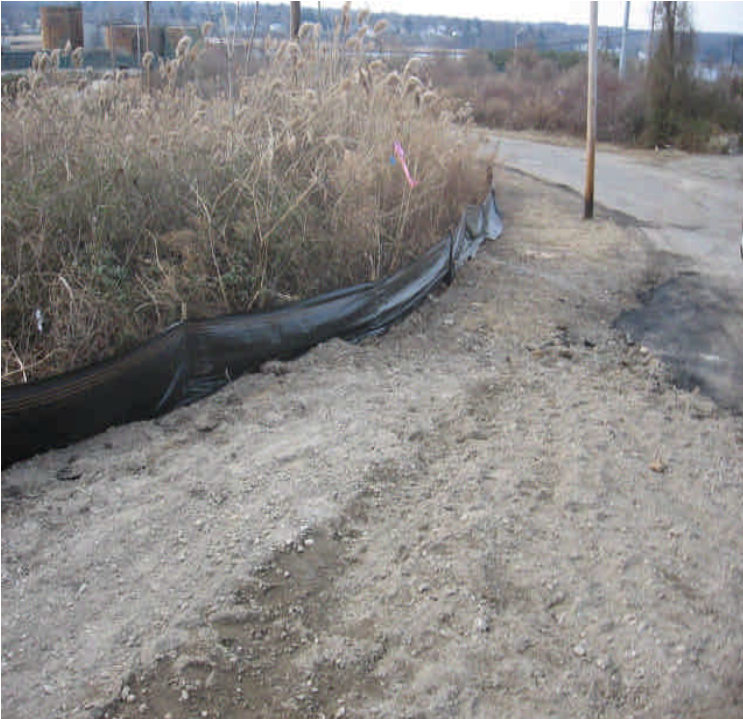
A portion of silt fence near station #1051 still needs to be toed-in. While soils are somewhat frozen and stable at this time, a wetland area is adjacent.

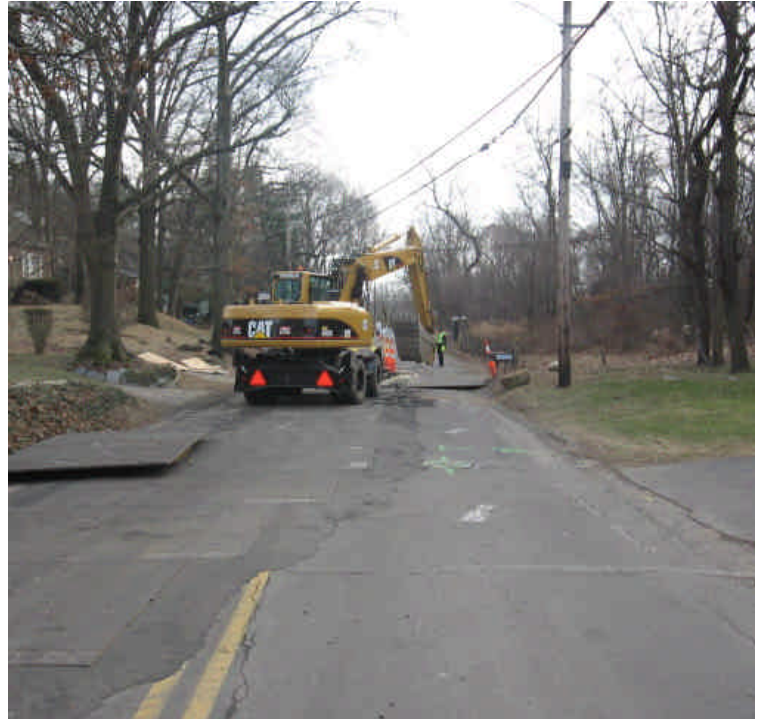
View of trenching activities in the roadway near station #1035.

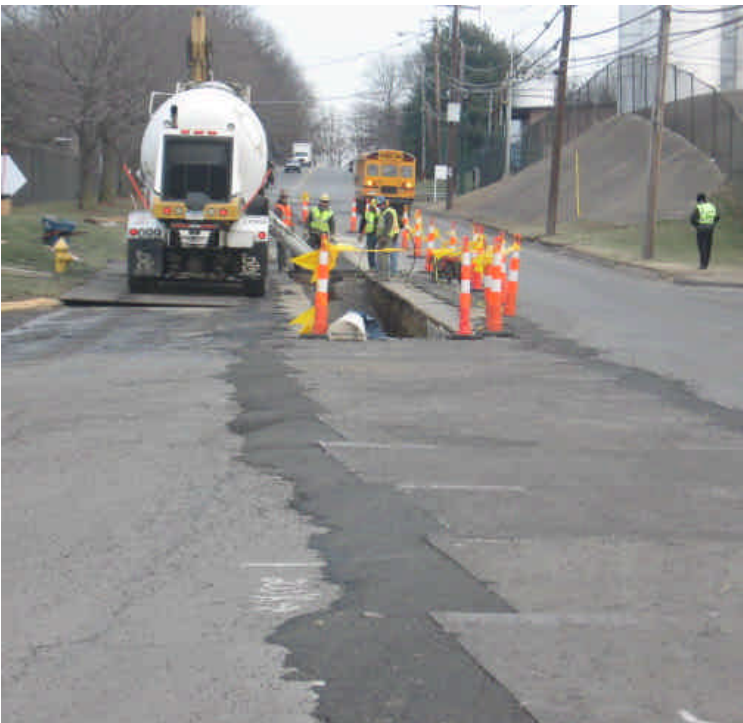
View of trenching activities in the roadway at station #1081.

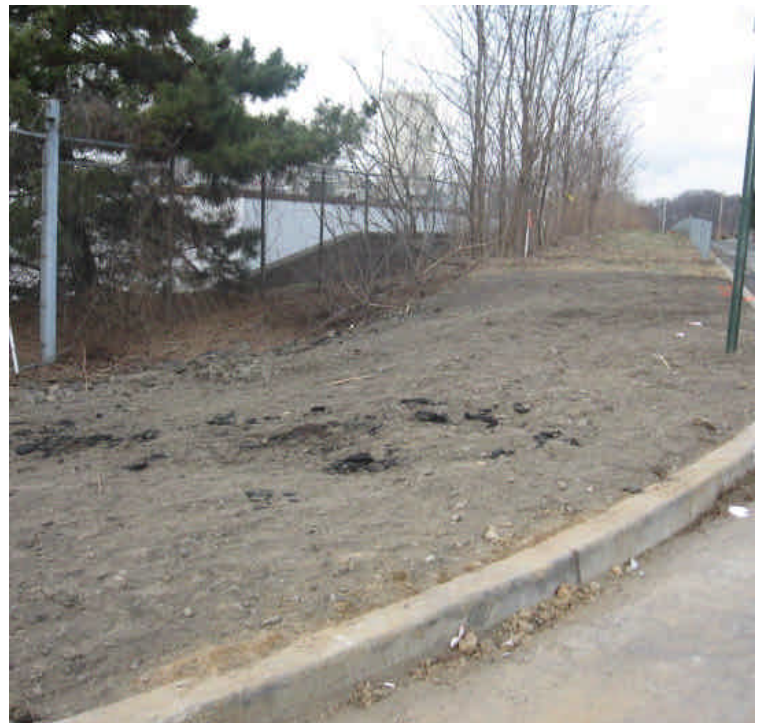
Exposed soils on the corner of Shelland and Caswell Sts. Although freezing temperatures are likely helping to stabilize soils, spread mulch or similar when feasible.

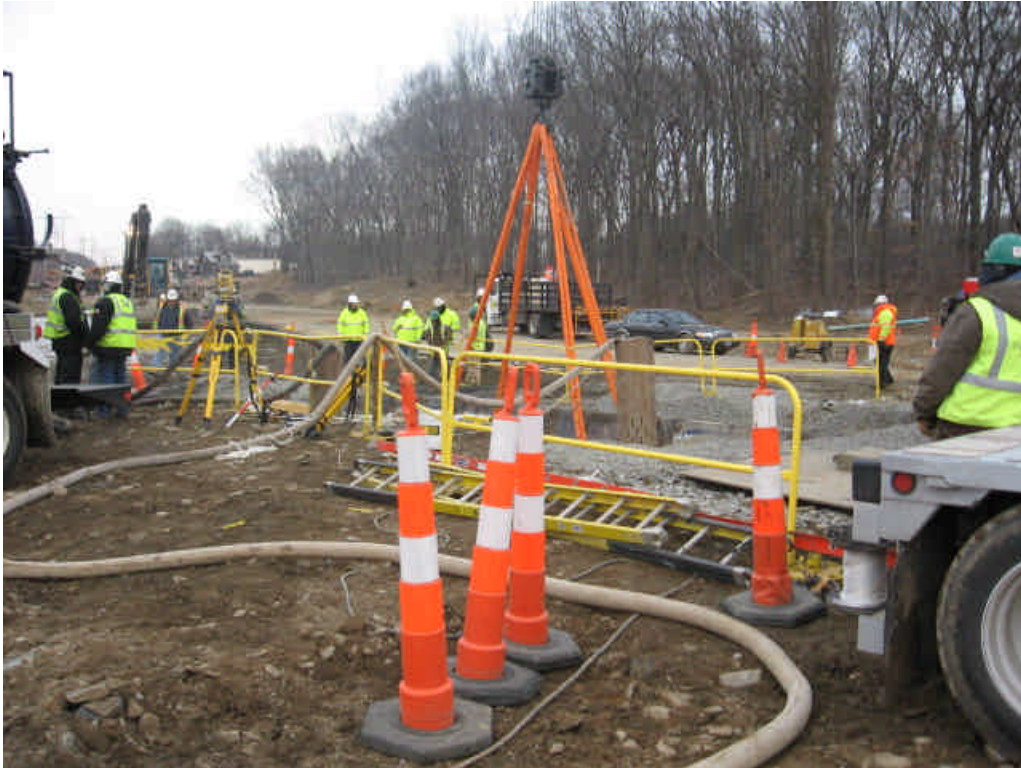
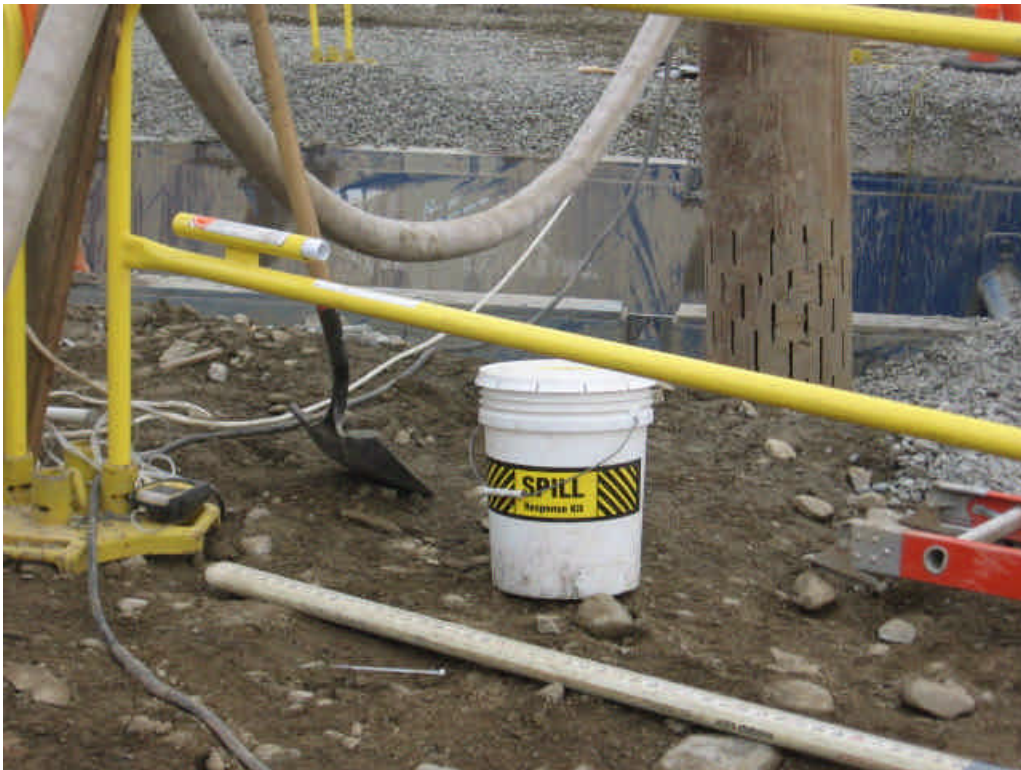
Above: Photo of Vault #7 installation activities. The adjacent construction activities are not covered by the Segment 3 inspection. Below: Photo shows a spill kit that was observed on site with the vault construction. Continue to be proactive about bringing these materials to active sites.
