**Docket No. 272 – Development and Management Plan Inspection**

**Segment 3 Underground Line**

**Date:** February 7, 2007

**Location:** East Devon Substation to the Housatonic River Crossing

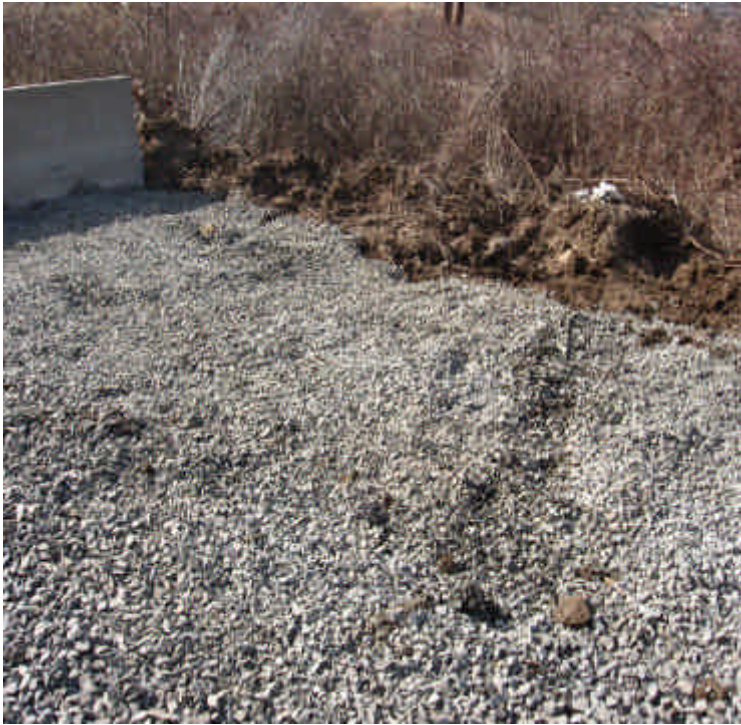
**Remnants of the concrete washout near station 1055 have been removed and properly disposed of.**

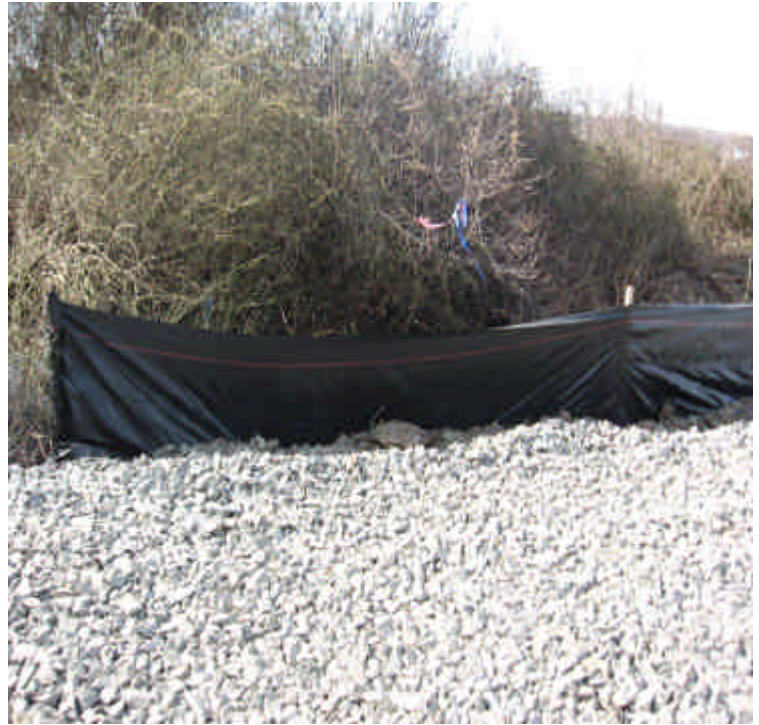
**Silt fence has been re-established/repared where necessary along the project route.**

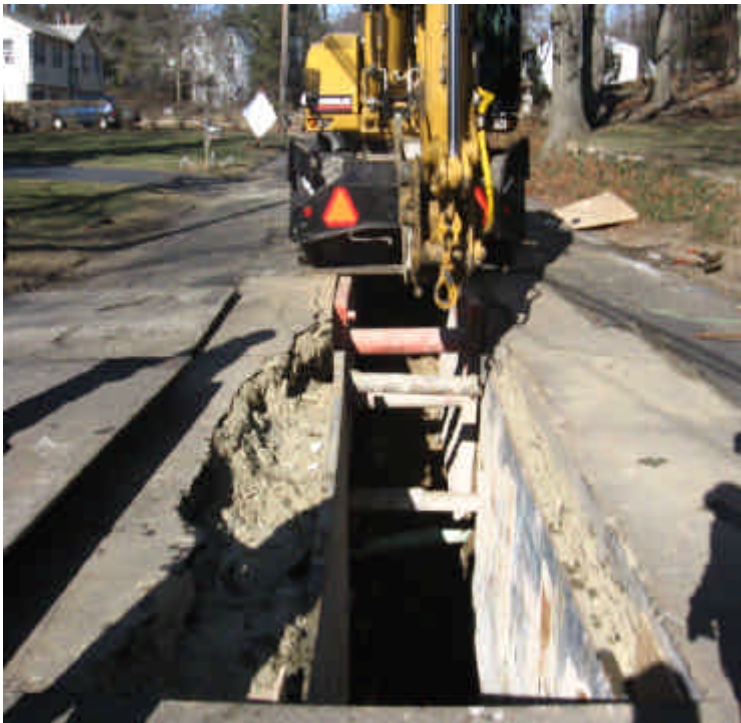
**Photograph of trenching activities from station 1035 to 1037,. Dewatering activities were being conducted.**

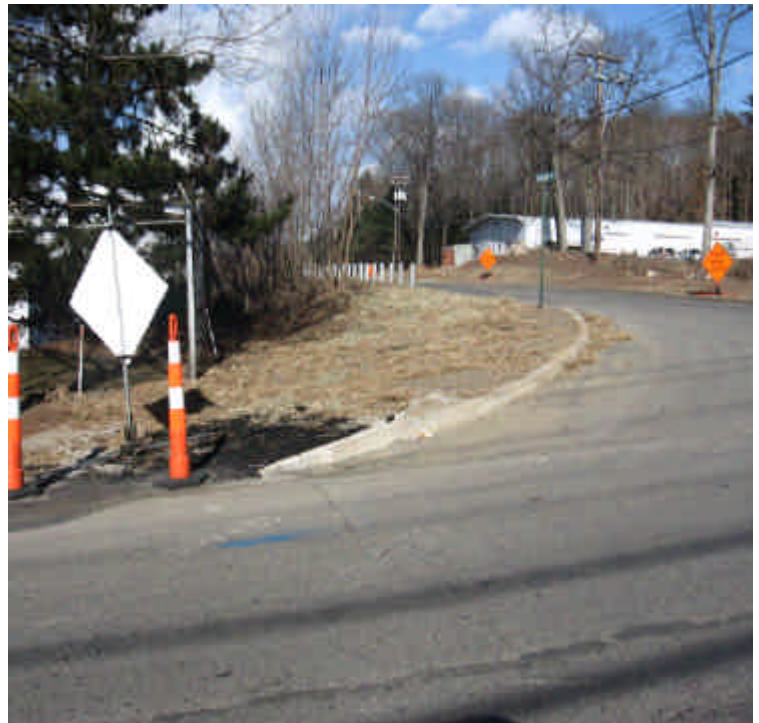
**Exposed soils on the corner of Shelland and Caswell Sts. have been temporarily stabilized with hay mulch.**

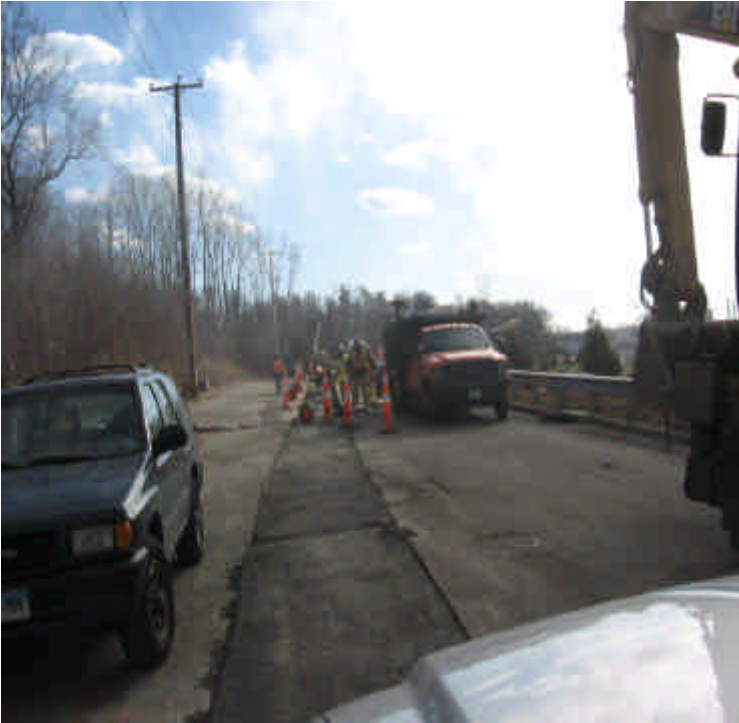
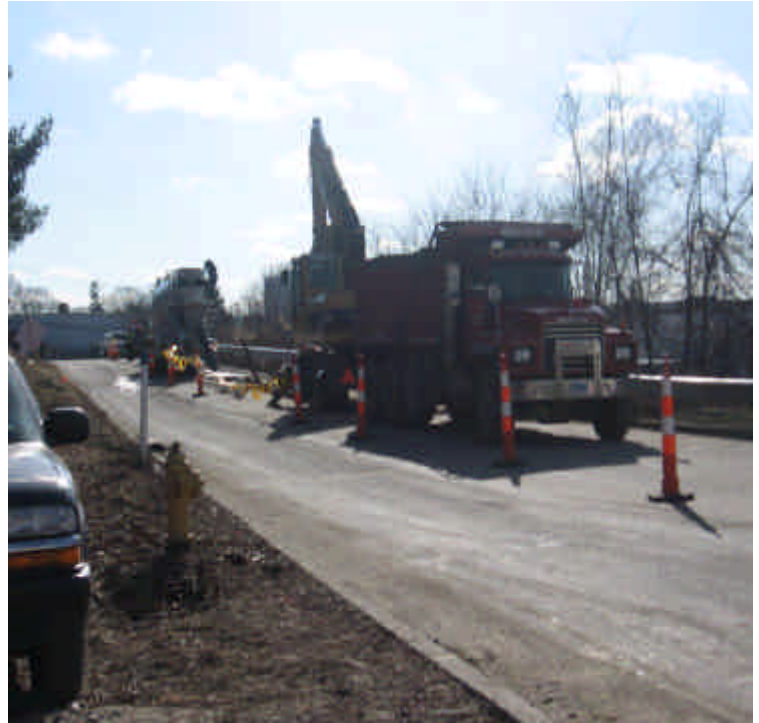
**Both photos show a view of trenching activities along Shelland St. All catch basins have been adequately protected with controls.**

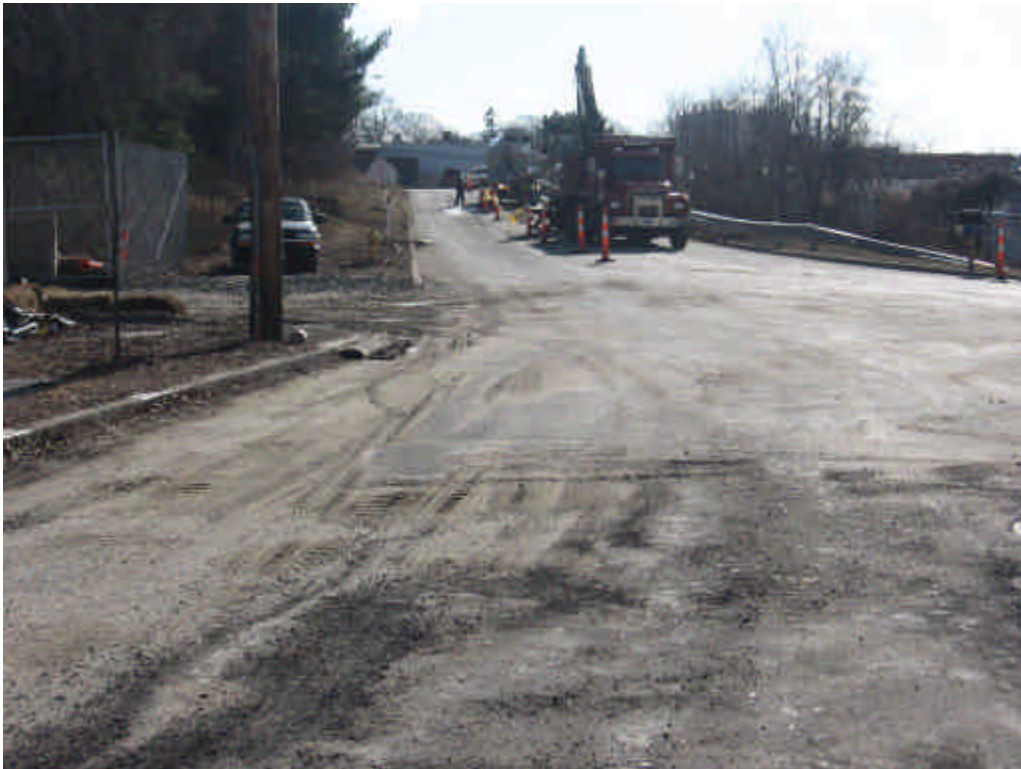
Shelland St (contractor yard)	The stone access stone pad remains in place at the entrance of the yard. Although the roadway appears to be swept, sediment accumulation was noted along the	Continue to monitor and maintain as necessary. Sweep roadway regularly and consider removing sediment accumulation from the gutter by hand if the sweeper cannot reach	Needs regular attention.

**Photo of the entrance of the Milford contractor lay-down yard.  
It appears that roadway sweeping is occurring, some sediment accumulation remains near the curbing or gutter. This may need to be removed by hand if sweepers can't reach it.**
