Docket No. 272 – Development and Management Plan Inspection

Segment 3 Underground Line

Date: February 16, 2007

Location: East Devon Substation to the Housatonic River Crossing

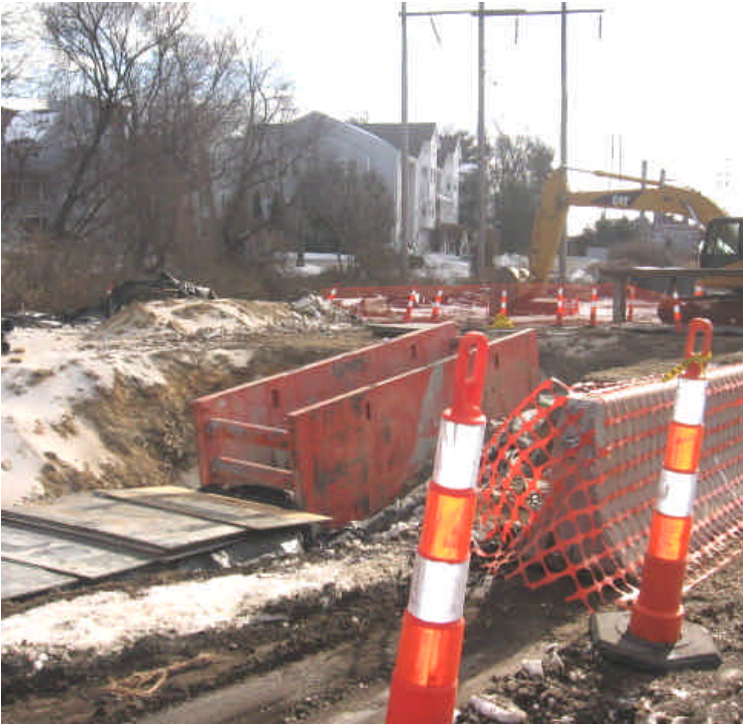
Photo of trenching activities at Vault #4.

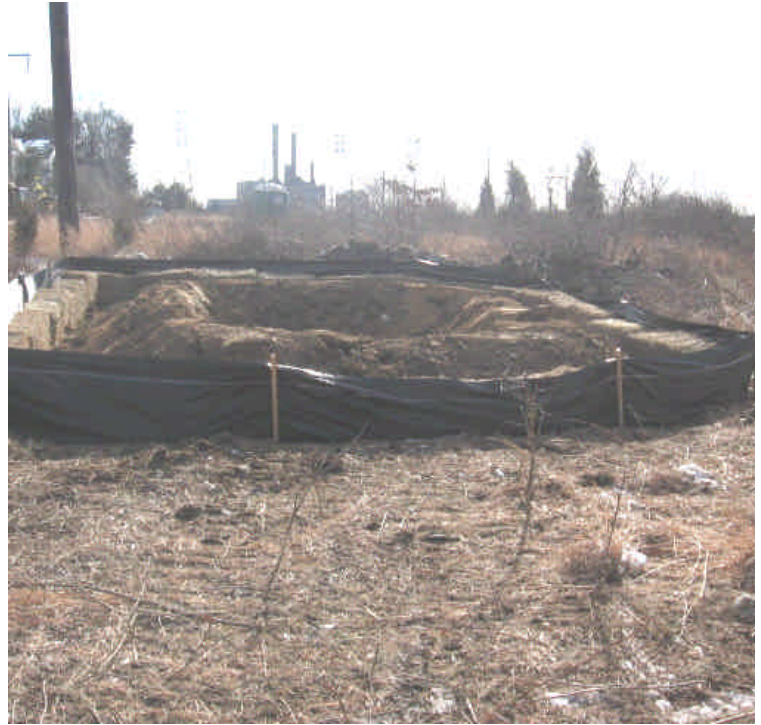
In preparation for construction activities, and potential dewatering or washout, a contained basin has been installed near station #1073.

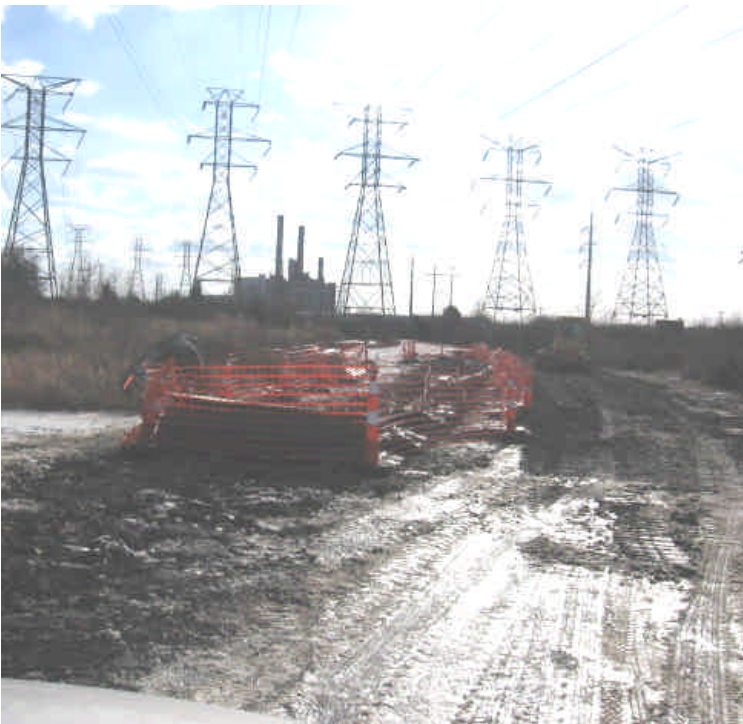
Photo of trenching activities from station #1058 to 1061.

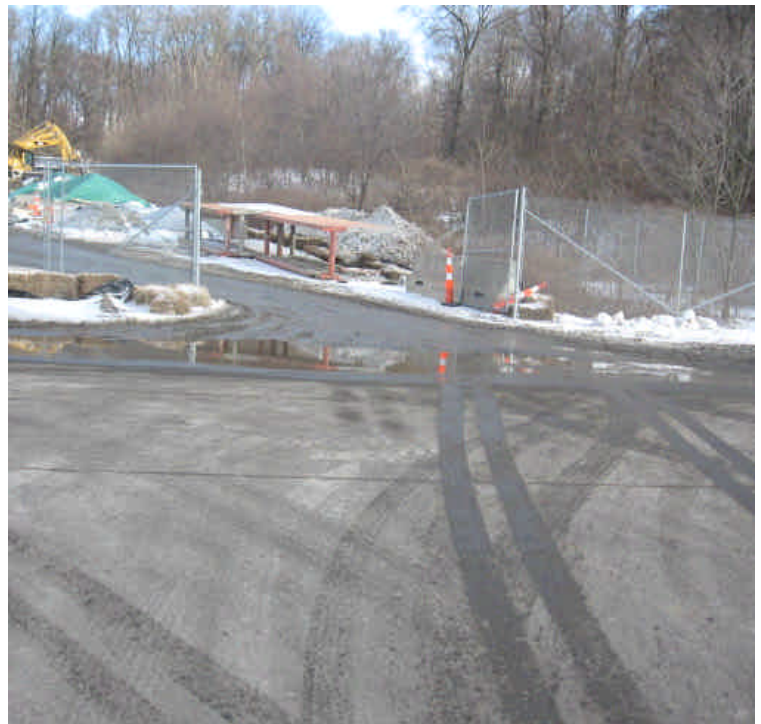
Shelland St (contractor yard)	The stone access stone pad remains in place at the entrance of the yard. Minimal sediment was noted within the	Continue to monitor and maintain as necessary. Sweep roadway regularly and continue to remove sediment accumulation	No issues noted with sediment accumulation but needs regular attention.

Minor sediment tracking noted from the Milford contractor lay-down yard. Continue to monitor and mitigate if necessary.

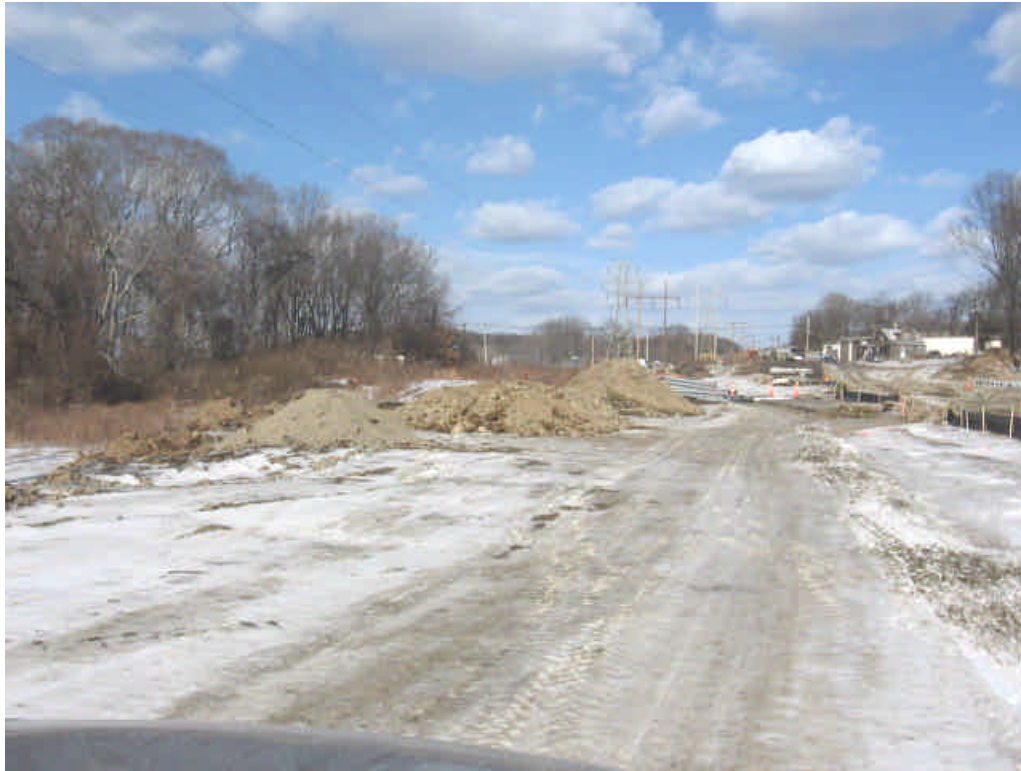
Areas of Inspection	Observation	Recommended Action	Corrected Action
Shelland St (contractor yard)	<p>Stockpiles that do not appear to be a result of the project were placed outside of the fence on the far side of the ROW. 2/16/07</p> <p>Erosion controls remain around the entire perimeter of the contractor lay-down yard. Sediment issues were not observed. 2/16/07</p>	<p>project. Remain aware of adjacent resource areas. 2/16/07</p> <p>Continue to monitor. 2/16/07</p>	NA
Inland Wetland and Watercourse encroachment and mitigation	<p>Inland Wetland resource areas are located near station # 1053, 1051, from #1012 to 1021. Stations #1117 to 1118 are located in a resource area. 2/16/07</p> <p>Wetland flagging was also noted along the trenchwork between station #1049-51. 2/16/07</p>	<p>Monitor resource areas to ensure that non-permitted encroachment or impacts do not occur. 2/16/07</p> <p>None at this time. 2/16/07</p>	NA

Photo taken near station #1111. Trenching activities shown to the right of the photo while wetland resource area is located to the far left. Stockpiles have potential to migrate towards wetland and into its buffer zone but do not appear to be here as a result of the project (noted for the record). NU contractors should continue to remain aware of the adjacent resource area.

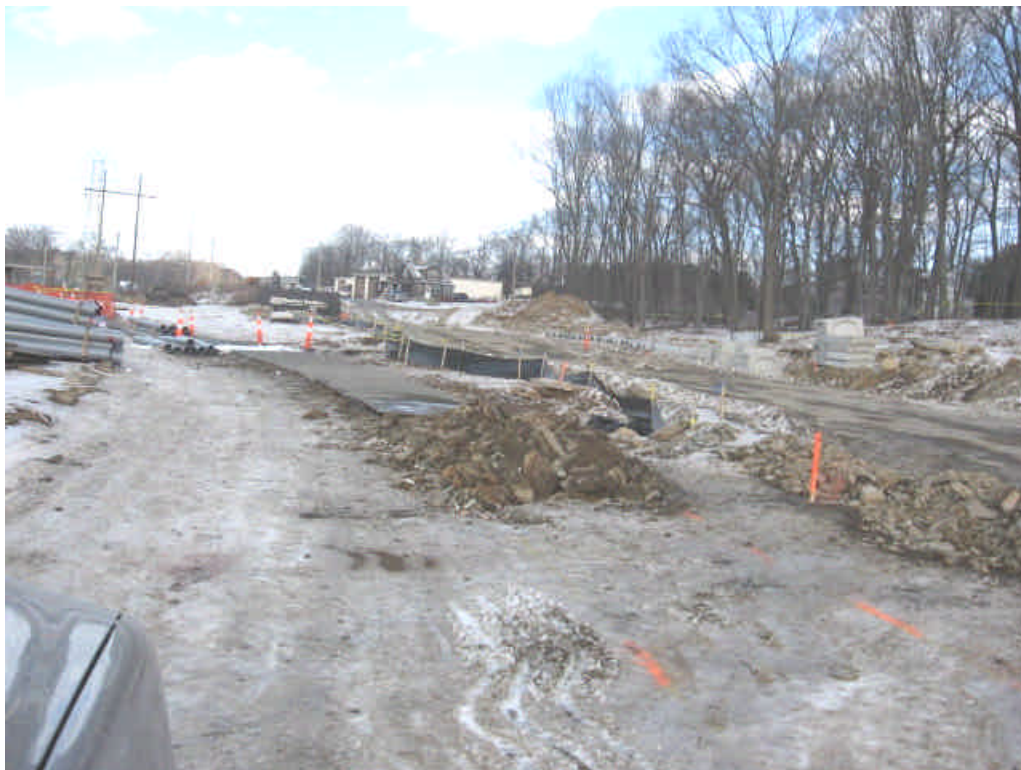
Photo of trenching activities from station #1112 to 1113. No issues were noted.
