Docket No. 272 – Development and Management Plan Inspection

Segment 3 Underground Line

Date: February 23, 2007

Location: East Devon Substation to the Housatonic River Crossing

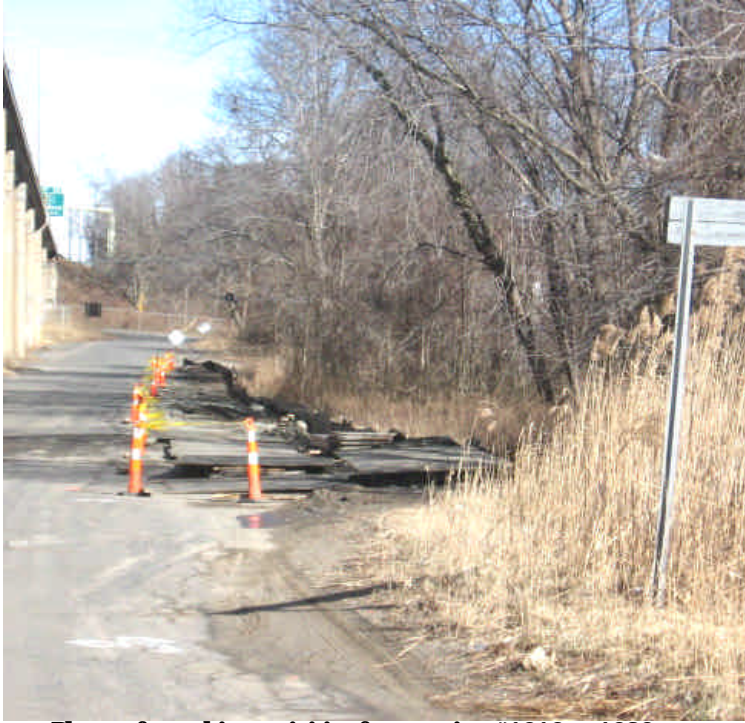
Photo of trenching activities from station #1016 to 1020.

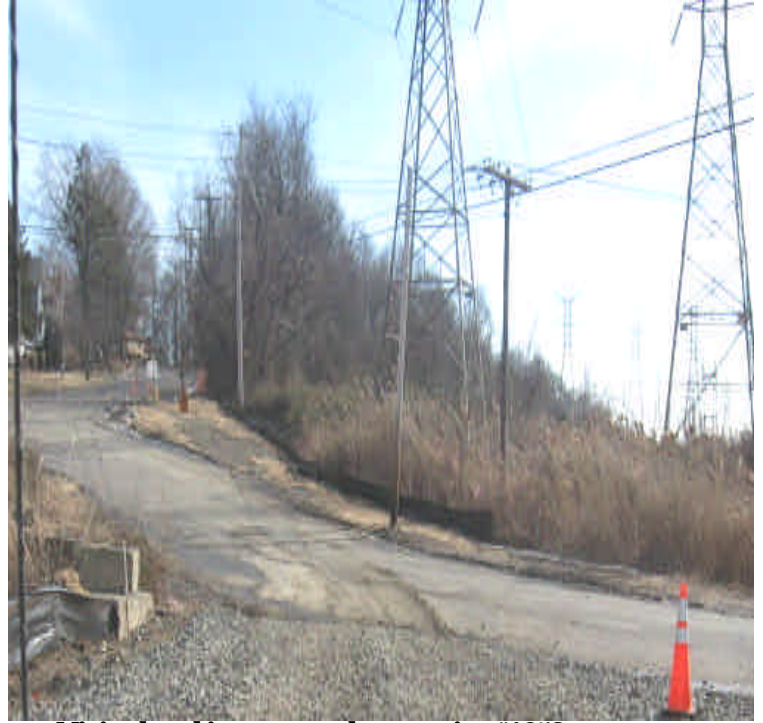
Minimal tracking was noted near station #1052 onto Naugatuck Ave. Sweep the roadway when necessary.

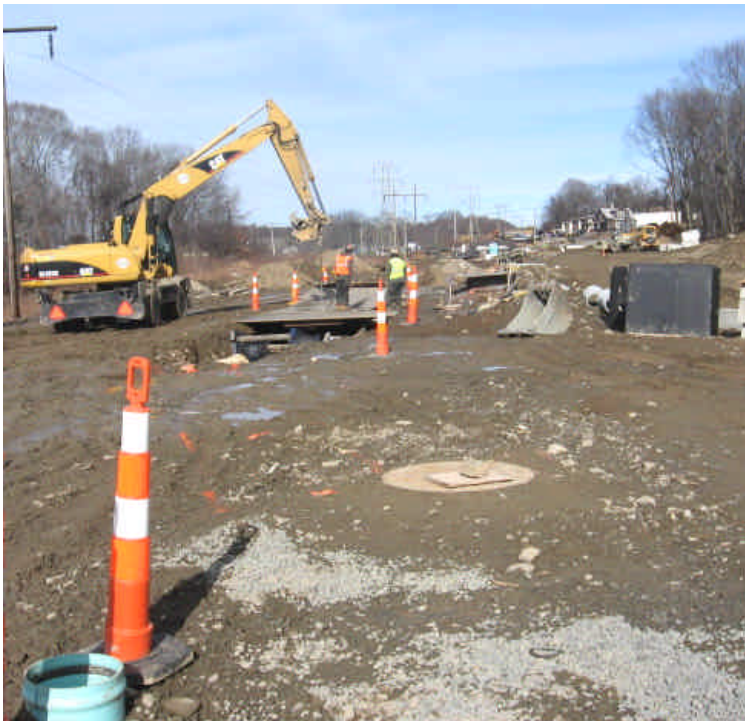
View of the trenching activities being conducted between stations #1110 to 1112.

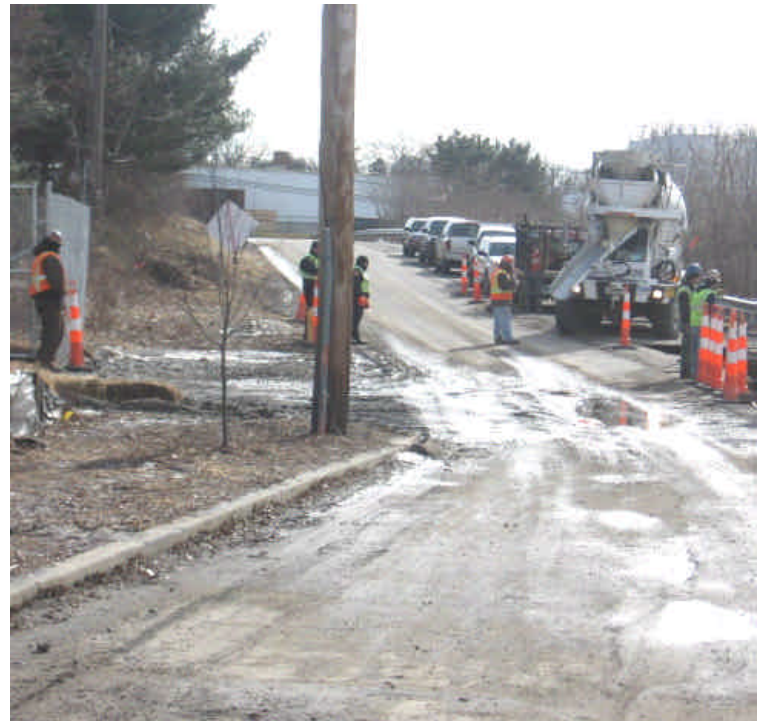
Photo of trenching activities on Shelland St. near the entrance to the Milford lay-down yard. Minimal sediment tracking was noted and the stone entrance pad had been refreshed since last week's inspection.
