**Docket No. 272 – Development and Management Plan Inspection**

**Segment 4a Underground Line**

**Date:** February 7, 2007

**Location:** Singer Substation to Fairfield/Westport Town Line

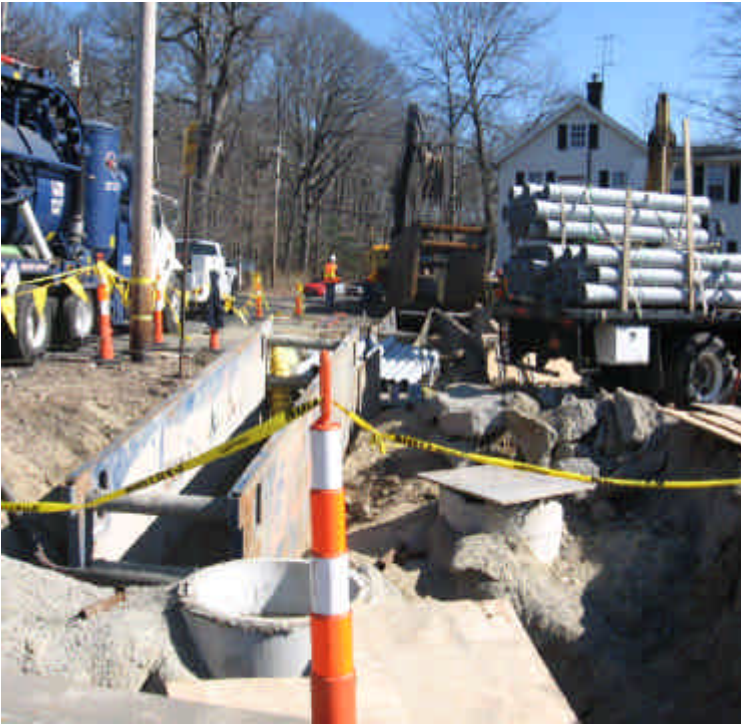
**Trenching activities adjacent to Vault #28. Catch basins located downgradient of trenching activities remain unprotected.**

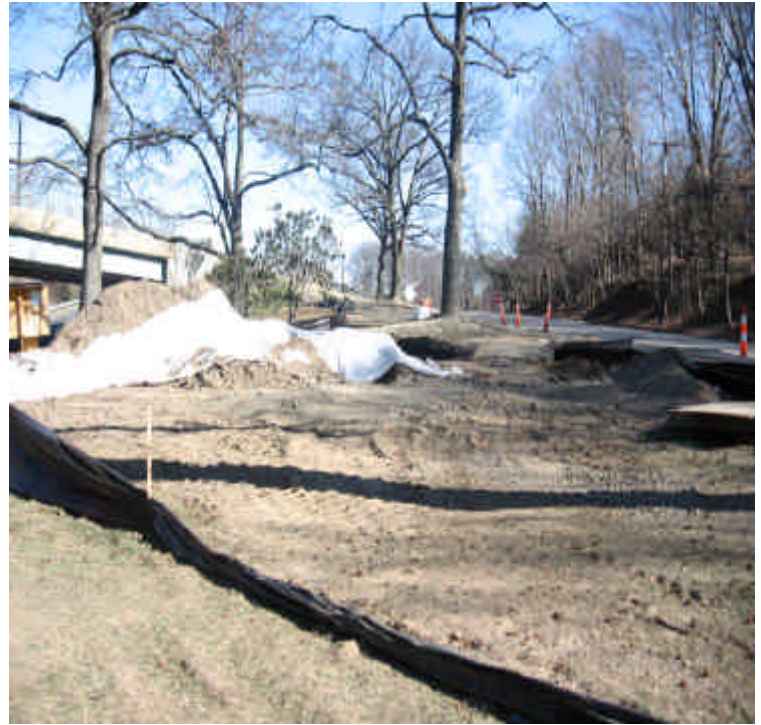
**Construction area along Pequot Ave. Soil pile remains stable. It is recommended that compromised erosion controls be re-established.**

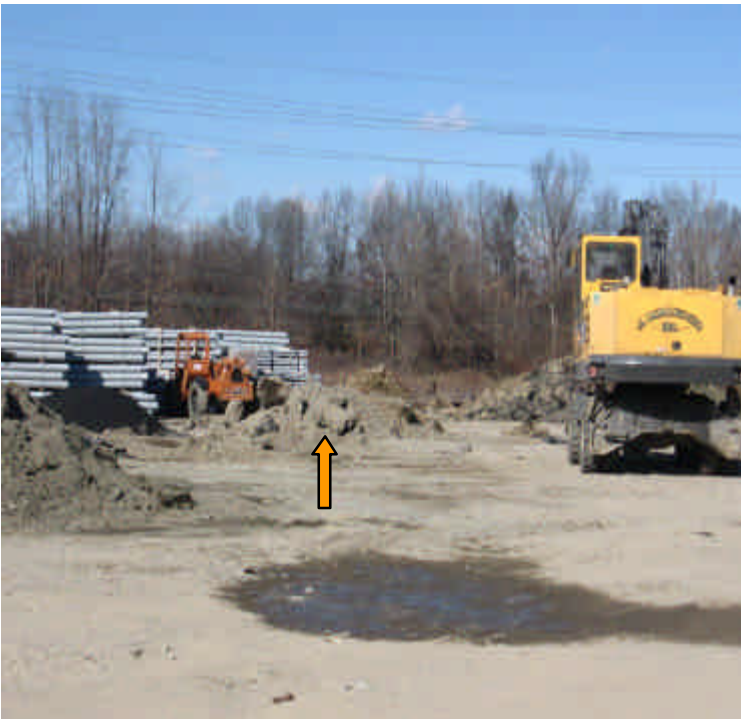
**The small stockpiles indicated are the remnants of the concrete washout area within the Kings Highway lay-down yard.**

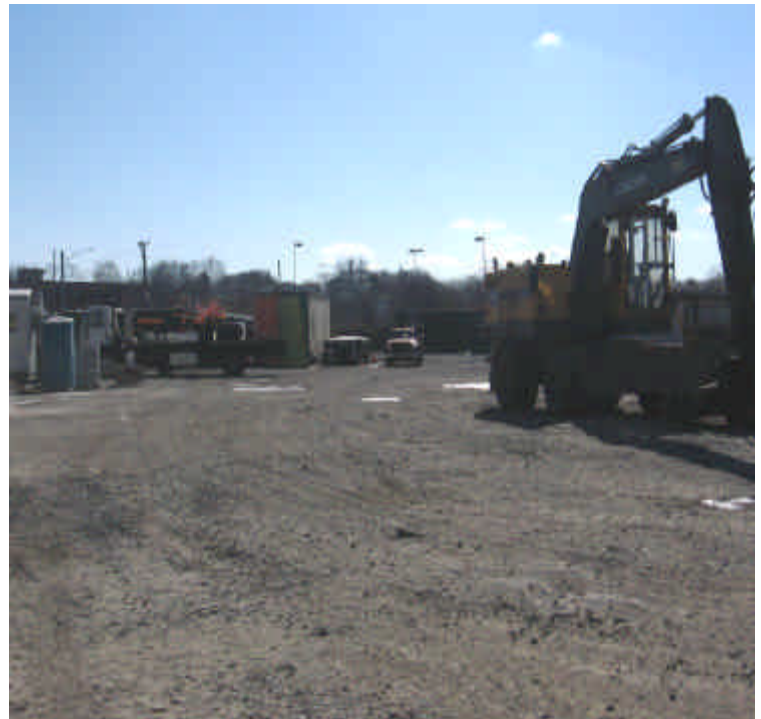
**Airborne dust was noted in the Kings Highway lay down yard at the time of our inspection. Attempt to water down soils or provide other dust control.**

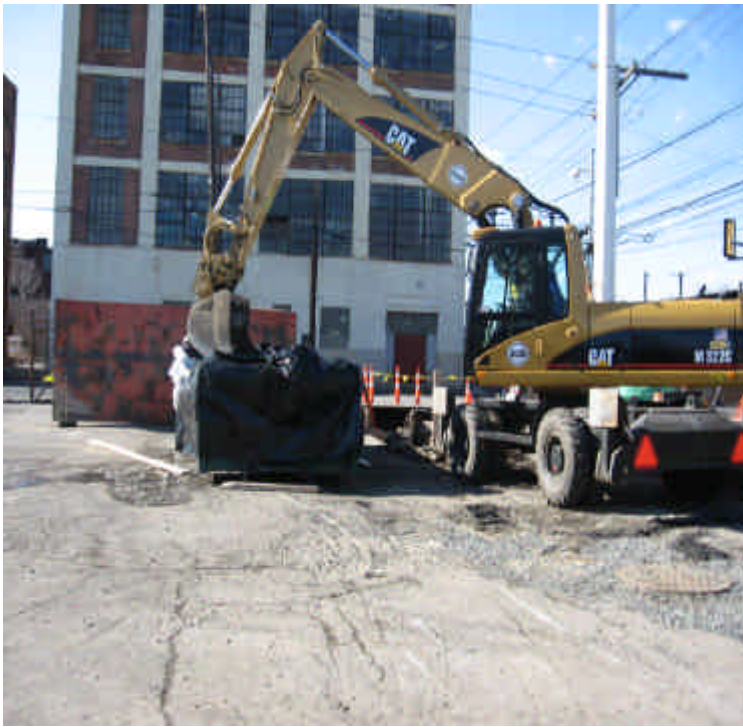
**Trenching activities at the intersection of Howard Ave. and Railroad Ave. Soils being removed were high in lead content and appeared to be handled appropriately.**

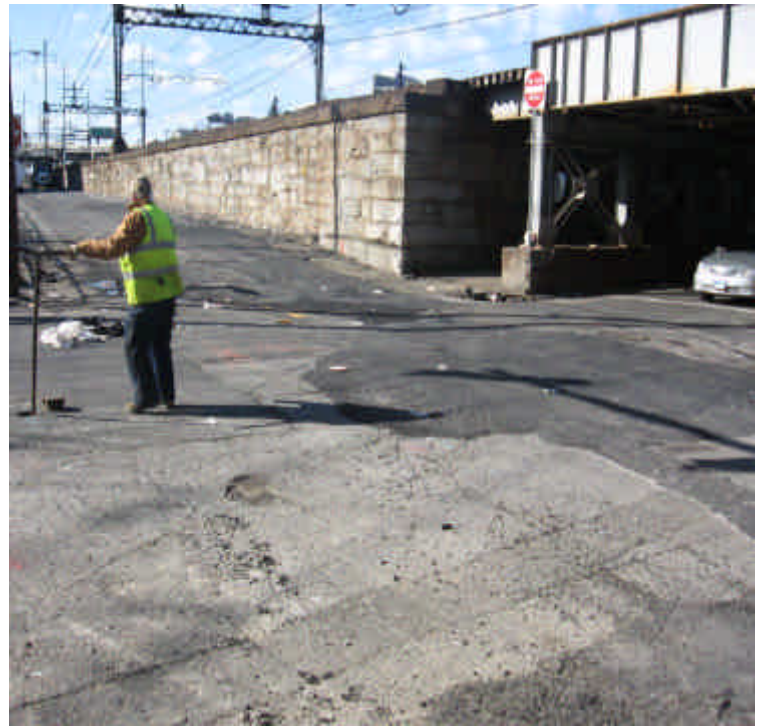
**Photo of a completed section of trench on Railroad Ave. near near its intersection with Myrtle Ave.**

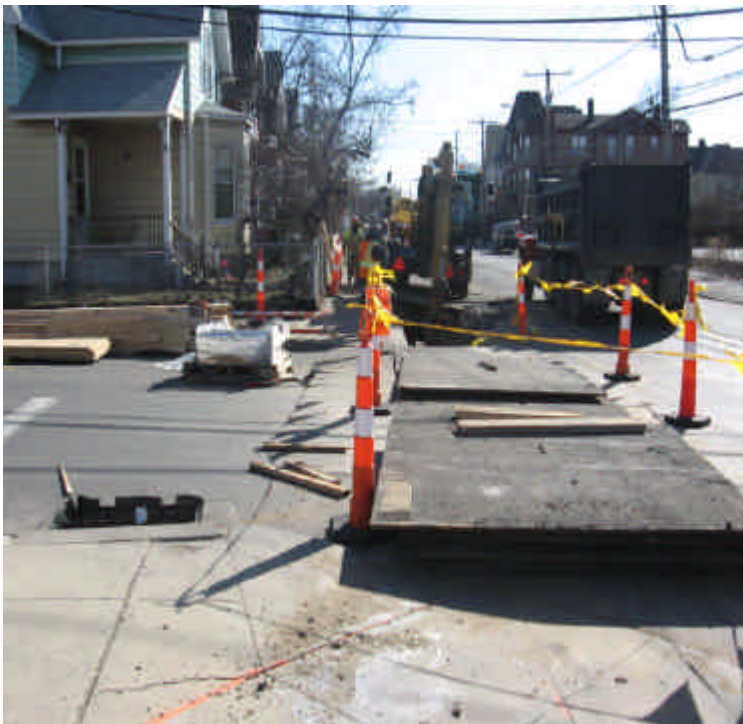
**Trenching activities along Broad St., all catch basins have appropriate controls in place.**

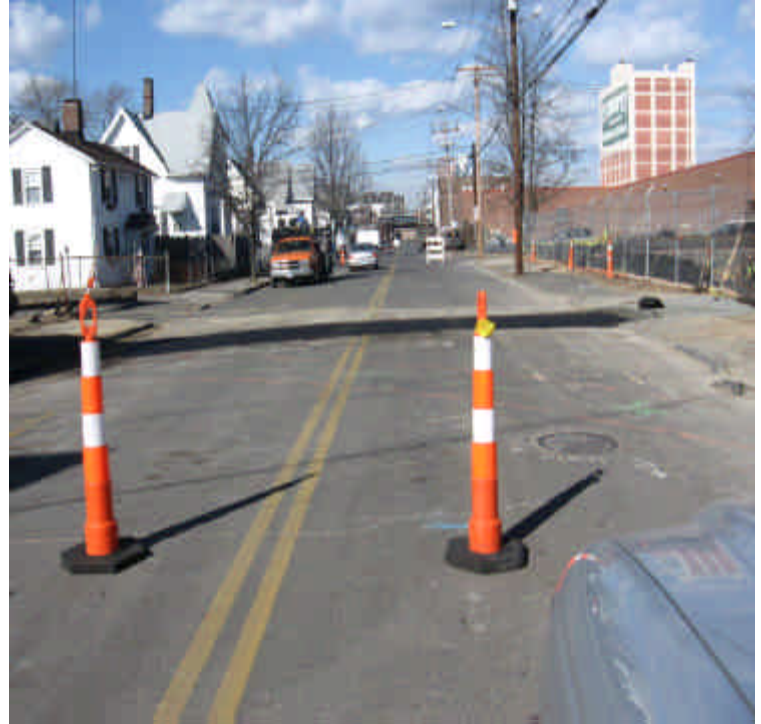
**Trenching activities across Main St. to the Singer substation yard appear to have been completed.**
