Docket No. 272 – Development and Management Plan Inspection

Segment 4a Underground Line

Date: February 23, 2007

Location: Singer Substation to Fairfield/Westport Town Line

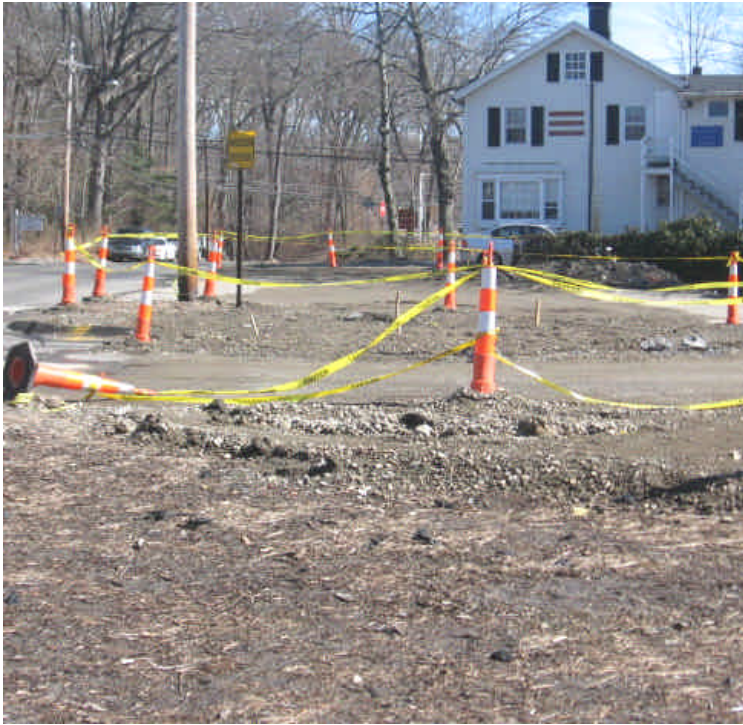
Trenching activities near Vault #28 are complete. Exposed soils are comprised of hard pack that resists erosion. Final stabilization will still be necessary.

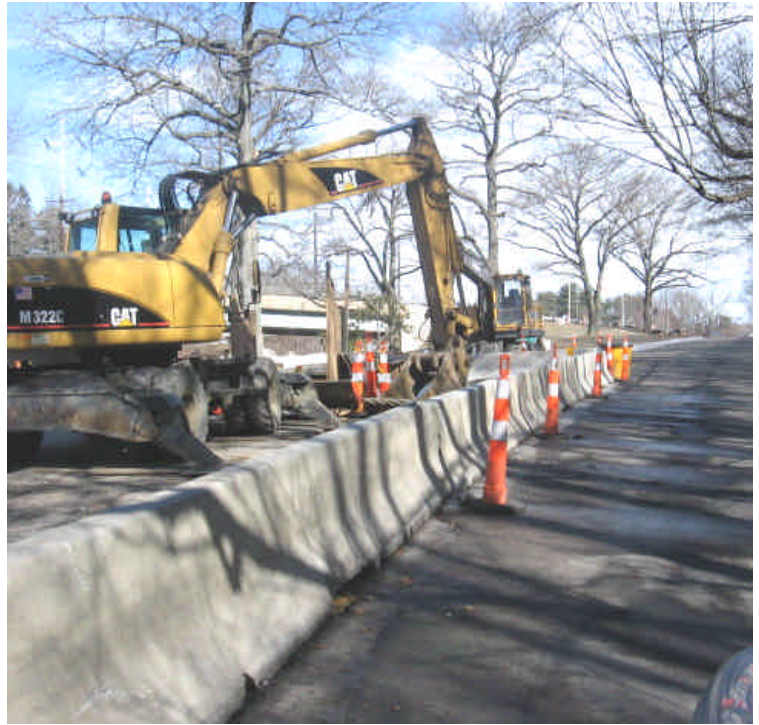
Trenching activities continue along Pequot Ave.

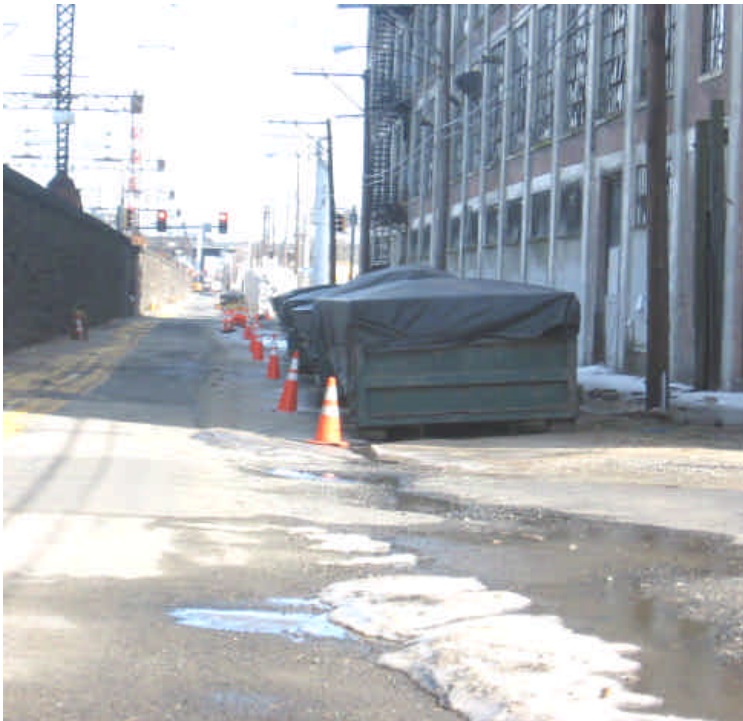
Photo of covered dumpsters storing soil along the shoulder of Railroad Ave. near its intersection with Howard Ave. It is anticipated that these dumpsters will be removed within the week.

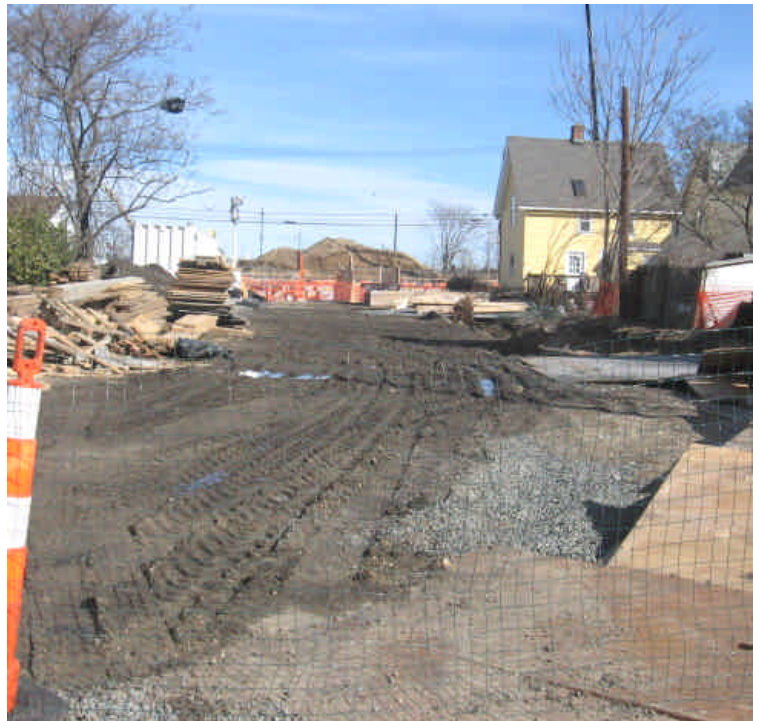
Photo of trenching activities between Broad St. and Main St. No issues were noted.
