**Docket No. 272 – Development and Management Plan Inspection**

**Segment 4b Underground Line**

**Date:** February 7, 2007

**Location:** Fairfield/Westport Town Line to Westport Avenue in Norwalk

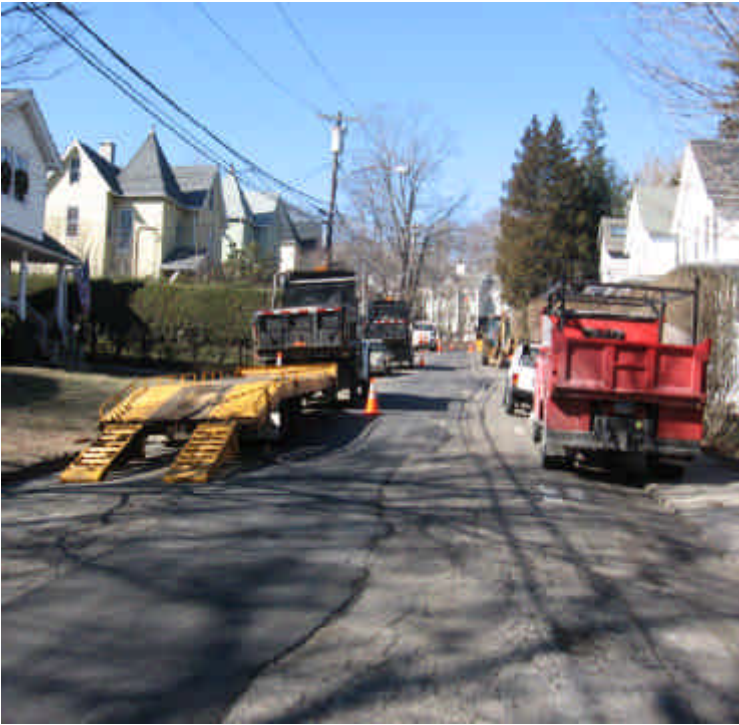
**Photo of completed trenching activities on Lincoln St. Some related utility work continues here (performed by others).**

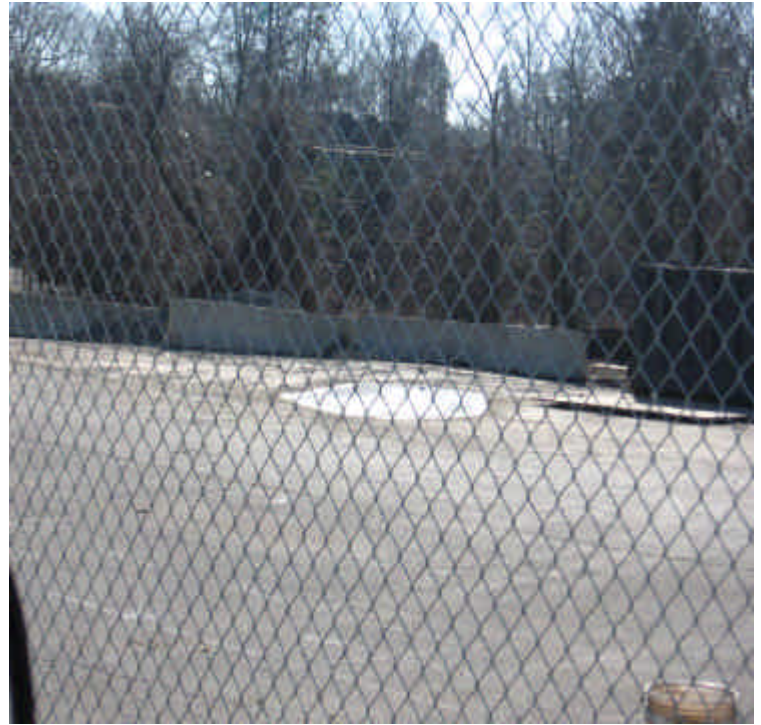
**Imperial Ave. lay-down yard was locked at the time of inspection. No issues were noted.**

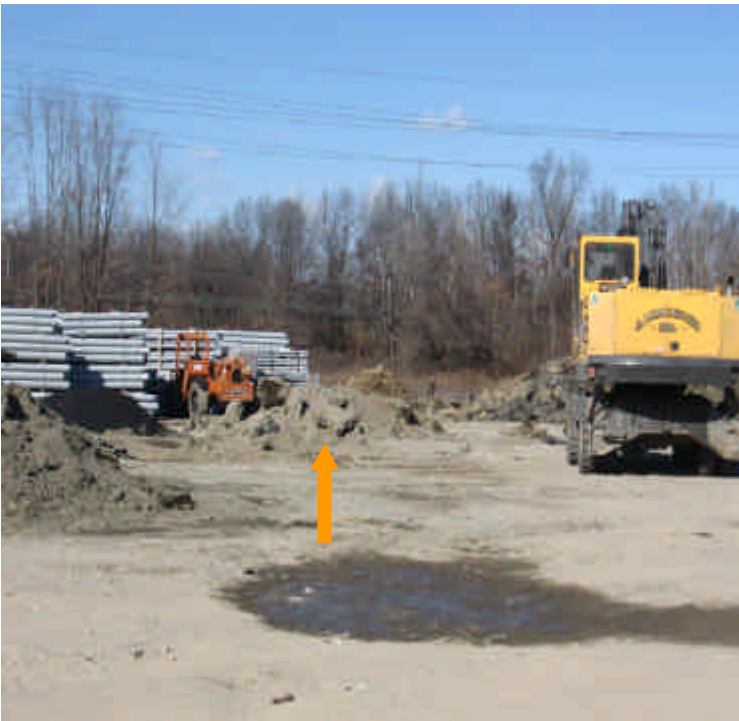
Kings Highway Lay-down Yard (Off Kings Highway) – (Currently being used for Segment 4a and 4b operations.)	The majority of the concrete wash-out basin materials has been removed from the site. One small pile of sediment remains. 2/7/07	Continue removing any materials that are no longer necessary in this area. Contractor states that washout containment will not be	Efforts were noted to remove the basin materials.

**The small stockpiles indicated are the remnants of the concrete washout area within the Kings Highway lay-down yard.**

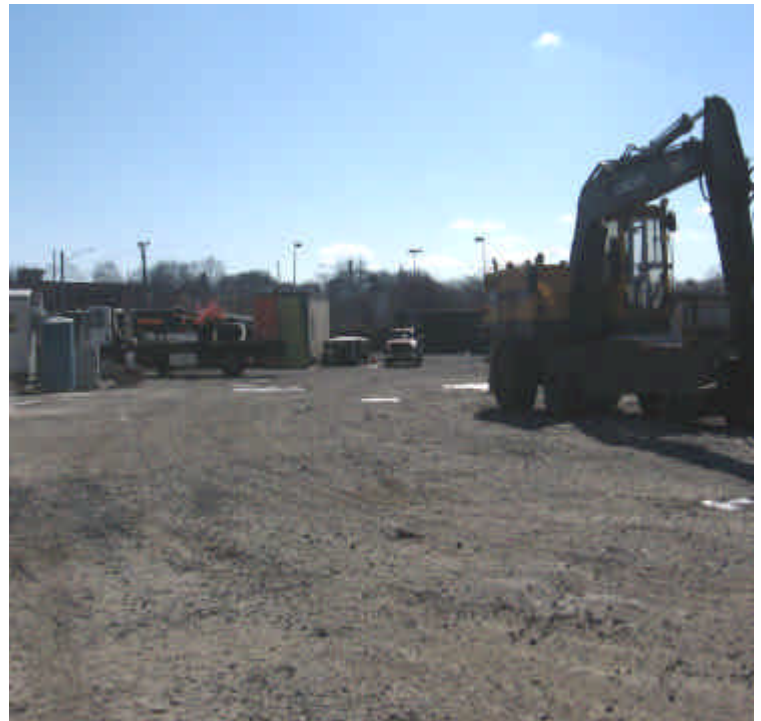
**Airborne dust was noted in the Kings Highway lay down Yard at the time of our inspection. Attempt to water down soils or provide other dust control.**

Areas of Inspection	Observation	Recommended Action	Corrected Action
operations.)	Airborne dust migration was observed during our inspection of the yard. 2/7/07	necessary at this time. 2/7/07  Prevent dust by implementing the dust control recommendations within the 2002 CT Guidelines for Soil Erosion and Sediment Control. 2/7/07	Needs attention.
Inland Wetland and Watercourse encroachment and mitigation	The Kings Highway lay-down yard is located adjacent to potential resource areas and a concrete lined waterway. 2/7/07  The Imperial Ave. lay-down yard is surrounded by the Saugatuck River on the southwestern, western, and northern sides. The majority of the yard is isolated from the nearby resource areas by an earthen berm. 2/7/07	See erosion control section. 2/7/07  See erosion control section. 2/7/07	NA  NA
Staging, Storage, and Parking Areas	A contractor lay-down yard is located off of Kings Highway near the Rt. 1 rotary. This is being used for both 4a and 4b activities. 2/7/07  A contractor lay-down yard is located off of Imperial Ave. in Westport. 2/7/07	See erosion control section. 2/7/07  See erosion control section. 2/7/07	NA  NA
