**Docket No. 272 – Development and Management Plan Inspection**

**Beseck Switching Station Inspection**

**Date:** January 16, 2007

**Location:** Beseck Switching Station

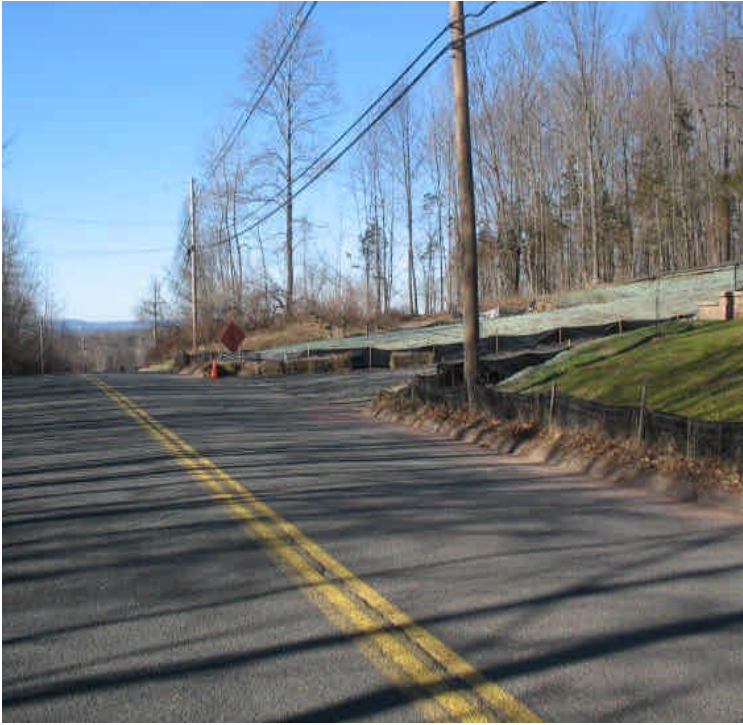
Site entrance off Carpenter Lane is at final grade; erosion controls have been removed. Monitor carefully for run-off.

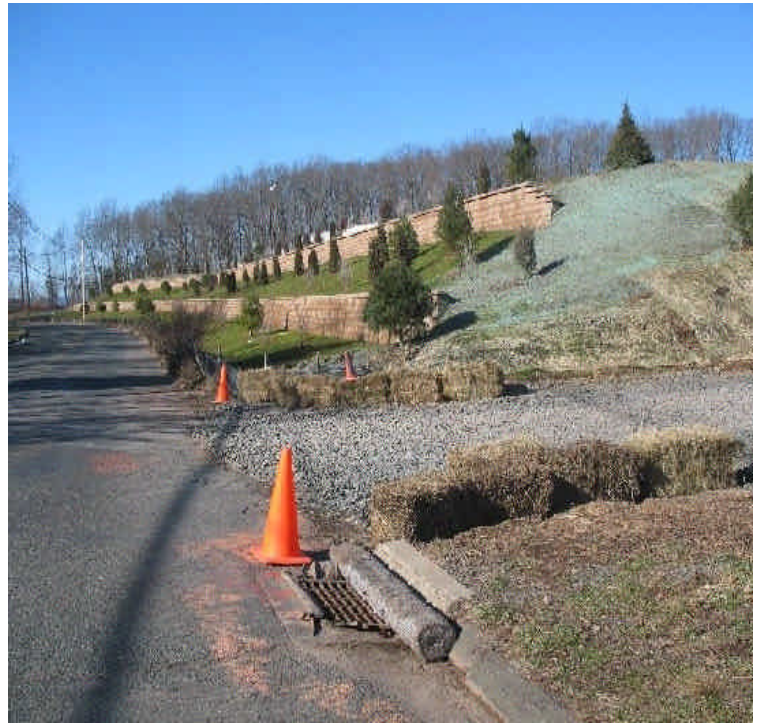
View of Carpenter Lane and retaining walls. Sediment accumulation was removed from the gutters, new haybales were installed, CB controls were cleaned and the stone entrance was improved.

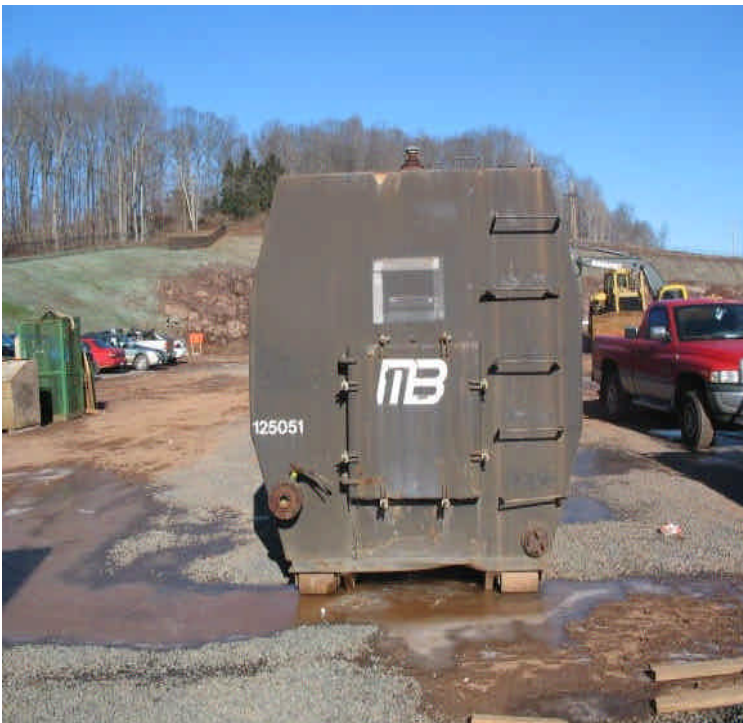
Dewatering from foundation pits is being pumped into frac tanks to settle and eventually released to the site. Clean water could be pumped directly to the protected CB at a low flow rate so as not to overwhelm controls.

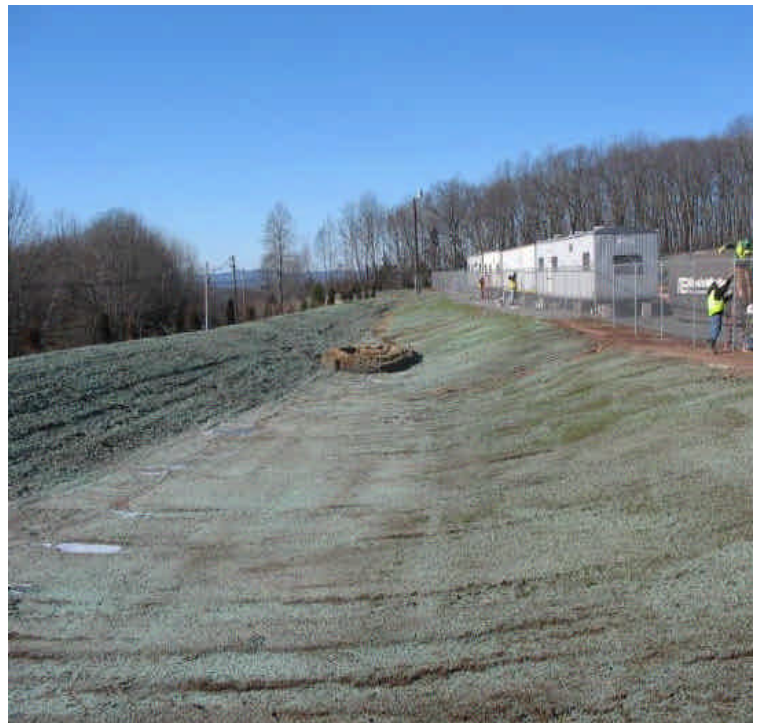
Surface areas on site have been fully hydroseeded (including a tackifier in an effort to stabilize soils. Additional haybales were installed at the inlet. Hay mulch was also added to the eroded gullies on the basin slope.

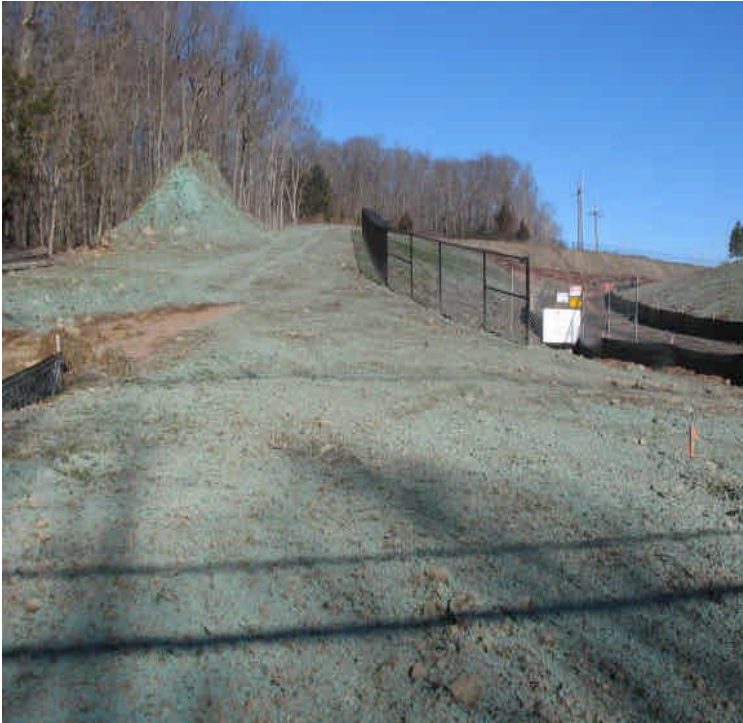
**Haybales were replaced across the old Zolnik driveway. The remaining stockpile and exposed surfaces have been hydroseeded (including a tackifier).**

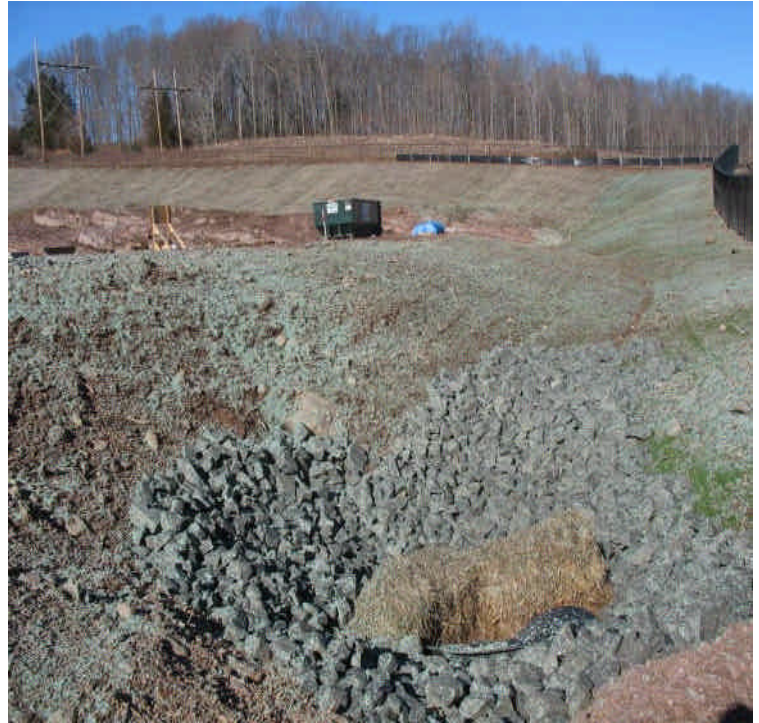
**View of the culvert under the new access road. A minor amount of sediment was noted but appears well contained within the trap. Beseck and Seg. 1A contractors are jointly sharing the access road.**

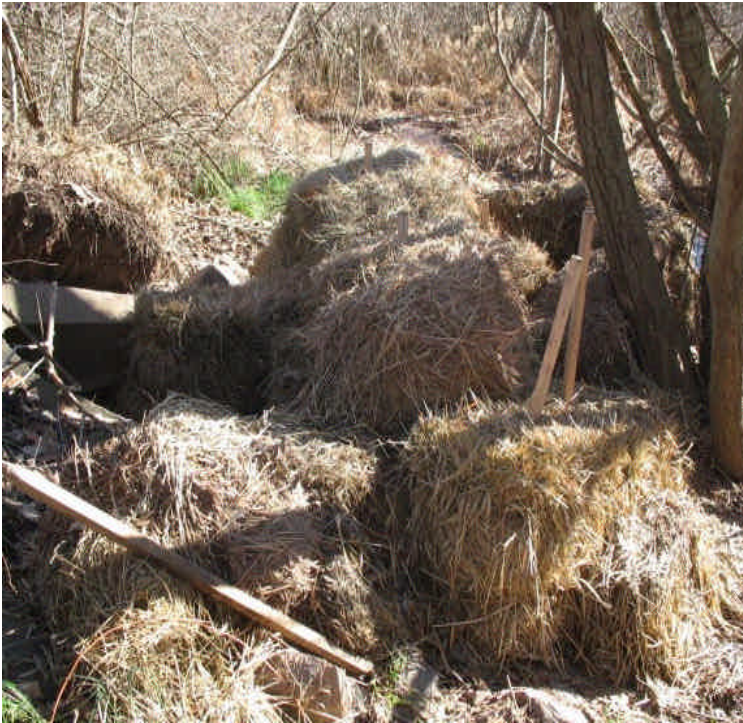
**Sediment has settled out at the storm drain outlet across Carpenter Lane. Clear water was noted flowing through the recently replaced haybales. The additional efforts on site appear to be effective at reducing sediment. Continue to monitor.**

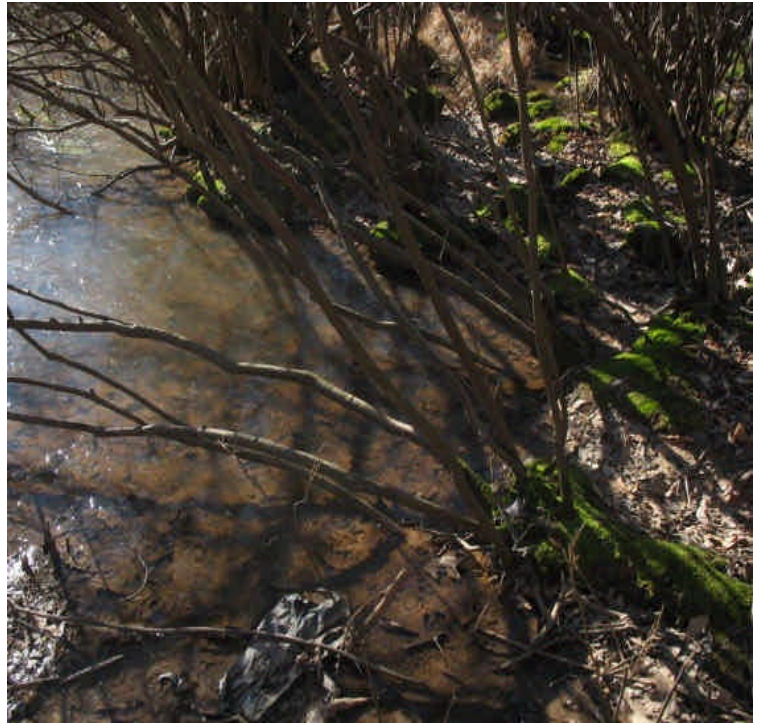
**Sediment has also settled out of the water column in the wetlands across Carpenter Lane. Sediment removal may still be necessary once the water level subsides. It will be evaluated whether the amount of accumulation justifies the minor disturbance to remove it.**
