Docket No. 272 – Development and Management Plan Inspection

Beseck Switching Station Inspection

Date: January 30, 2007

Location: Beseck Switching Station

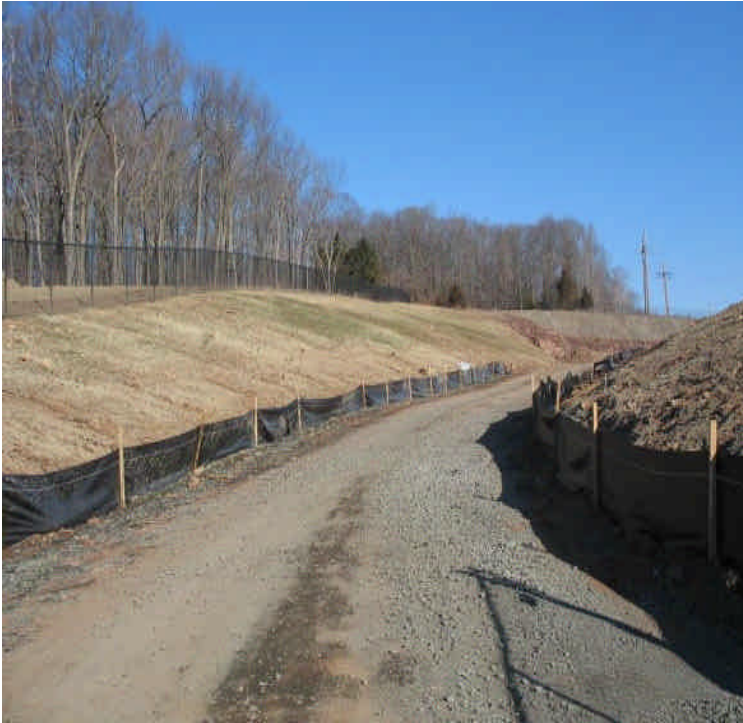
Site entrance off Carpenter Lane is at final grade; erosion controls have been restored following conduit installation. Monitor carefully for run-off.

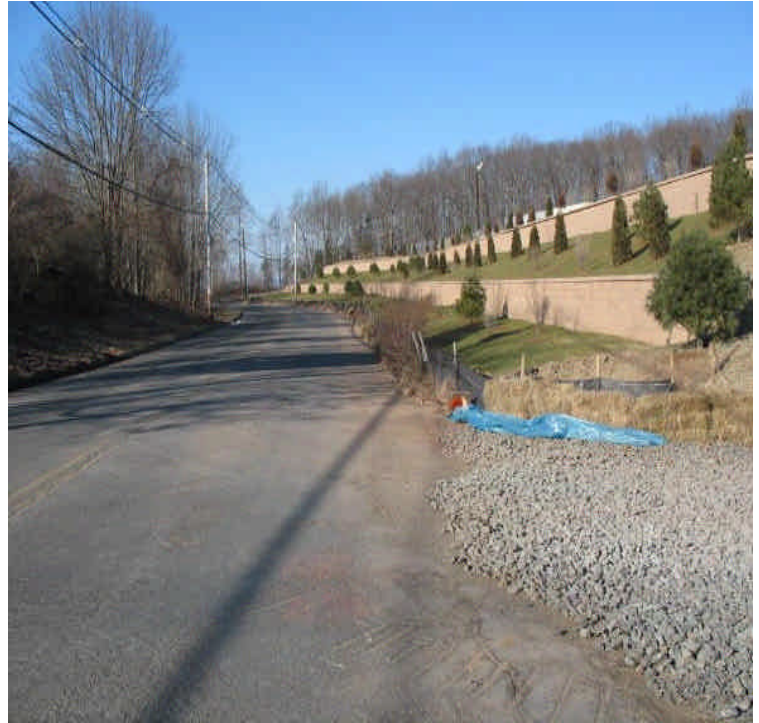
View of Carpenter Lane and retaining walls. Since the improvements were made at the stone pas and along the roadway, sediment tracking And turbid run-off were not issues at this time.

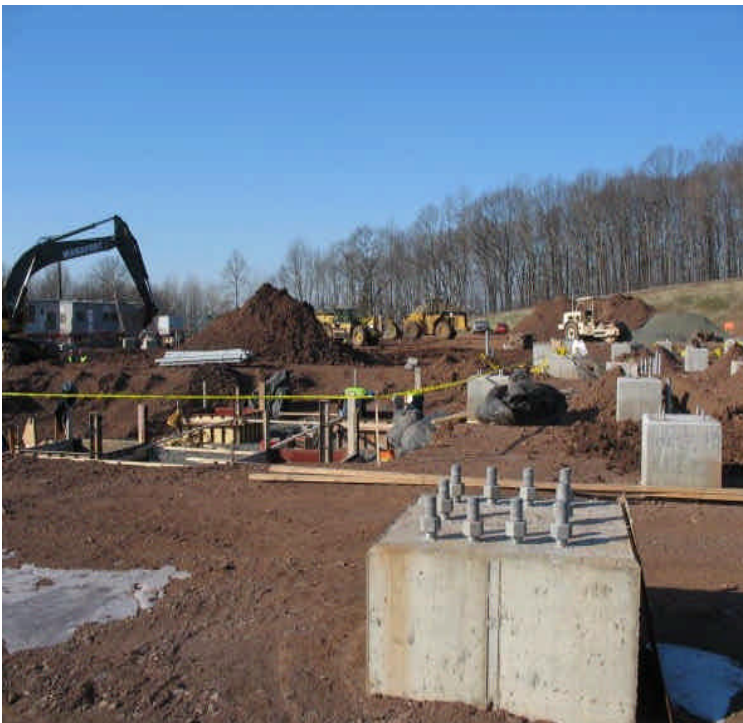
View of foundation installation looking east to west across the site.

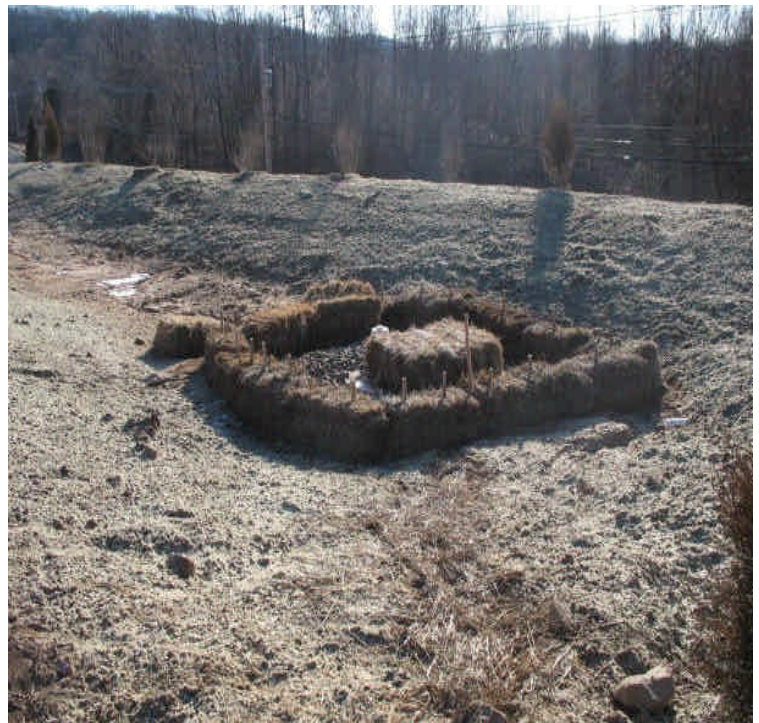
Surface areas on site are fully hydroseeded (including a tackifier) in an effort to stabilize soils. Additional haybales were installed at the inlet. Hay mulch covers the eroded gullies on the basin slope. No run-off was observed this week.

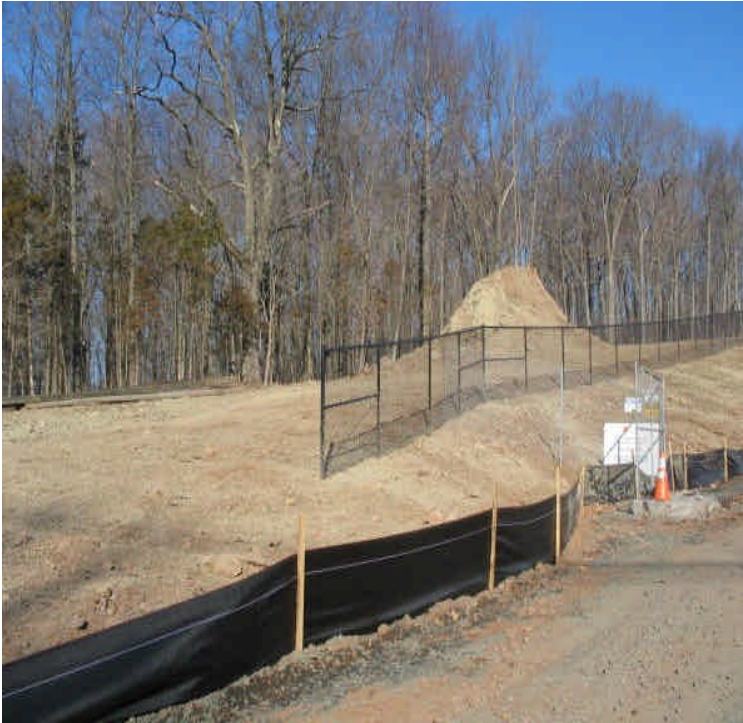
Haybales were in place across the old Zolnik driveway. The remaining stockpile and exposed surfaces are hydroseeded (including a tackifier).

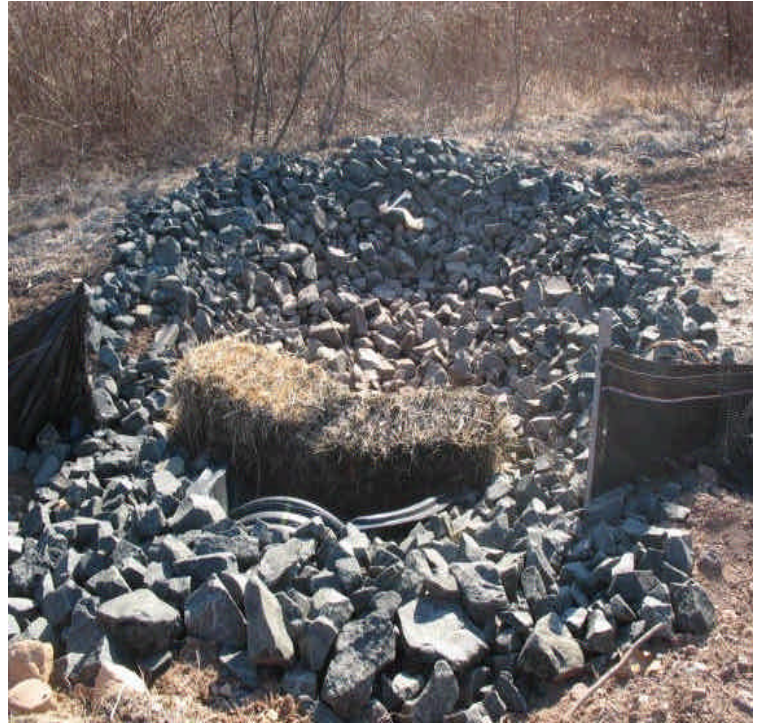
View of the culvert under the new access road. A minor amount of sediment was noted but appears well contained within the trap. Beseck and Seg. 1A contractors are jointly sharing the access road.

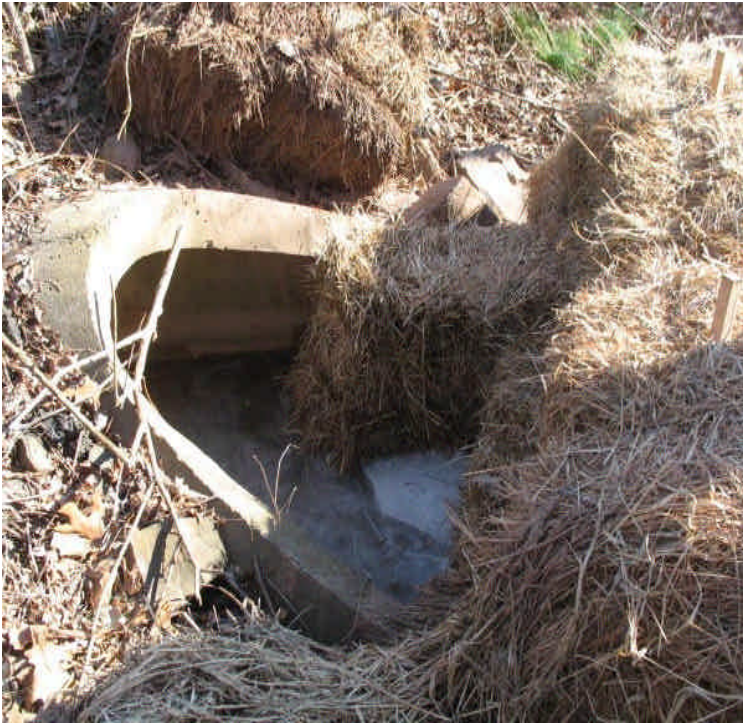
Sediment appears to have settled out at the storm drain outlet across Carpenter Lane. Ice was observed in the culvert but sedimentation was not apparent. The additional efforts on site appear to be effective at reducing sediment. Continue to monitor.

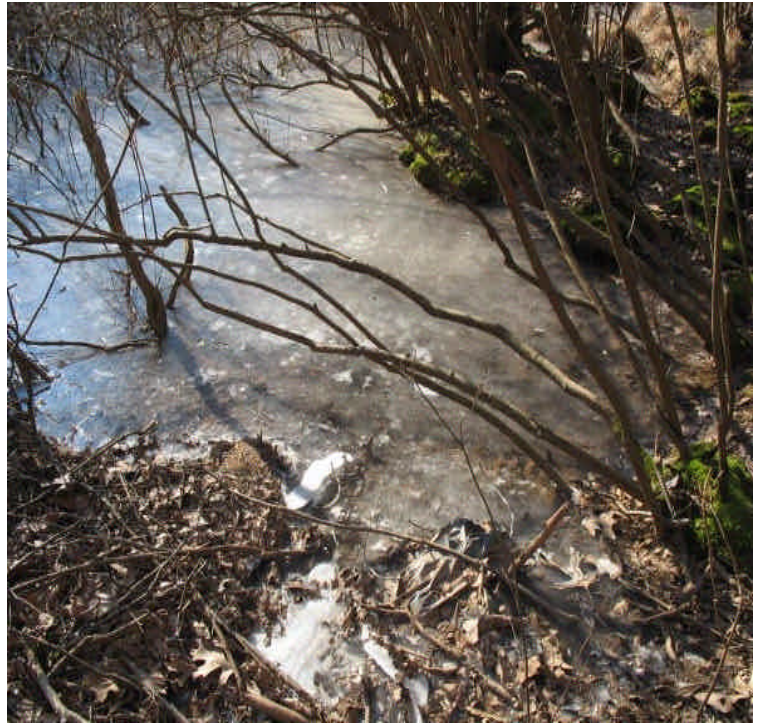
<p>Inland Wetland and Watercourse encroachment and mitigation</p>	<p>Turbid water within the wetland and outlet across Carpenter Lane appears to have settled out of the water column but ice cover made evaluation difficult. Ice was also observed at the outlet pipe so flow was not apparent. Sediment is extremely fine and difficult to remove or filter. 1/30/07</p> <p>Wetlands on east side of site were clean and well protected. 1/30/07</p>	<p>Several areas have sediment accumulation. Sediment should be removed from the outlet and adjacent areas when water levels recede 12/26/06- 1/30/07. It will be evaluated whether the accumulation justifies the minor disturbance required to remove it. 1/23-1/30/07</p> <p>Continue to monitor. This area is also covered by the Segment 1a inspections. 1/30/07</p>	<p>Ice cover/frozen conditions have helped to temporarily stabilize the area.</p> <p>Continue to evaluate</p> <p>NA</p>

Snow and ice cover made conditions difficult to observe in the wetlands across Carpenter Lane. Sediment removal may still be necessary once the water level subsides. It will be evaluated whether the amount of accumulation justifies the minor disturbance to remove it.
