Docket No. 272 – Development and Management Plan Inspection

Scovill Rock Switching Station Inspection

Date: January 2, 2007

Location: Scovill Rock Switching Station

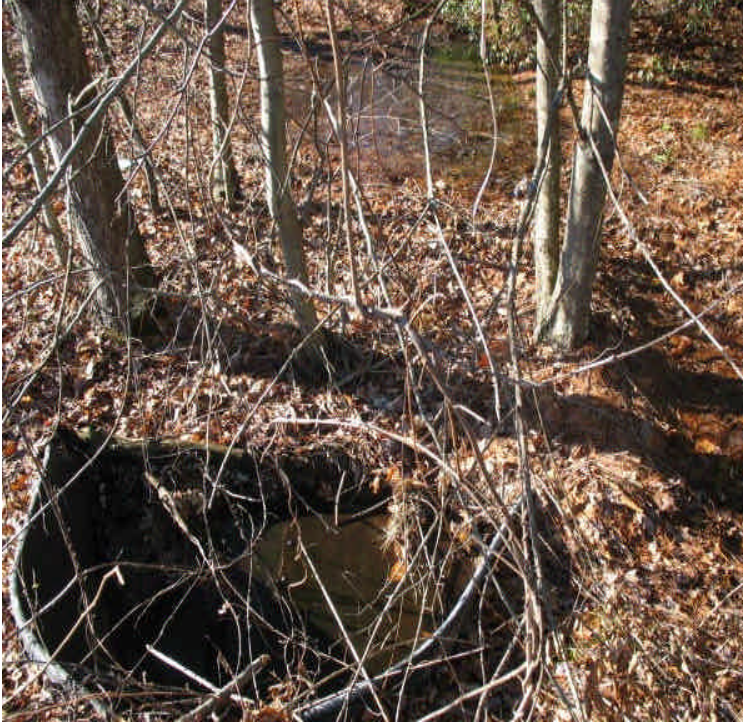
| Areas of Inspection | Observation | Recommended Action | Corrected Action |
|---|---|---|---|
| | Water flow was noted through the culvert under the access driveway. No sedimentation issues have been observed. 1/2/07 | Closely monitor any work done near the culvert. 1/2/07 | NA |

View of the culvert under the access drive. No sediment issues have been observed.

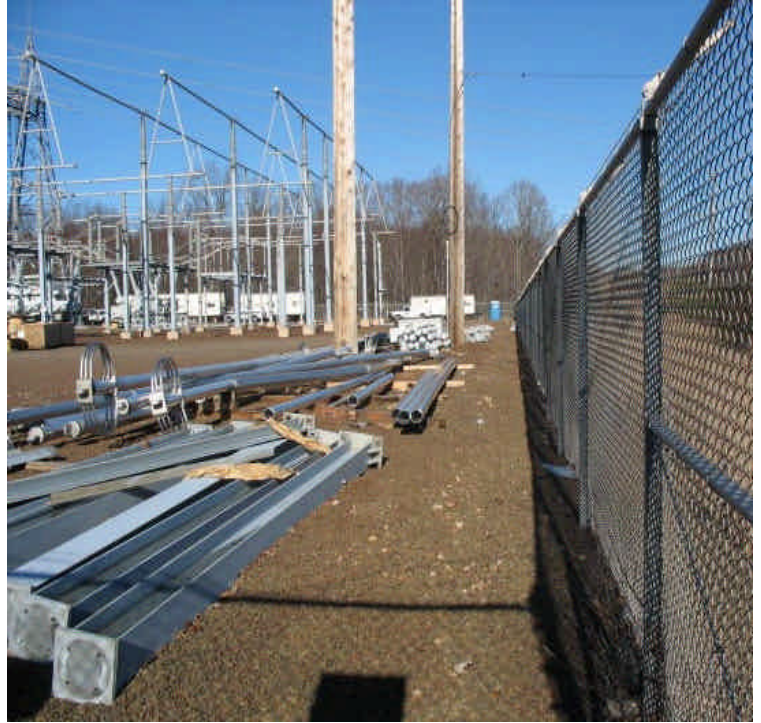
View of the perimeter of the yard. The site is stable and soil disturbing work is now complete.

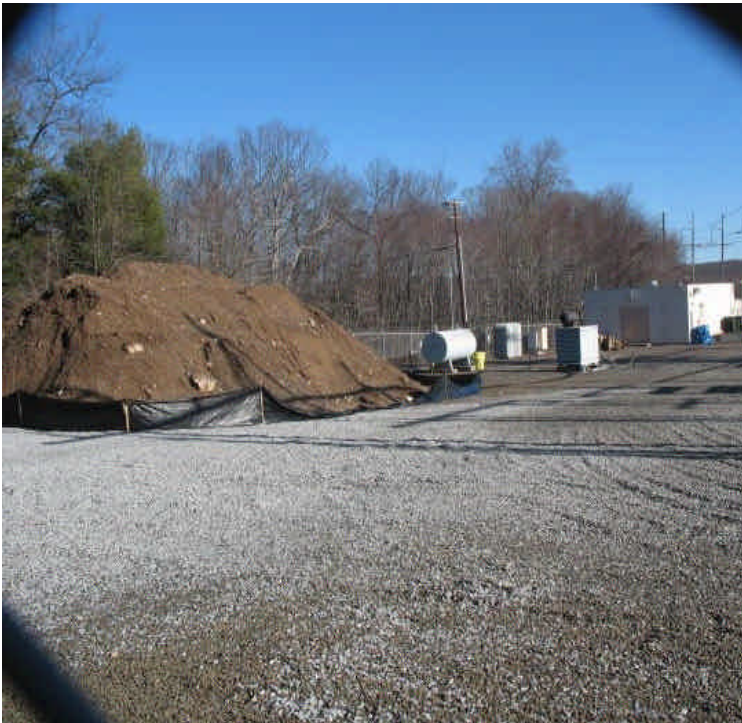
| Areas of Inspection | Observation | Recommended Action | Corrected Action |
|---|---|---|---|
| | One stockpile remains in the yard, surrounded by silt fence and a flat | Once soil analysis is complete, remove soil and dispose of properly. | Silt fence needs attention when feasible |

The remaining soil stockpile is surrounded by silt fence. Repair fallen section of silt fence and remove soil from site when feasible.

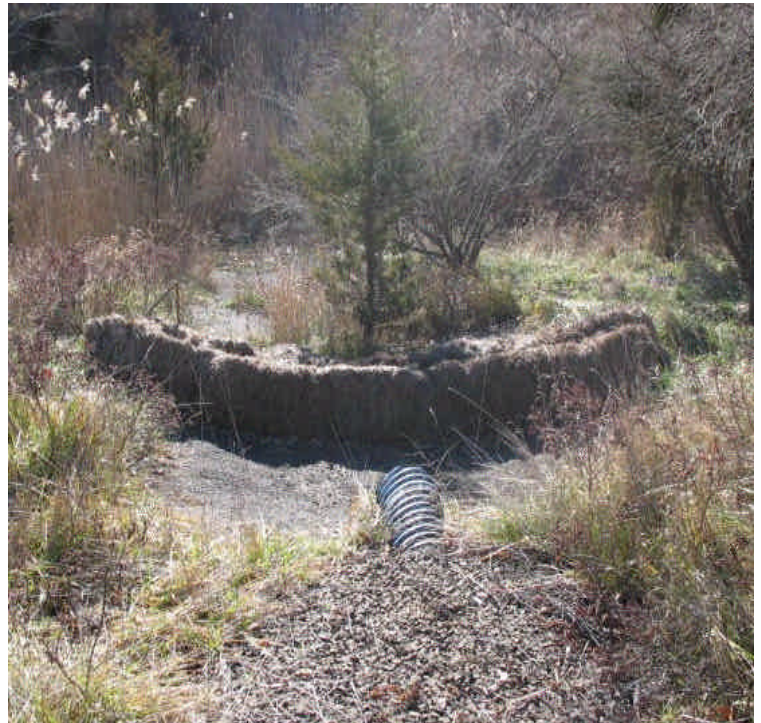
| Areas of Inspection | Observation | Recommended Action | Corrected Action |
|---|---|---|---|
| | Haybales installed at the 12" storm drain pipe are degraded; however, water flow was not observed throughout duration of work. 11/21/06-1/2/07 | Haybales can be removed now that soil-disturbing work on site is complete. 11/21/06-1/2/07 | Remove haybales when feasible. |

Remove degraded haybales when feasible. Site is stable.
