Docket No. 272 – Development and Management Plan Inspection

Scovill Rock Switching Station Inspection

Date: January 8, 2007

Location: Scovill Rock Switching Station

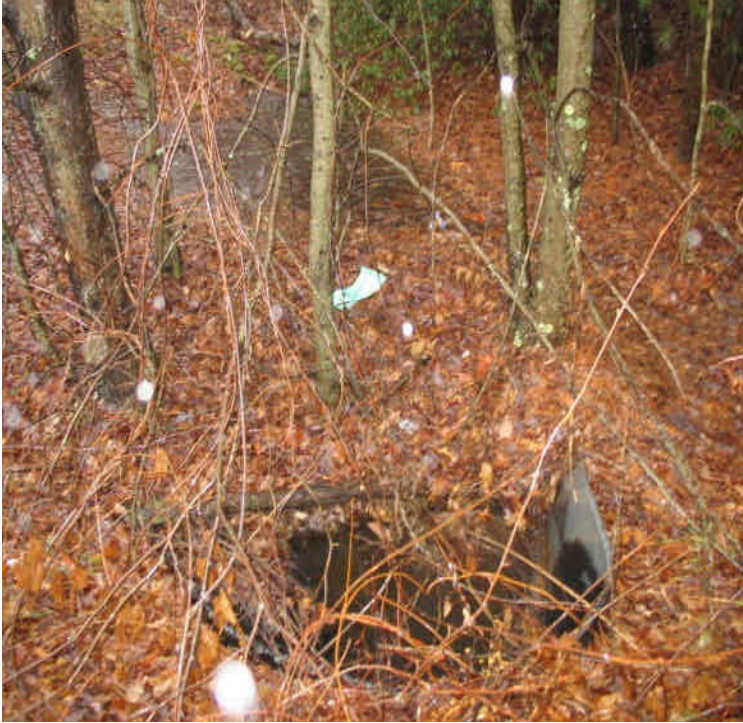
View of the culvert under the access drive. No sediment issues have been observed.

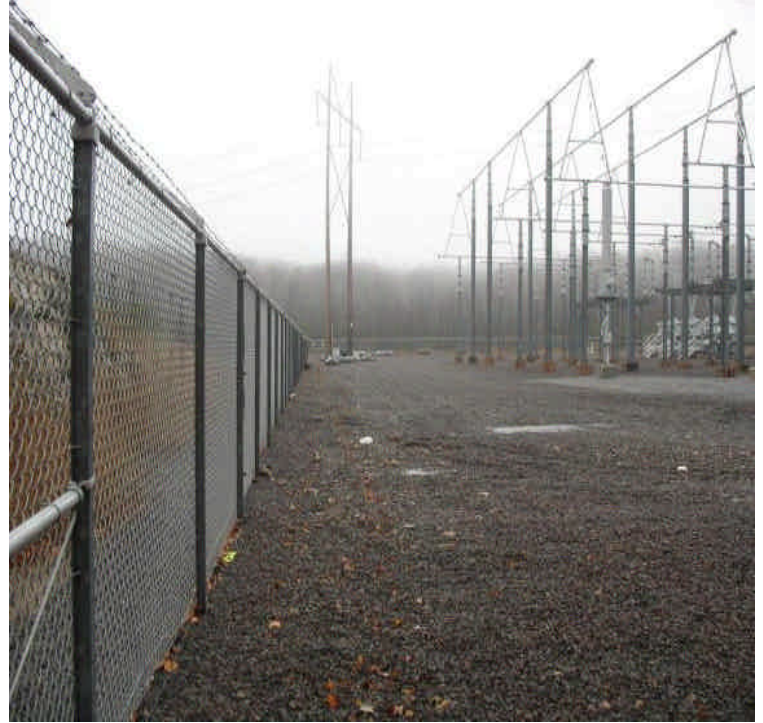
View of the perimeter of the yard. The site is stable and soil disturbing work is now complete.

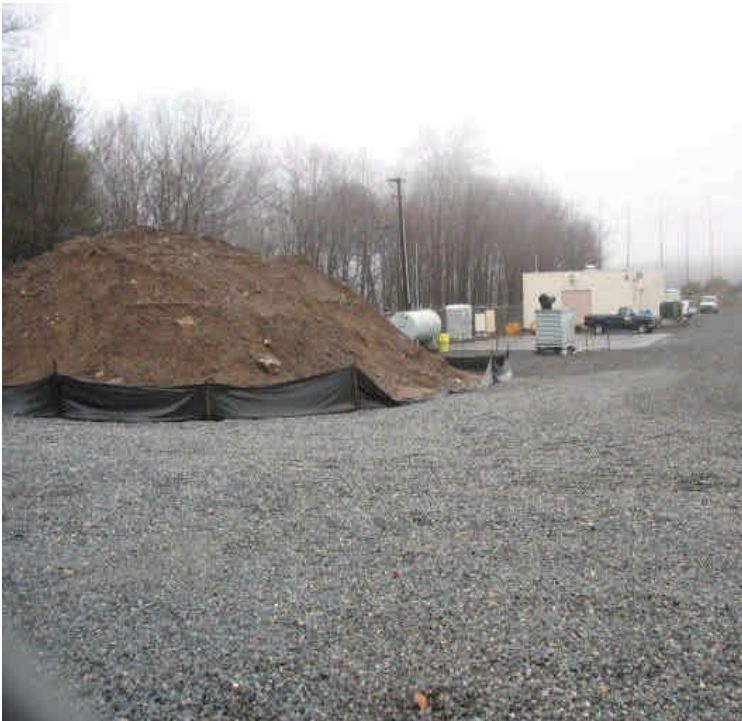
The remaining soil stockpile is surrounded by silt fence. Repair fallen section of silt fence and remove soil from site when feasible. All soil remains well contained to the site.

One stockpile remains in the yard, surrounded by	Once soil analysis is complete, remove soil	Silt fence needs attention when feasible

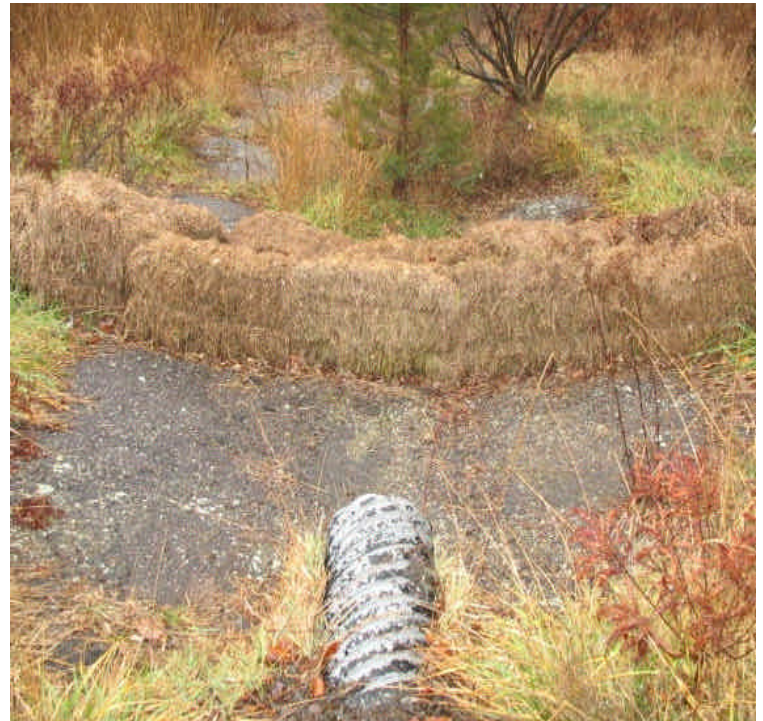
Remove degraded haybales when feasible. Site is stable.
