**Docket No. 272 – Development and Management Plan Inspection**

**Scovill Rock Switching Station Inspection**

**Date:** January 15, 2007

**Location:** Scovill Rock Switching Station

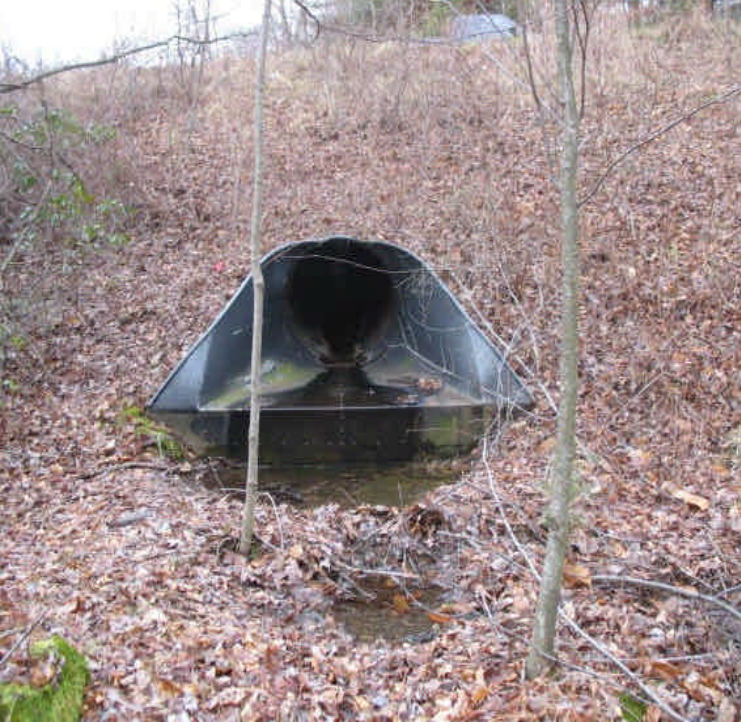
**View of the culvert under the access drive. No sediment issues have been observed.**

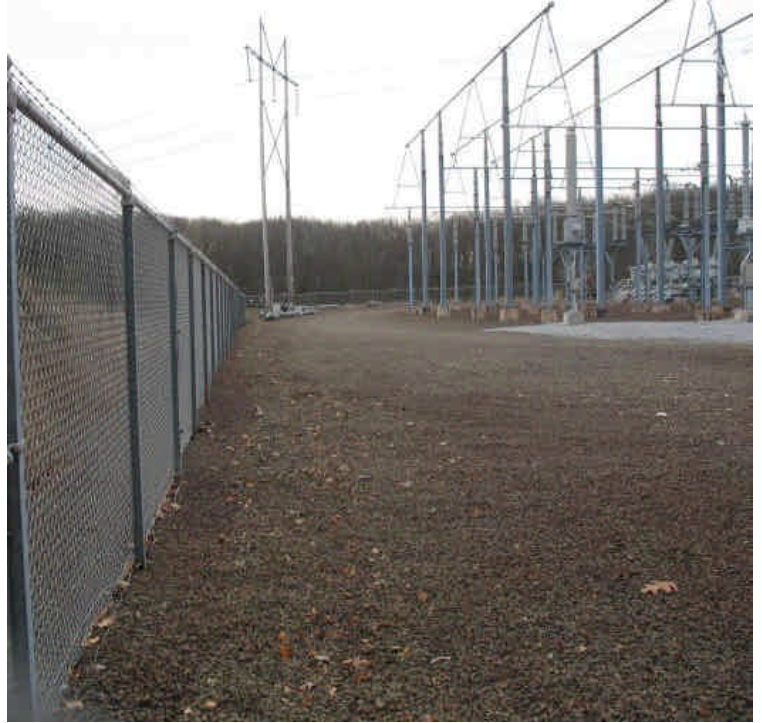
**View of the perimeter of the yard. The site is stable and soil disturbing work is now complete.**

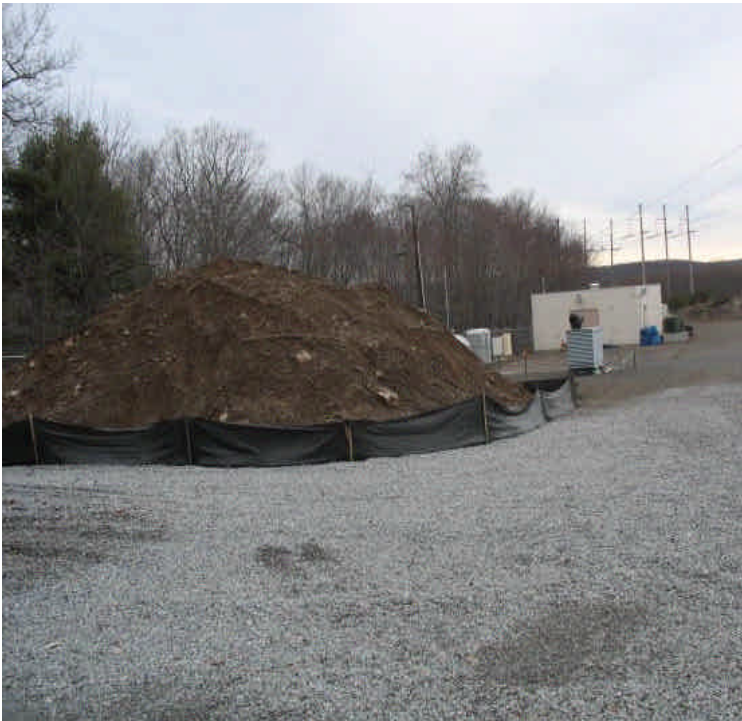
**The remaining soil stockpile is surrounded by silt fence. Fallen section of silt fence has been repaired; remove soil from site when feasible. All soils remain well contained to the site.**

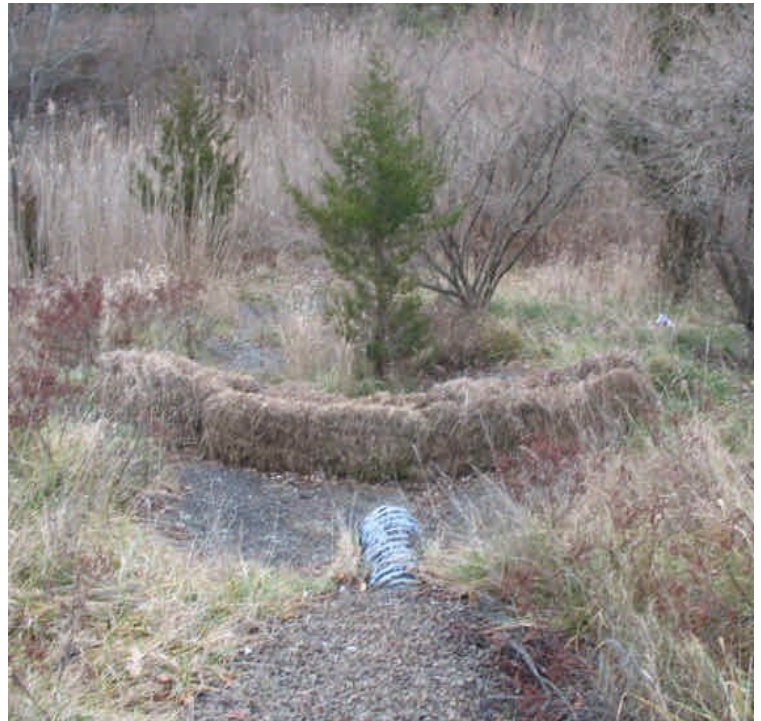
<b>Haybales installed at the 12” storm drain pipe are degraded; however, water flow was not observed throughout duration of work. 11/21/06-1/15/07</b>	<b>Haybales can be removed now that soil-disturbing work on site is complete. 11/21/06-1/15/07</b>	<b>Remove haybales when feasible.</b>
	<b>One stockpile remains in the yard, surrounded by silt fence and a flat</b>	<b>Once soil analysis is complete, remove soil and dispose of properly.</b>	<b>NA</b>

**Remove degraded haybales when feasible. Site is stable.**
