**Docket No. 272 – Development and Management Plan Inspection**

**Scovill Rock Switching Station Inspection**

**Date:** January 22, 2007

**Location:** Scovill Rock Switching Station

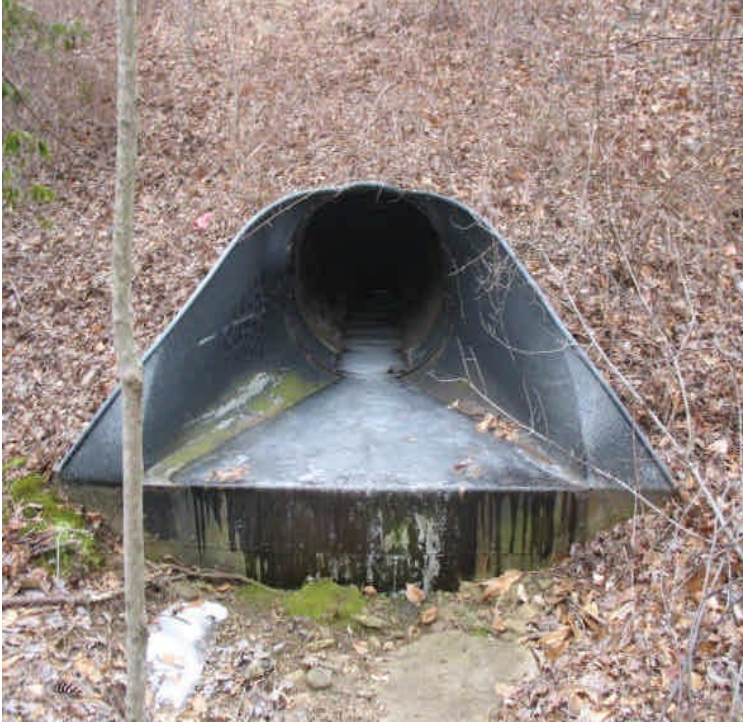
**View of the culvert under the access drive. No sediment issues have been observed.**

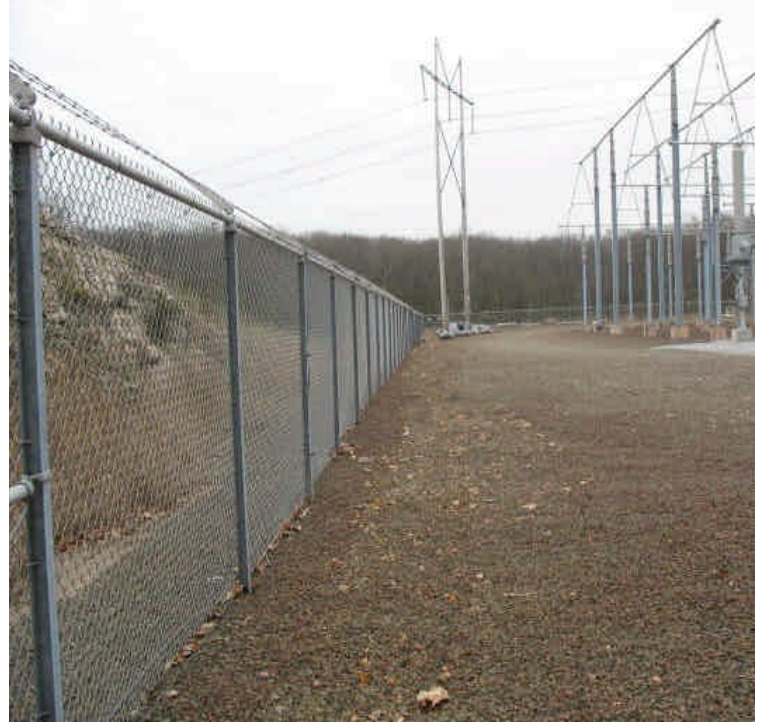
**View of the perimeter of the yard. The site is stable and soil disturbing work is now complete.**

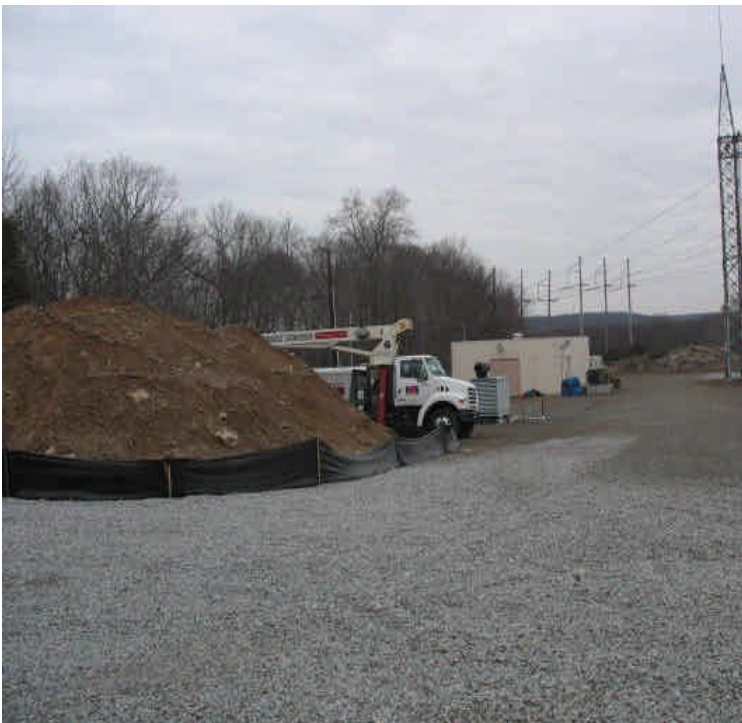
**The remaining soil stockpile is surrounded by silt fence. Fallen section of silt fence has been repaired. All soils remain well contained to the site.**

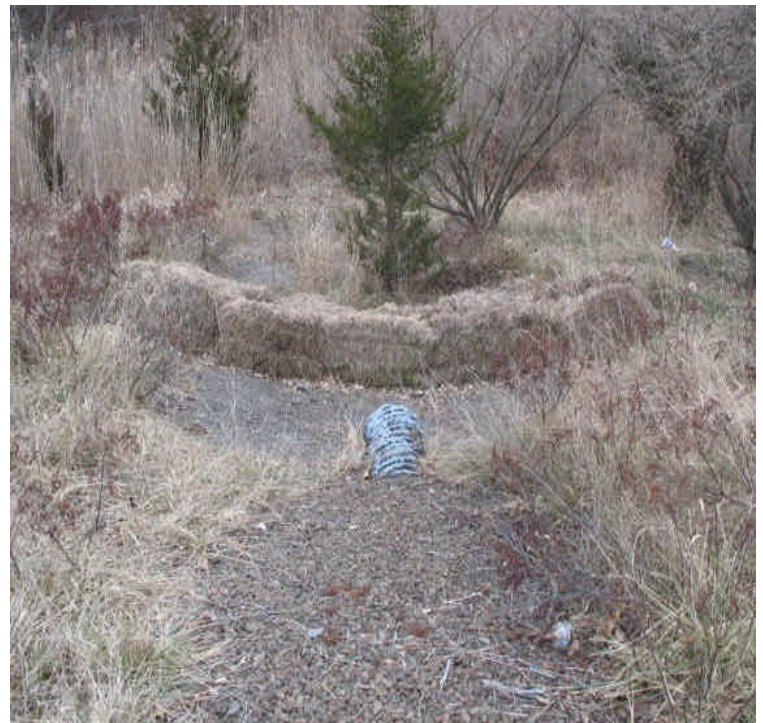
<b>Haybales installed at the 12" storm drain pipe are degraded; however, water flow was not observed throughout duration of work. 11/21/06-1/22/07</b>	<b>Haybales can be removed now that soil-disturbing work on site is complete. 11/21/06-1/22/07</b>	<b>Remove haybales when feasible.</b>
	<b>One stockpile remains in the yard, surrounded by silt fence and a flat</b>	<b>Once soil analysis is complete, remove soil and dispose of properly.</b>	<b>NA</b>

**Remove degraded haybales when feasible. Site is stable.**
