Docket No. 272 – Development and Management Plan Inspection

Segment 1a Inspection

Date: January 2, 2007

Location: Segment 1a – Scovill Rock Switching Station to Chestnut Junction, Oxbow Junction to Beseck Switching Station (excluding Royal Oak Bypass), Black Pond Junction to Beseck Switching Station

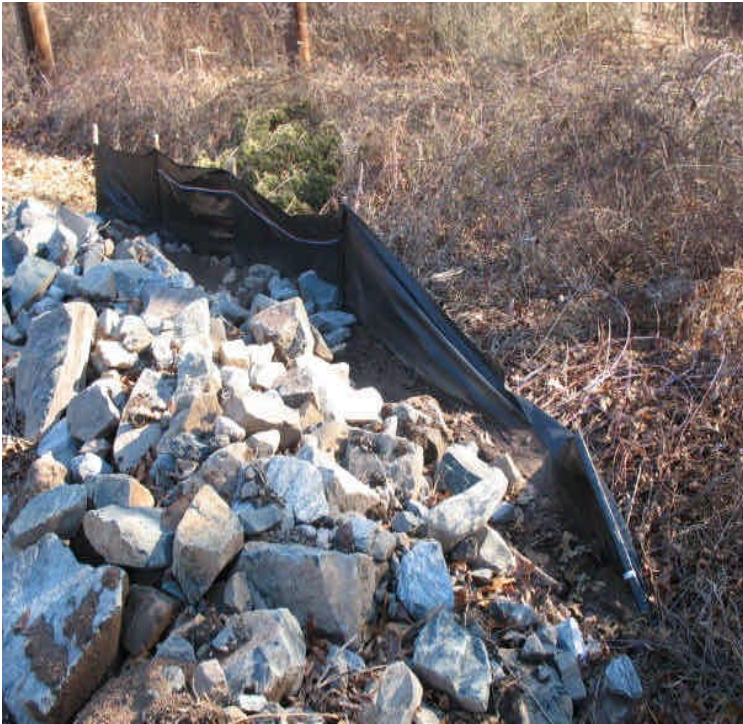
Riprap sediment trap and silt fence along the access road off Black Walnut Drive. Accumulated sediment should be removed and the silt fence repaired.

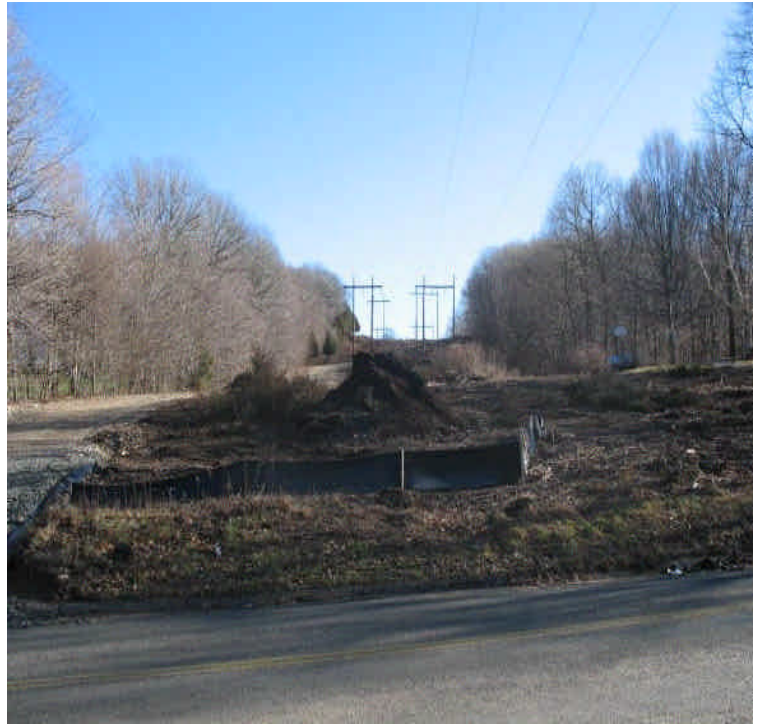
Silt fence, clearing, grading, and access road off Arbutus Street. Pull back stone from the roadway as needed.

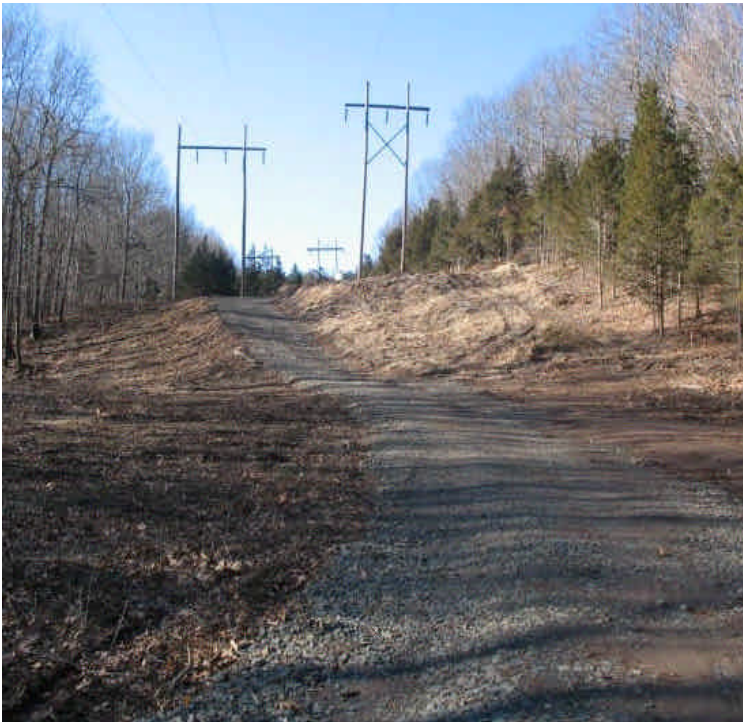
ROW access road off Black Walnut Dr.

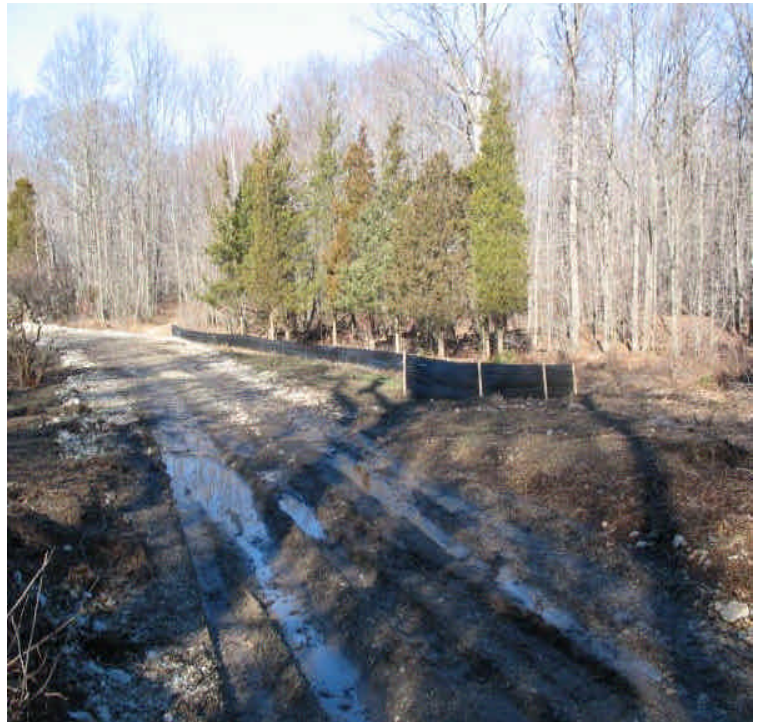
Access road off Haddam Quarter Rd. Clean water was leaving the site.

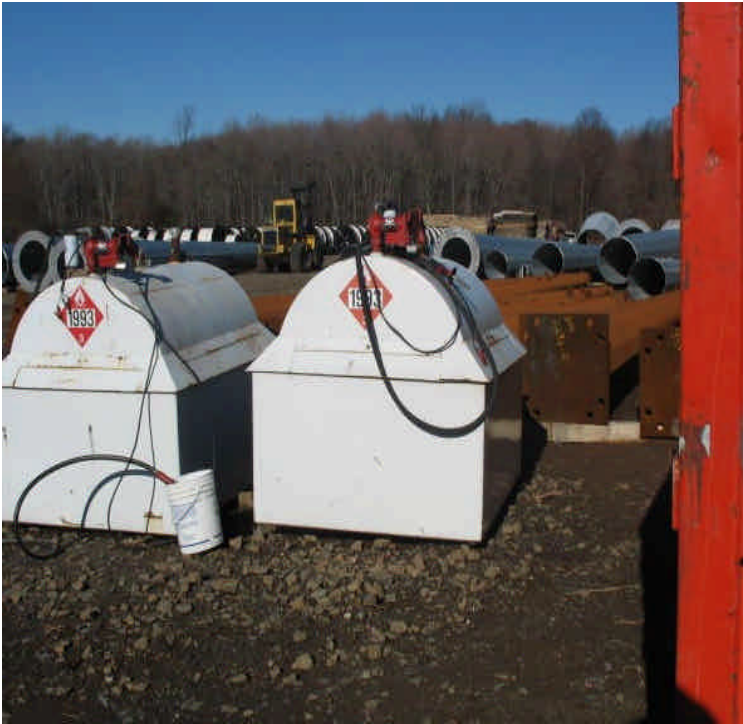
Fuel tanks and dumpster moved, controls for nozzles were partially reinstalled.

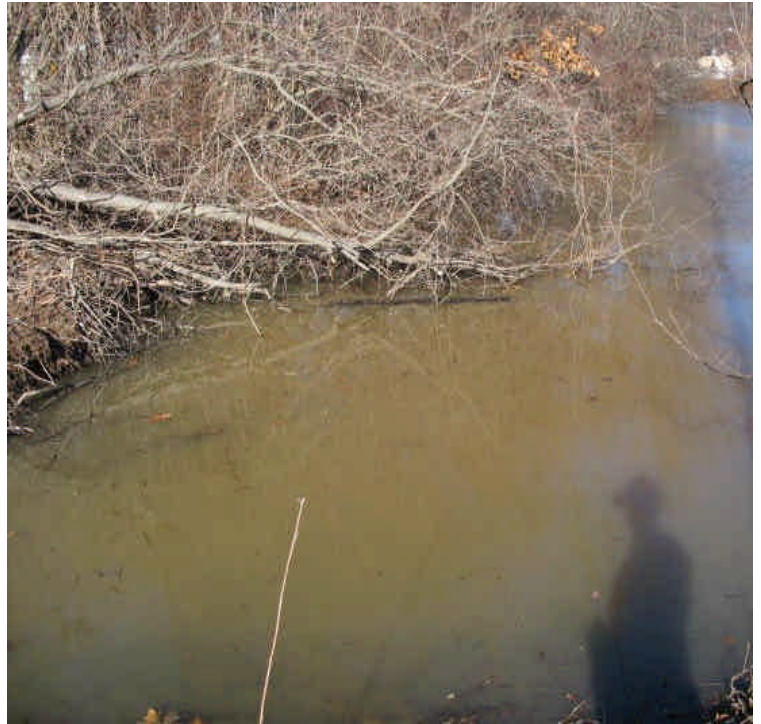
Turbidity in the pond adjacent to the contractor receiving yard has increased. A direct source is still being investigated.

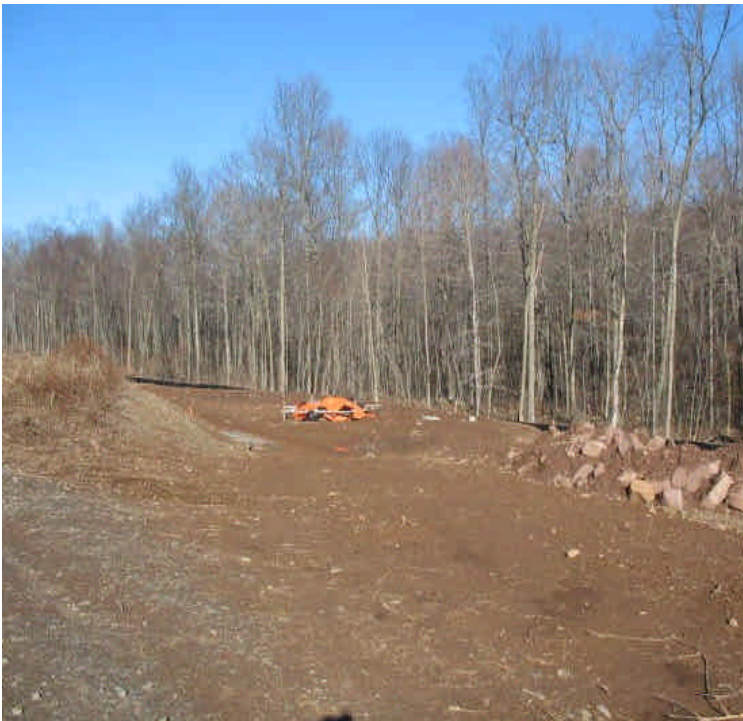
Foundations installed within the ROW north of Beseck SS. Controls are in place.

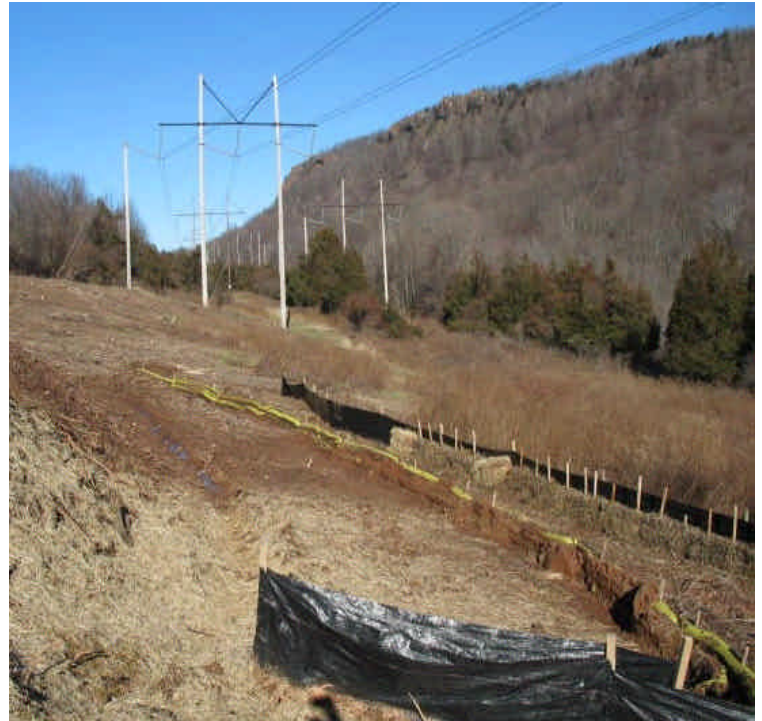
Silt fence/bio-sock barrier along the access road adjacent to Black Pond used for dewatering slurry. Slurry has been spread around the site.

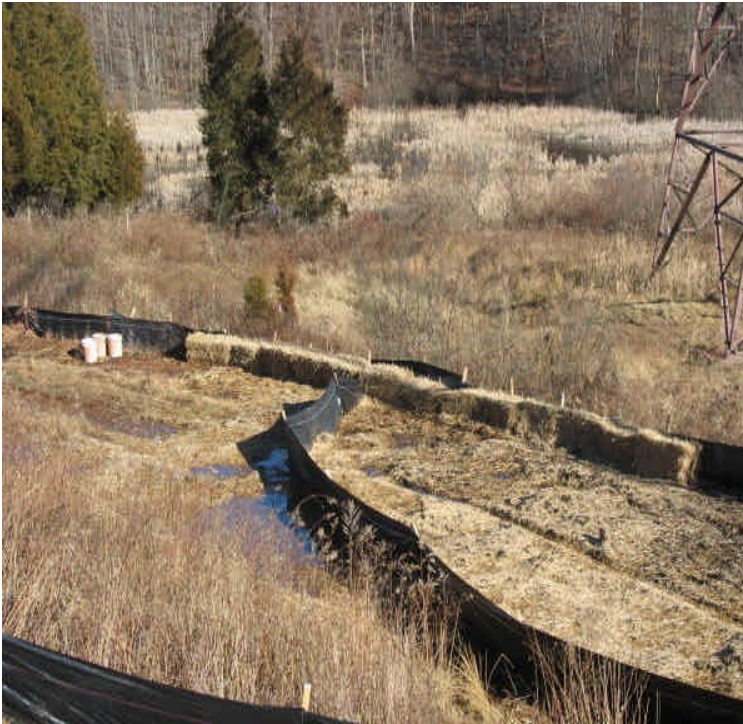
View of the new haybales and silt fence at Black Pond. Mulch is in place around the site for increased stabilization.

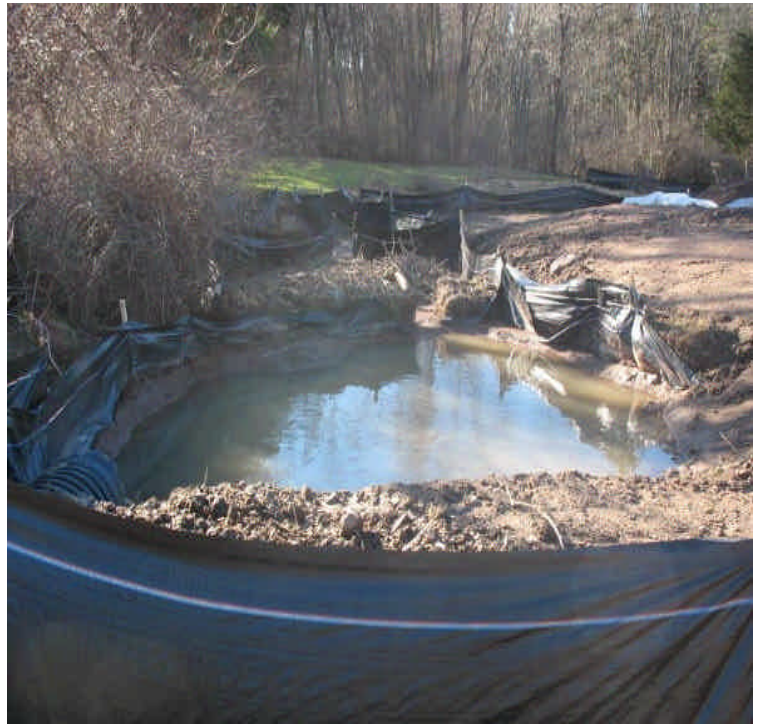
Slurry containment areas located in the ROW north of the contractor yard along Rte 17. Stormwater remains contained in the basin.

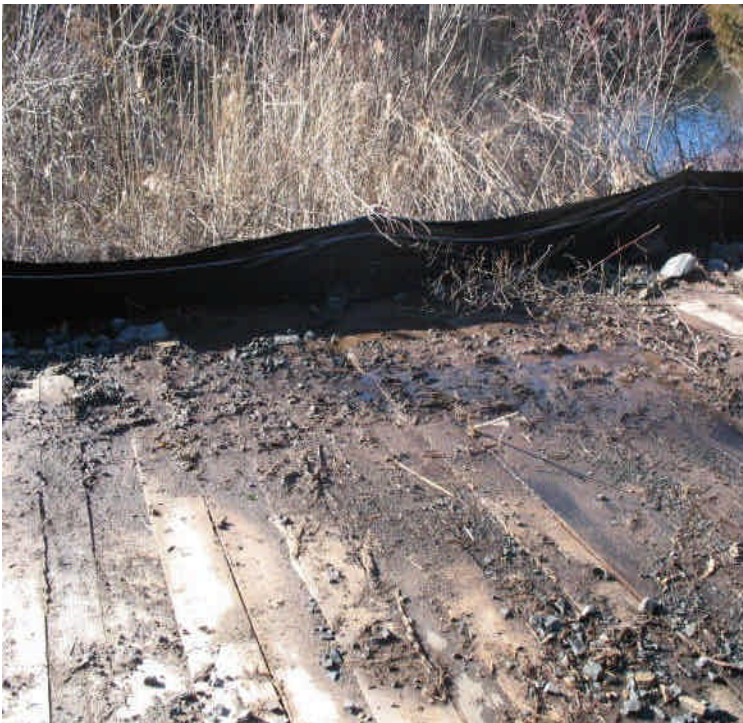
Sediment buildup along the timber mats crossing at a saturated spot in the wetlands located off Powder Hill Rd. Monitor controls and stabilize mats as necessary.

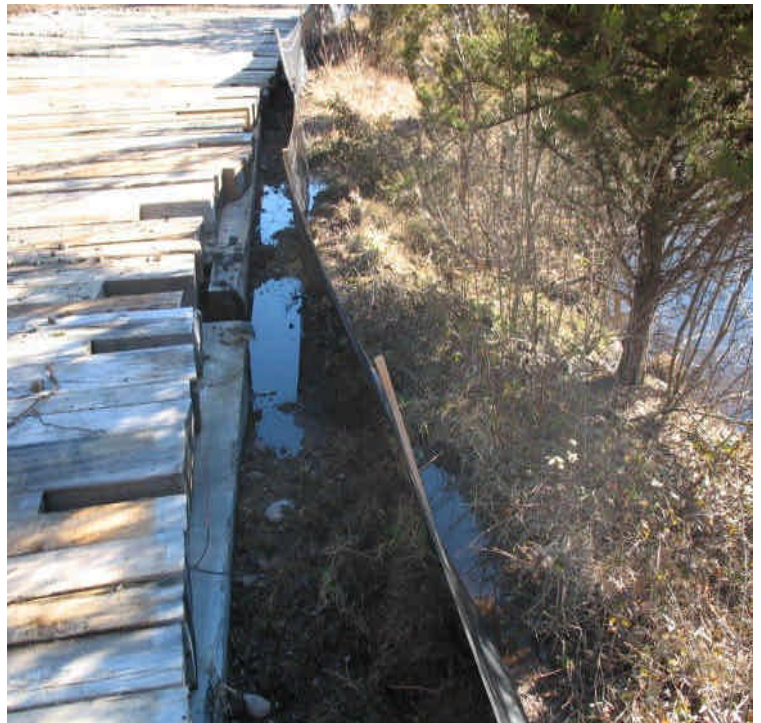
Silt fence and timber mats are in place along the access road off Powder Hill Rd. Access road follows an existing road through a wetland; silt fence protects a pond adjacent to the access road.
