Docket No. 272 – Development and Management Plan Inspection

Segment 1a Inspection

Date: January 8, 2007

Location: Segment 1a – Scovill Rock Switching Station to Chestnut Junction, Oxbow Junction to Beseck Switching Station (excluding Royal Oak Bypass), Black Pond Junction to Beseck Switching Station

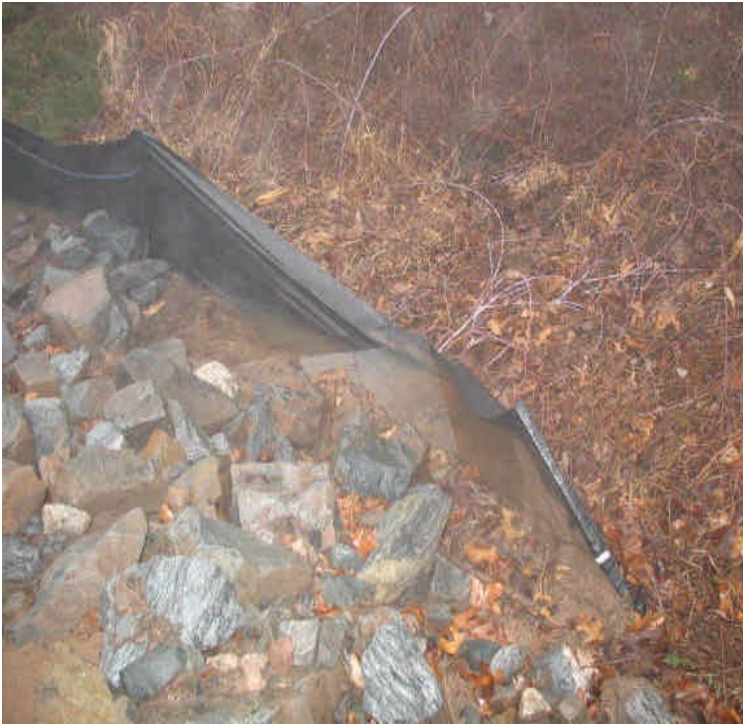
Riprap sediment trap and silt fence along the access road off Black Walnut Drive. Some run-off was pooling over the fence at the time of inspection. The accumulated sediment should be removed and the silt fence repaired, but this does not affect resource areas.

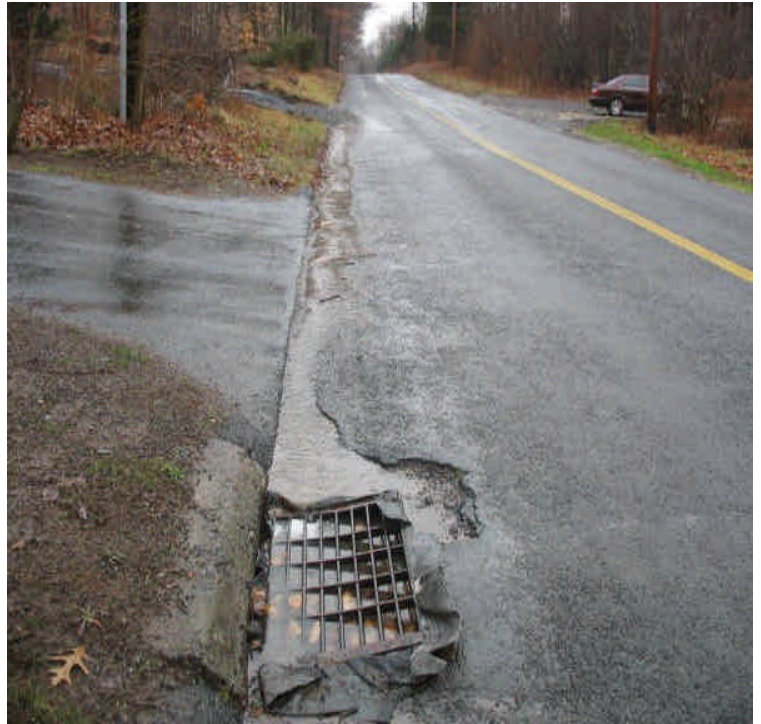
Arbutus Street	Slightly turbid run-off was flowing from the ROW entrance to a nearby CB. The CB controls were filtering the water effectively. No sediment was noted in the wetlands at the outlet. 1/8/07	Monitor access entrance and maintain CB controls when needed. Run-off was observed during a heavy rain event. 1/8/07	CB controls were in place and filtering run-off.

Slightly turbid run-off from the access road off Arbutus St was being filtered by controls in the CB. Pull back construction entrance stone from the roadway and maintain CB protection as needed.

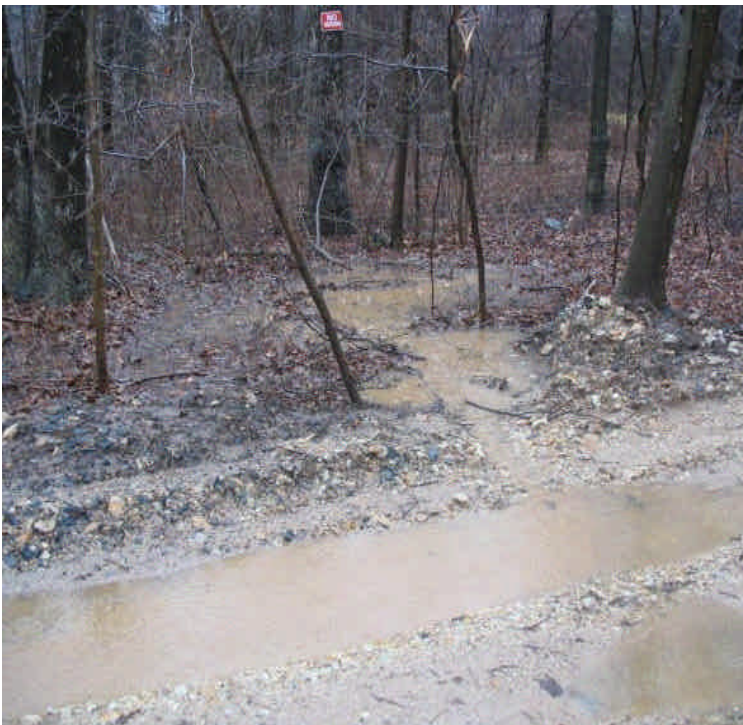
Access road off Haddam Quarter Rd. Turbid run-off from the access road was flowing off-site but was not reaching resource areas. Berm up the road or install strategically placed controls when feasible.

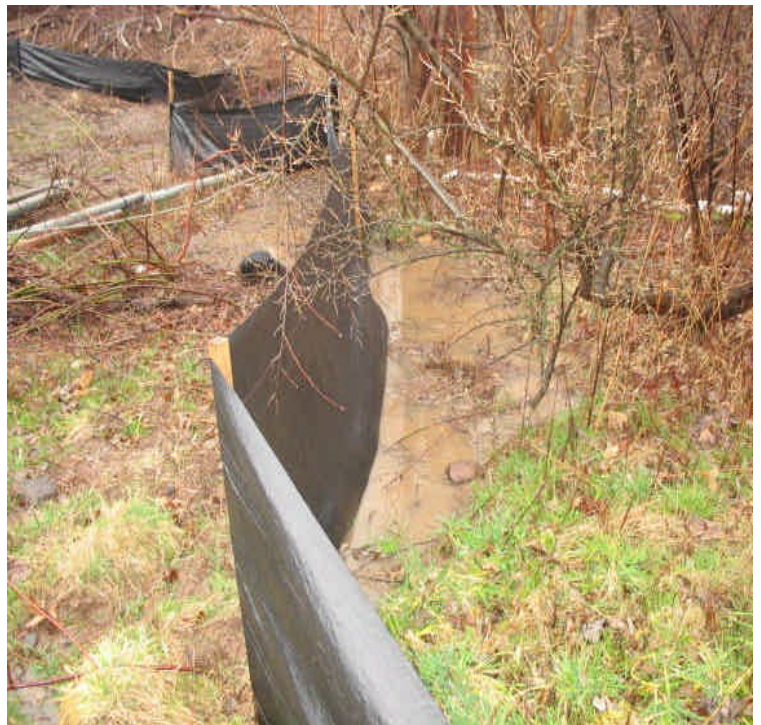
Turbid water was observed flowing under the silt fence above the pond at the contractor receiving yard.

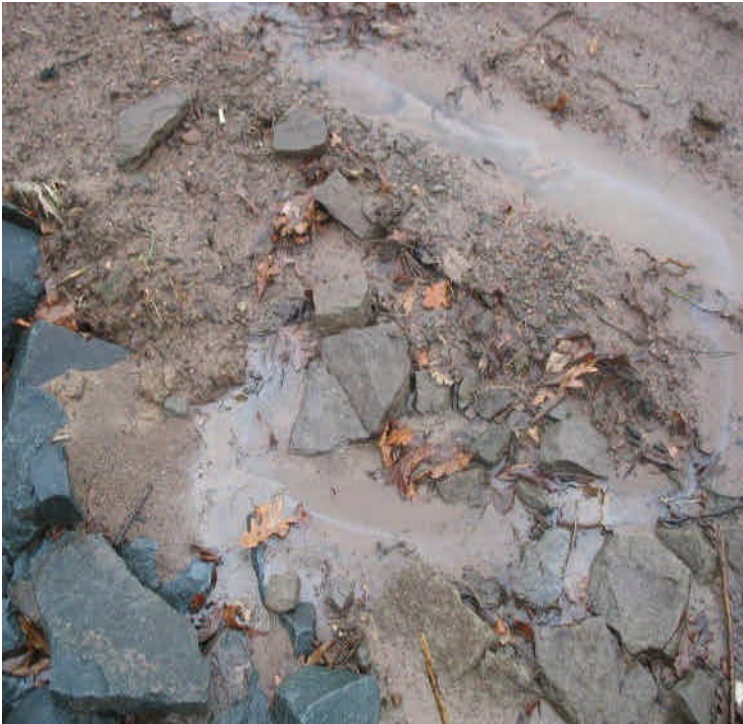
A small sheen, likely from an old equipment drip stain was flowing within the stormwater towards a culvert.

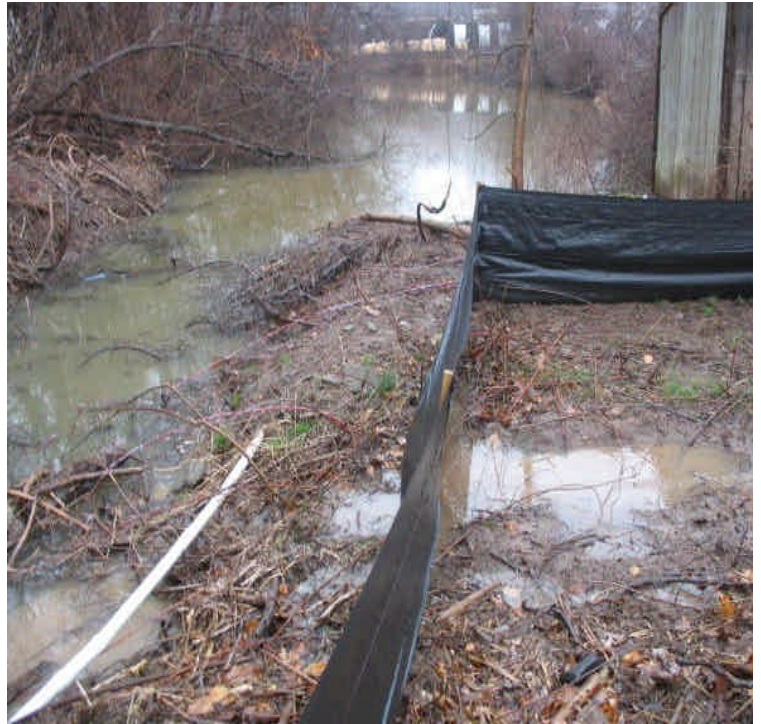
Areas of Inspection	Observation	Recommended Action	Corrected Action
<p>Contractor Storage Yard</p> <p>Powder Hill Rd.</p>	<p>With heavy rains, suspended sediment has increased in the pond west of the site. Turbid stormwater was noted flowing under/through silt fence and entering existing drains on site as well as in the wetlands and stream off-site. 1/8/07</p> <p>Timber mats are in place along an existing access road through a small section of wetlands. Water flowing off site was free of sediment 1/8/07</p>	<p>Contractor walked the site with BSC and intends to install additional silt fence, hay bales, and mulch. Closely monitor during heavy rain events. See erosion controls section for more details. 1/8/07</p> <p>These activities were defined as maintenance. However, the remainder of the access road work will not be addressed until ACOE permits are obtained. 1/8/07</p>	<p>Needs attention. Contractor has a plan to implement this week. Corrective actions will be reflected in the following report.</p> <p>NA.</p>

Turbidity was observed in the pond adjacent to the contractor receiving yard. During the rain event, turbid water was observed flowing under/through controls and into pre-existing drains.

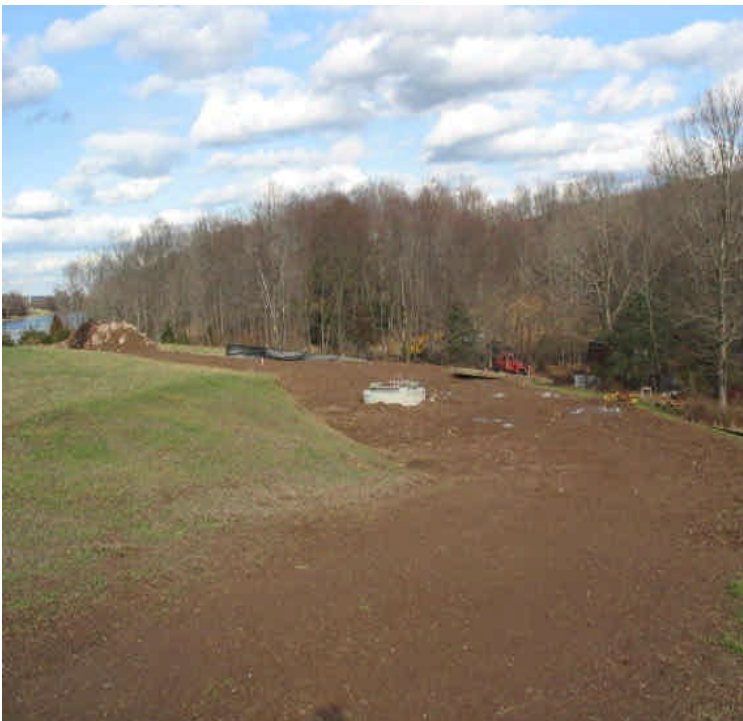
Foundations installed within the ROW north of Beseck SS. Controls are in place. Some grass cover noted.

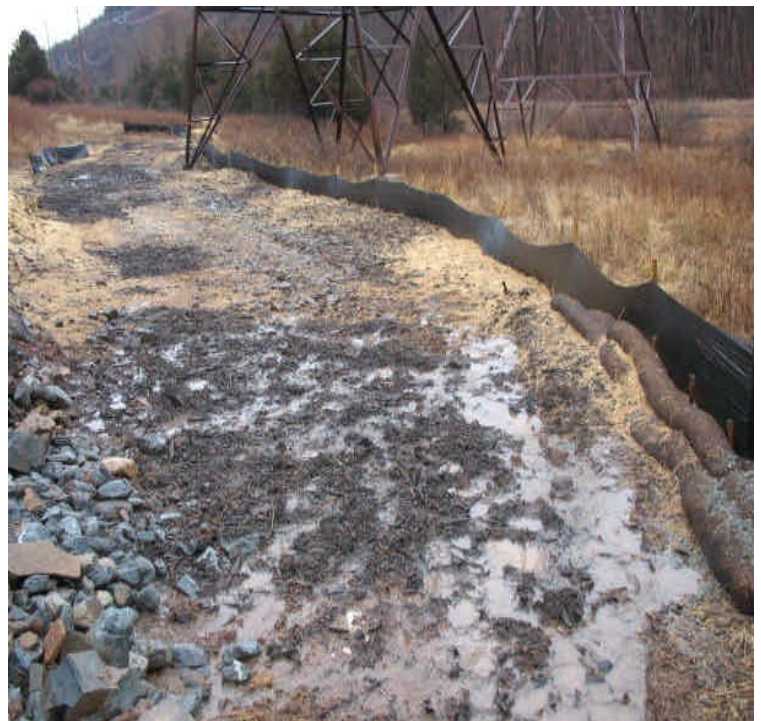
Silt fence/filter-sock barrier along the access road adjacent to Black Pond used for dewatering slurry and controlling run-off. Run-off was filtering through the fence and appeared free of sediment on the other side.

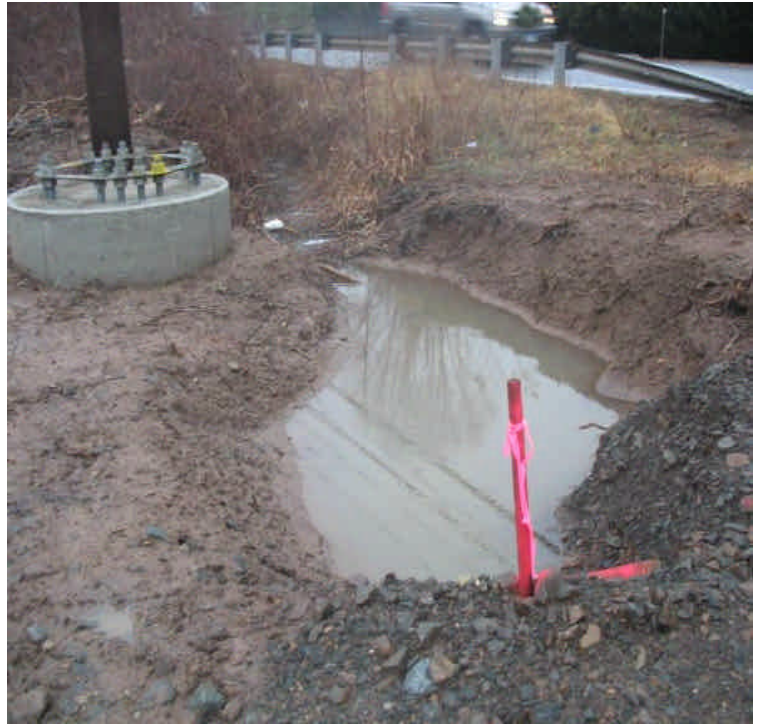
Some turbid run-off was noted in the swale adjacent to the foundation in the ROW north of the contractor yard along Rte 17. The stormwater flows to the slurry holding areas where it remains contained.

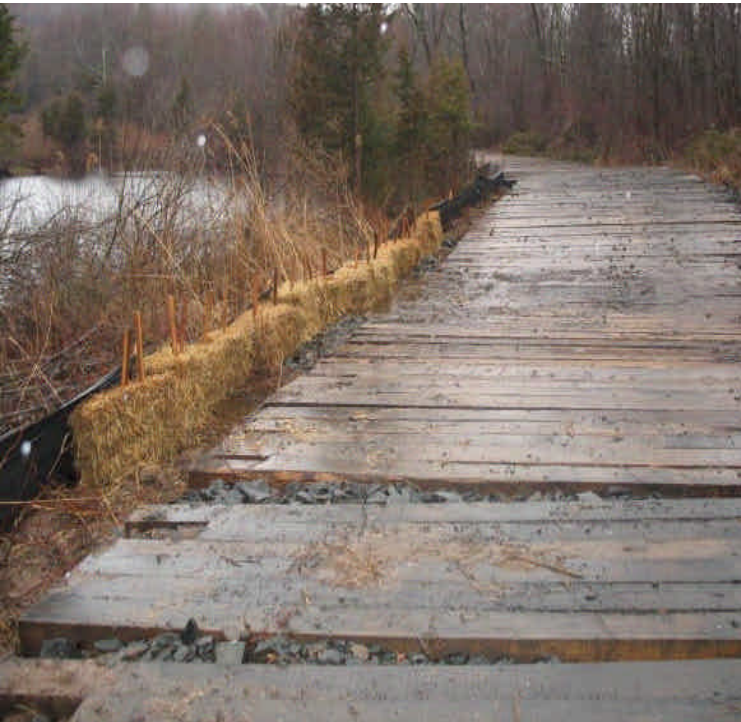
View of a low, saturated spot at the timber mats crossing in the wetlands located off Powder Hill Rd. Haybales were added for increased protection. Continue to monitor.

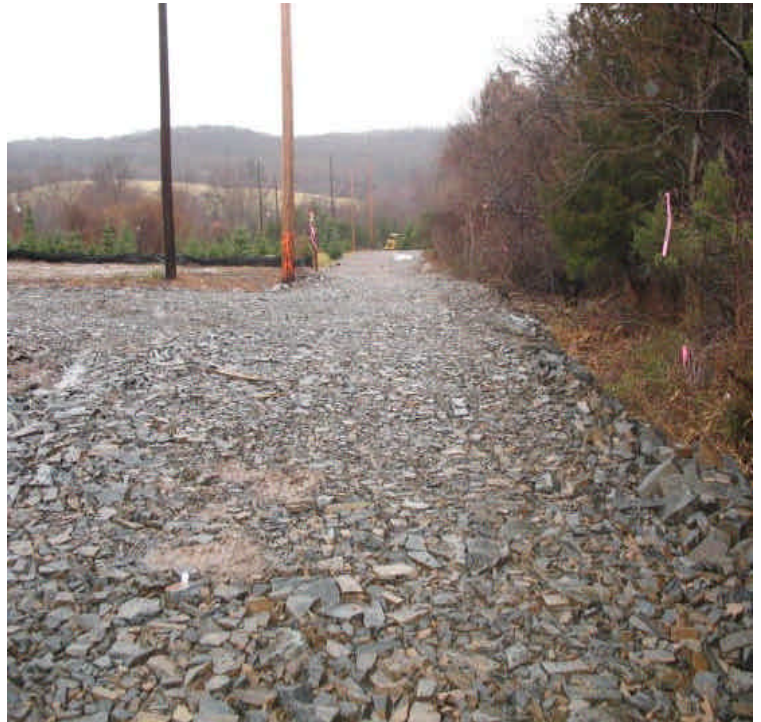
New access road and pad construction east of Powder Hill Rd.
