**Docket No. 272 – Development and Management Plan Inspection**

**Segment 1a Inspection**

**Date:** January 15, 2007

**Location:** Segment 1a – Scovill Rock Switching Station to Chestnut Junction, Oxbow Junction to Beseck Switching Station (excluding Royal Oak Bypass), Black Pond Junction to Beseck Switching Station

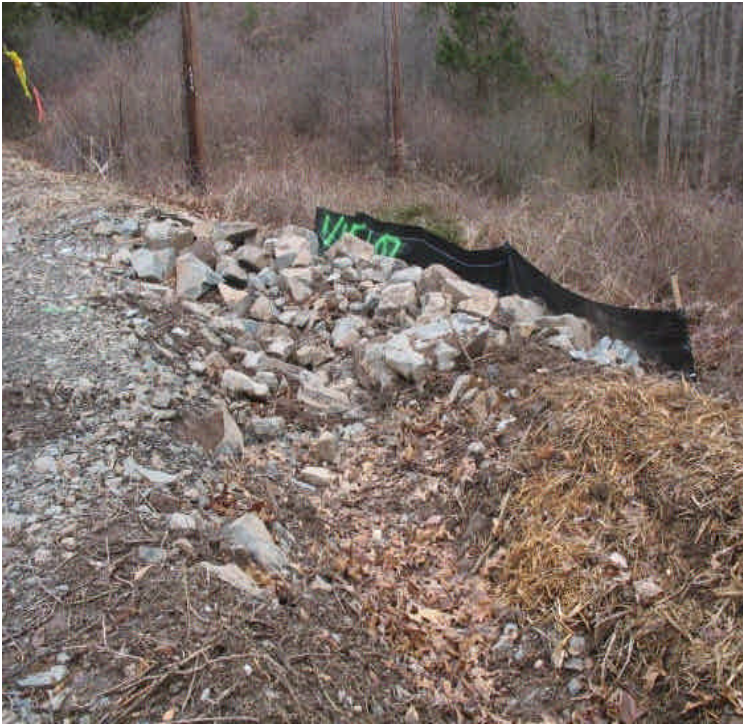
**Riprap sediment trap and silt fence along the access road off Black Walnut Drive. Accumulated sediment has been removed and silt fence was repaired.**

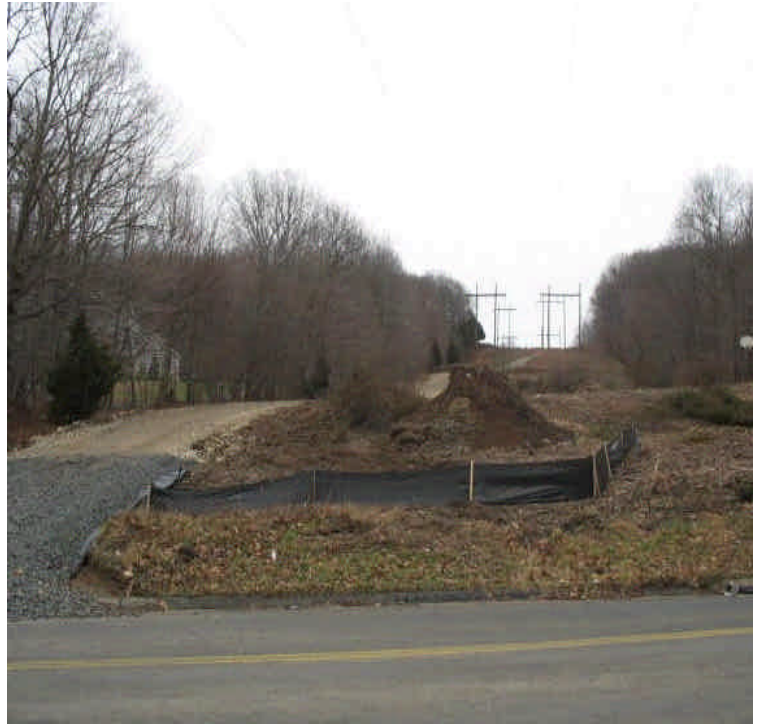
**Access road and ROW off Arbutus Street. No run-off was noted during the inspection.**

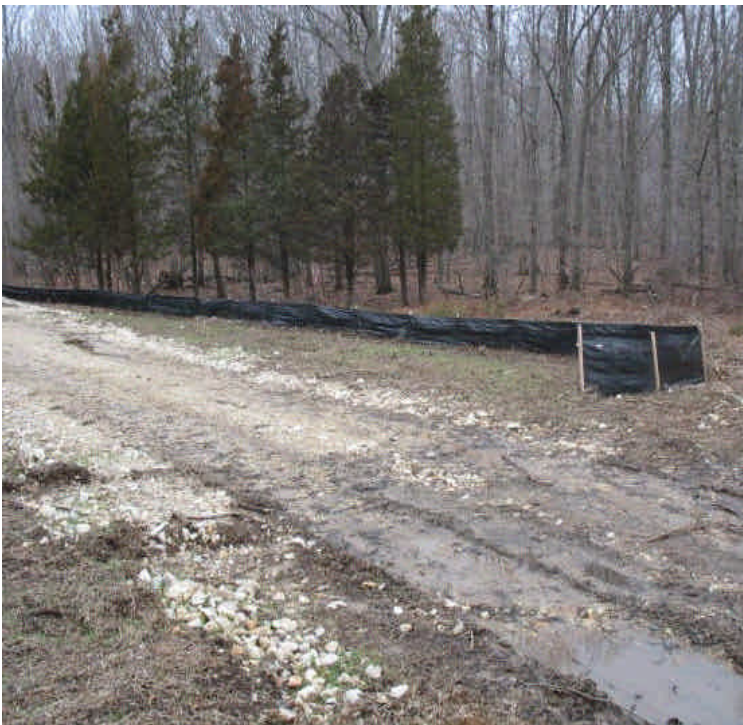
**Access road off Haddam Quarter Rd. Clear water was leaving the site, filtered by existing controls.**

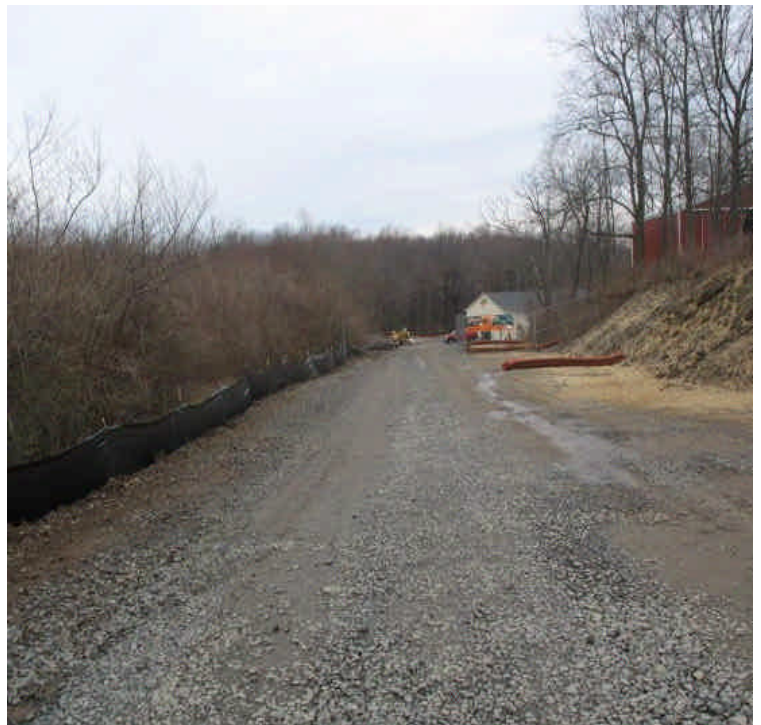
**Silt fence, fiber rolls, and hay mulch have been added upgradient of wetland areas adjacent to the contractor receiving yard.**

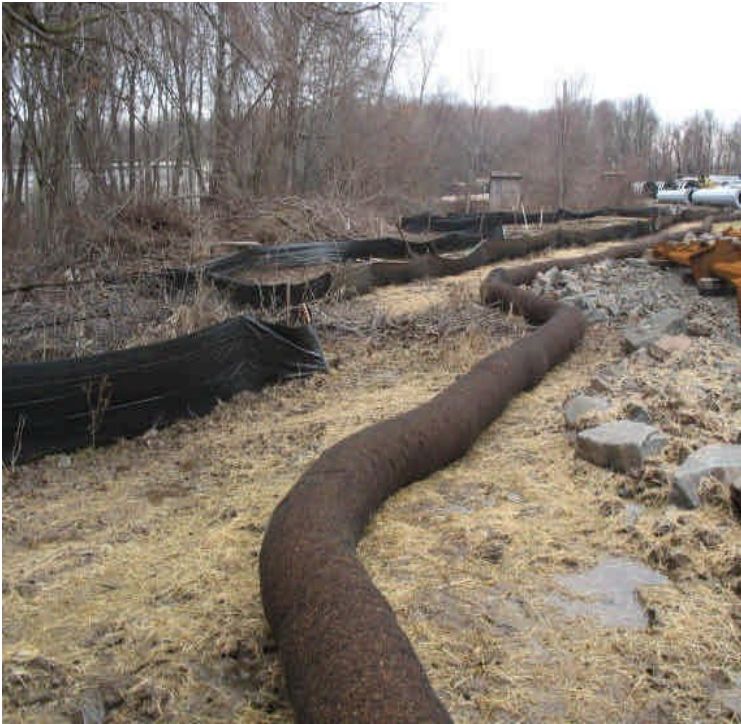
Additional controls were added adjacent to wetlands to filter/contain turbid run-off leaving the site.

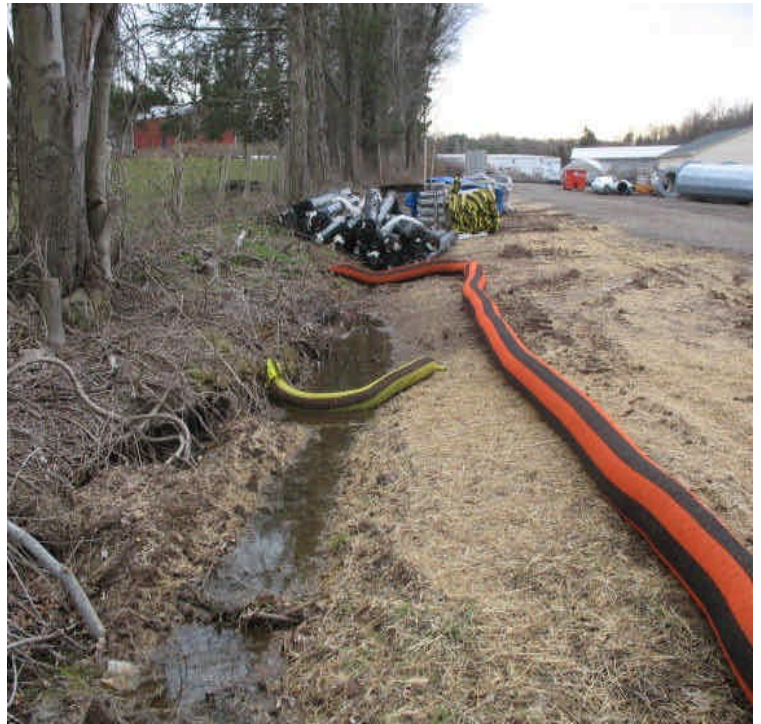
Additional controls were also added to drainage areas/swales at the contractor receiving yard.

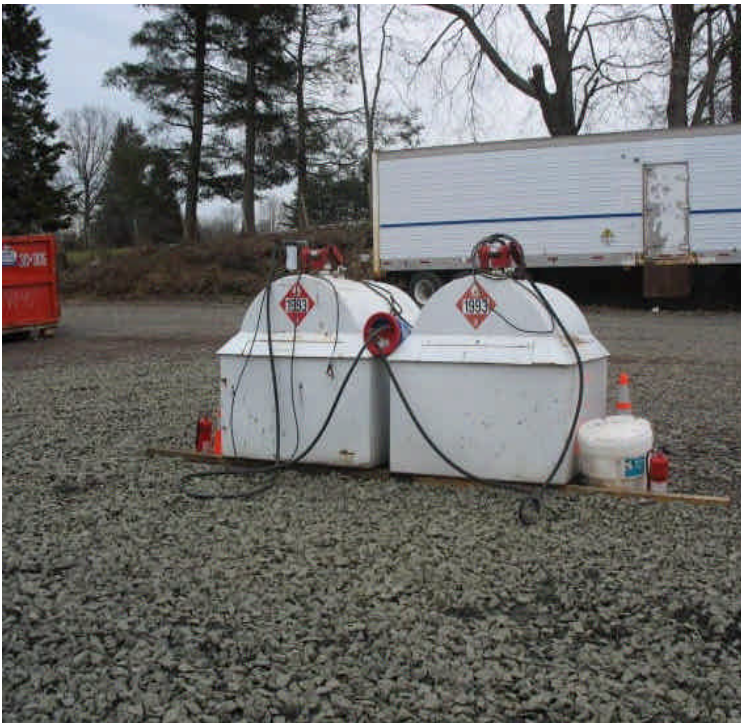
New location, stone spill pad, and handle containment for the fuel storage tanks at the contractor receiving yard. Spill kits and fire extinguishers were also added.

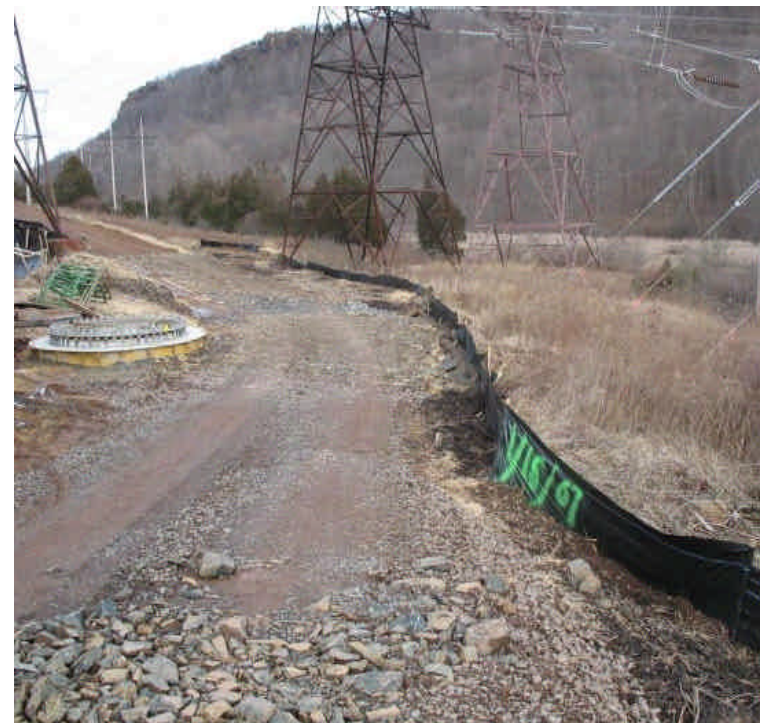
Silt fence extension located upgradient of the wetlands at Black Pond

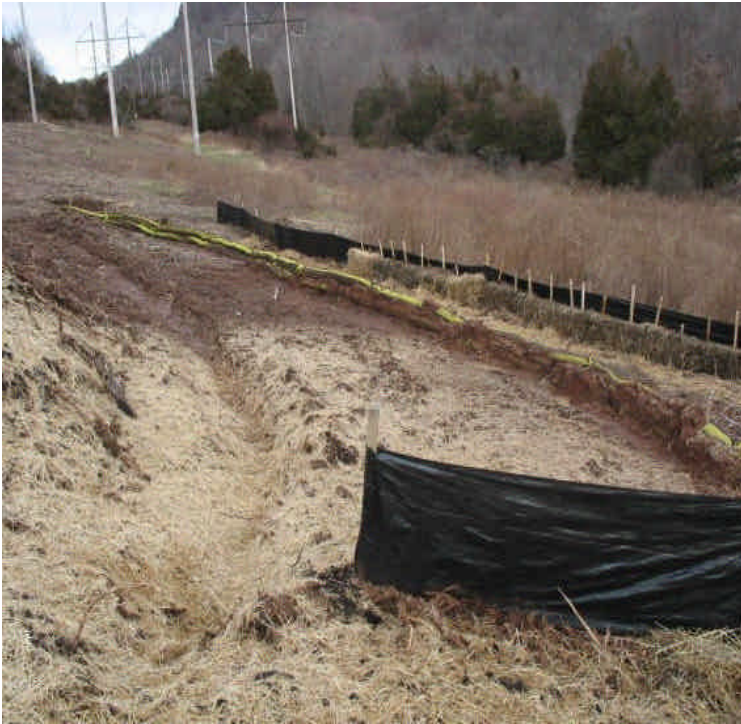
**Overview of the haybales, silt fence, and filter socks at Black Pond. Mulch remains in place around the site for increased stabilization.**

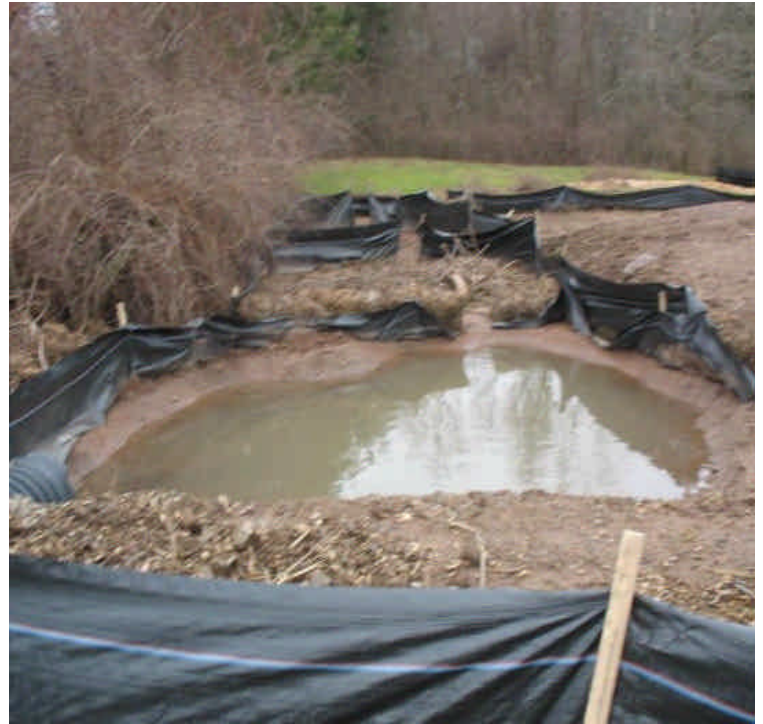
**Some run-off was noted in the swale adjacent to the foundation in the ROW north of the contractor yard along Rte 17. The stormwater flows to the slurry holding areas where it remains contained.**

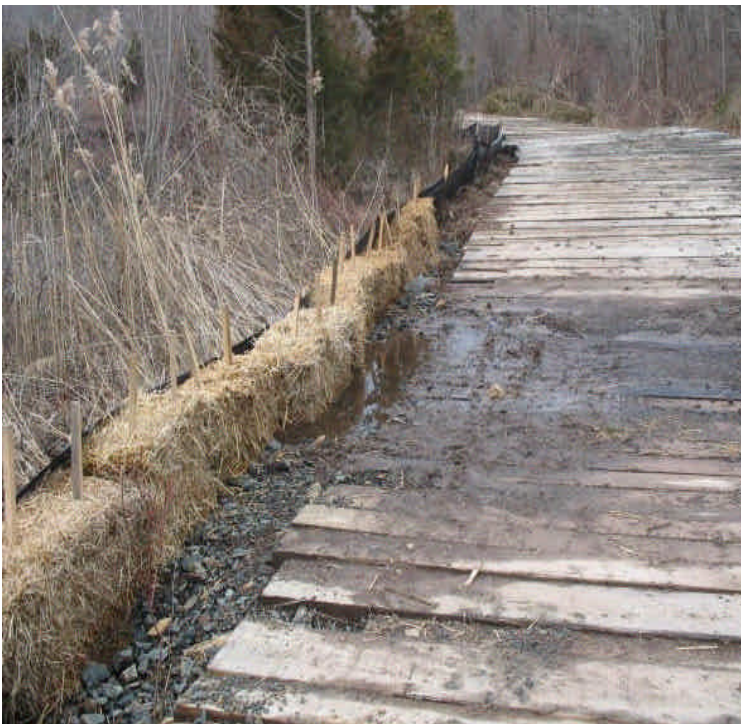
**View of a low, saturated spot at the timber mats crossing in the wetlands located west of Powder Hill Rd. Haybales are in place for further control. Continue to monitor and adjust when the road is active.**

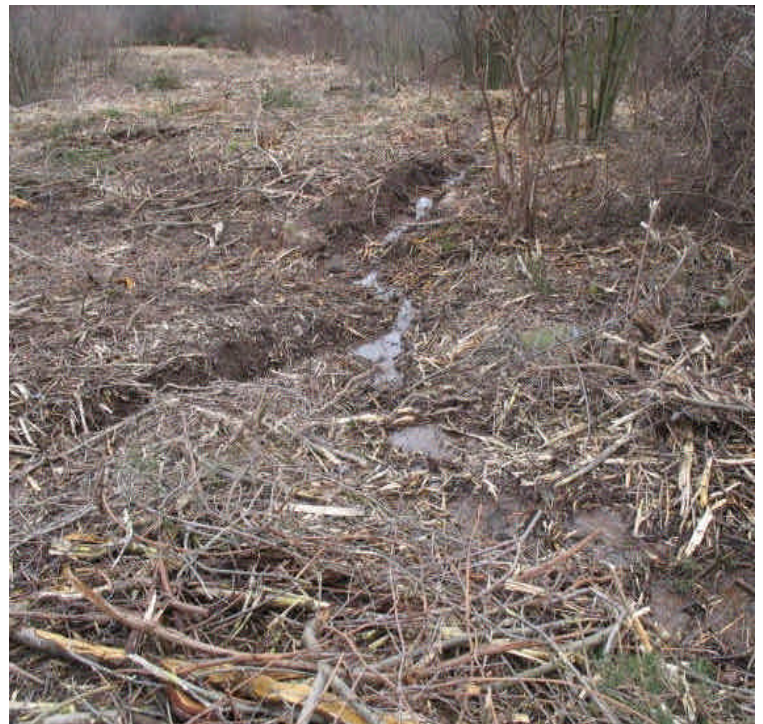
**Saturated slope east of Powder Hill Rd within the new clearing. Monitor slope for erosion and changes to run-off patterns. Soils appear stable.**
