Docket No. 272 – Development and Management Plan Inspection

Segment 1a Inspection

Date: January 22, 2007

Location: Segment 1a – Scovill Rock Switching Station to Chestnut Junction, Oxbow Junction to Beseck Switching Station (excluding Royal Oak Bypass), Black Pond Junction to Beseck Switching Station

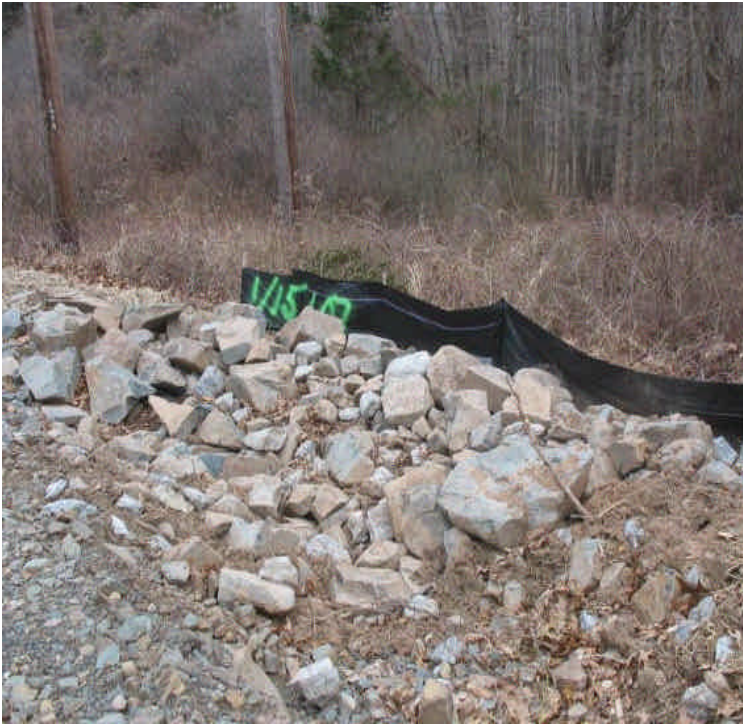
| Areas of Inspection | Observation | Recommended Action | Corrected Action |
|--|--|---|--|
| Black Walnut Dr. | <p>Riprap trap and adjacent silt fence are in good shape. 1/22/07</p> | <p>Continue to maintain controls. 1/22/07</p> | <p>NA.</p> |

Riprap sediment trap and silt fence along the access road off Black Walnut Drive remains clear of sediment and controls are intact.

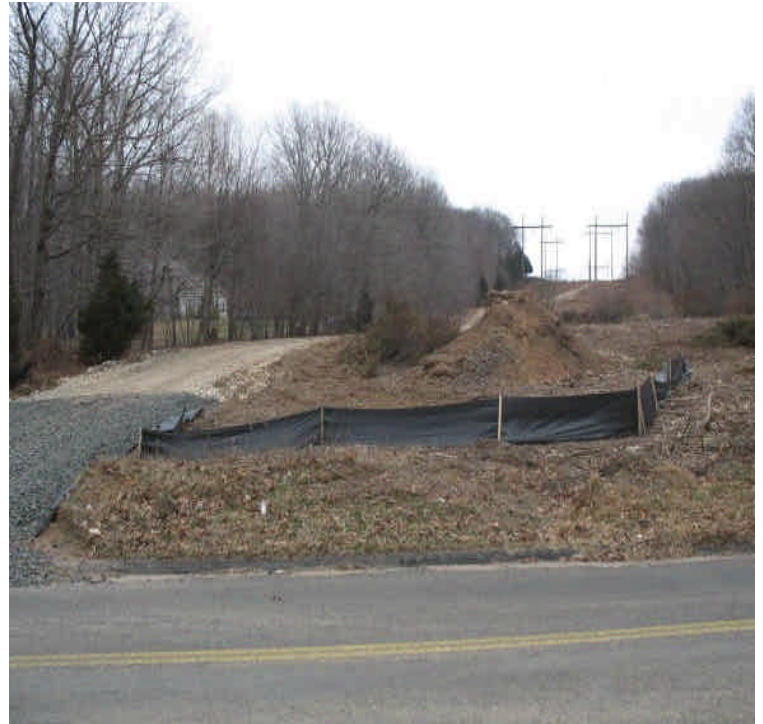
Access road and ROW off Arbutus Street. No run-off was noted during the inspection.

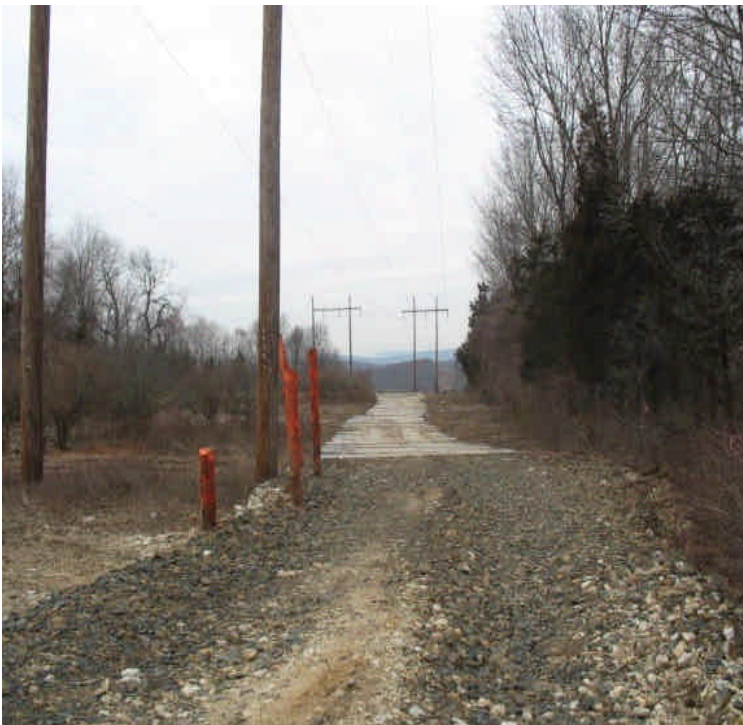
Access road off Haddam Quarter Rd.

| Areas of Inspection | Observation | Recommended Action | Corrected Action |
|---|---|---|--|
| Haddam Quarter Rd. To Foot Hills Rd. | The pond adjacent to the access road has some haybales in place but more should be added to prevent sedimentation as needed, especially as work resumes. 1/22/07 | Continue to add controls where needed, i.e. mulch, check dams, silt fence, to control sediment and prevent erosion. Clean roadway as needed. 12/5/06-1/22/07 | NA |
| | After larger storm events, turbid run-off ponds and flows off-site from the access road. Clear run-off was noted this week 1/22/07 | Although run-off was not reaching resource areas, consider extending controls or re-grade or berm the access road. 1/22/07 | Needs evaluation when feasible. |

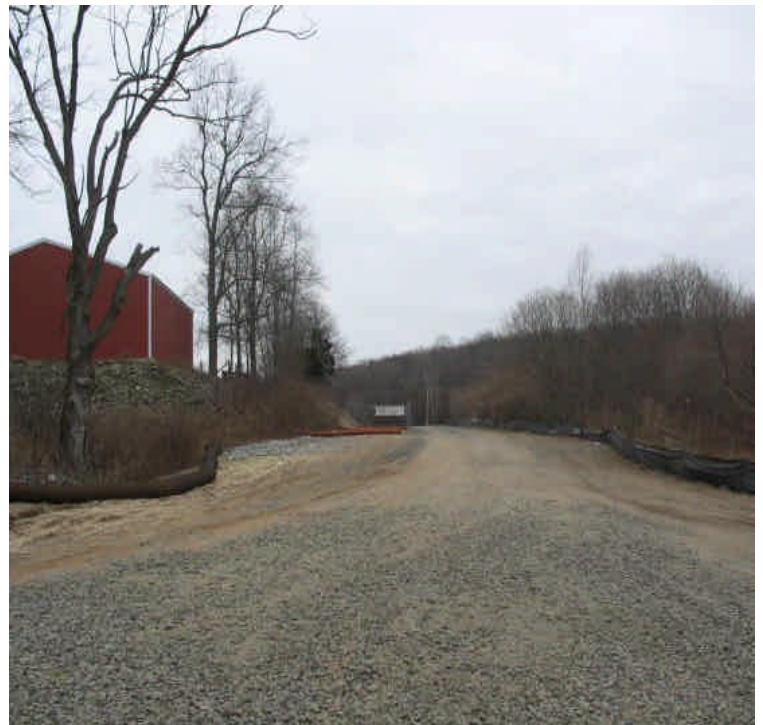
| Areas of Inspection | Observation | Recommended Action | Corrected Action |
|--|--|---|--|
| Contractor Receiving Yard and Storage Area | <p>Silt fence and fiber rolls remain in place around the perimeter of the yard to reinforce existing controls where issues were noted last week. Controls were also added along drainage areas/swales as needed. 1/22/07</p> <p>Exposed, inactive soil surfaces were also temporarily stabilized with hay. 1/22/07</p> | <p>Continue to add, maintain, and monitor controls as necessary. 1/22/07</p> <p>Continue to stabilize areas that will remain inactive. 1/22/07</p> | <p>Silt fence and fiber rolls were added around the site to filter/contain run-off.</p> <p>Mulch was added to some areas around site</p> |

Silt fence, fiber rolls, and hay mulch have been added upgradient of wetland areas adjacent to the contractor receiving yard.

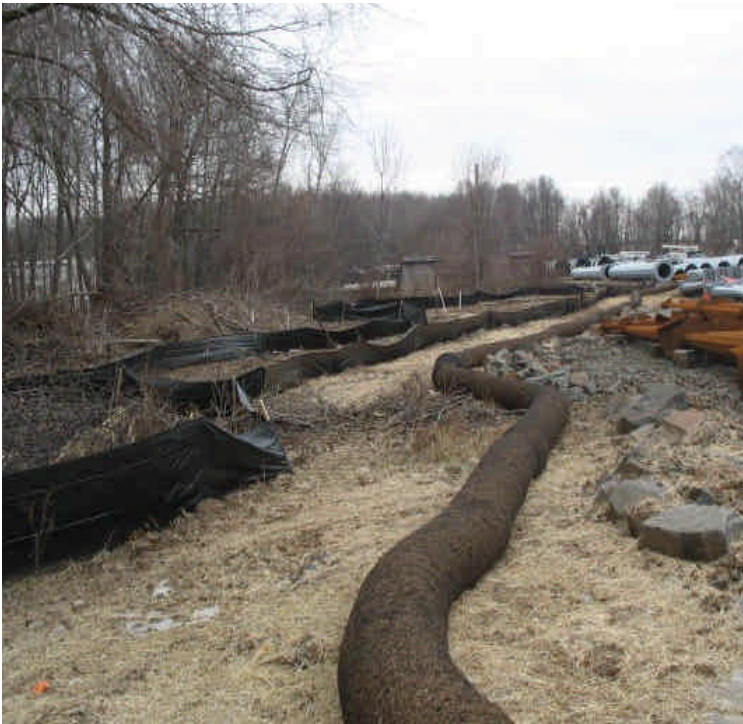
Additional controls remain in place adjacent to wetlands to filter/contain any turbid run-off leaving the site.

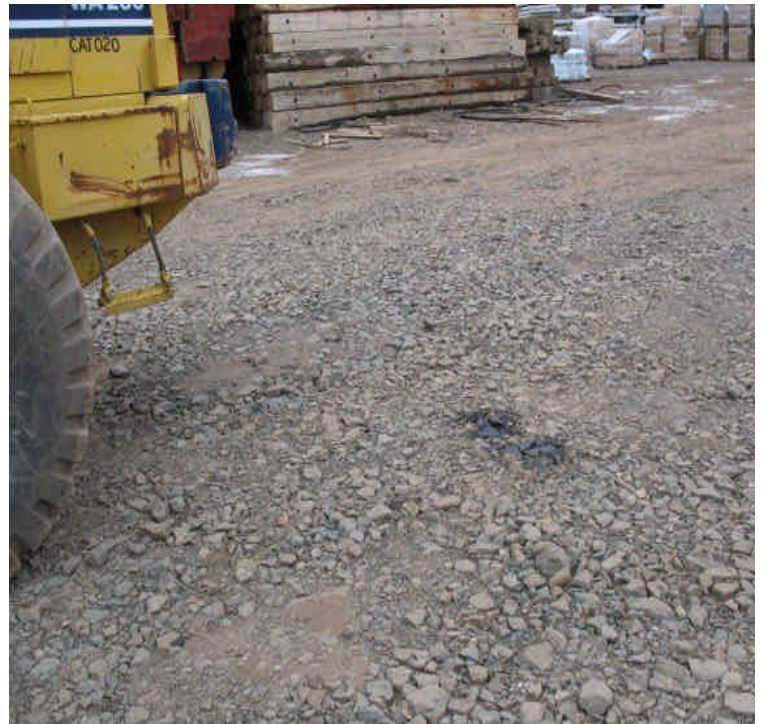
| Areas of Inspection | Observation | Recommended Action | Corrected Action |
|--|--|---|---|
| <p>Black Pond and ROW, North of Beseck SS</p> | <p>wetlands or swales. 1/22/07</p> <p>A forklift was dripping fluid (oil) onto the ground and several small drops were observed while walking the site. This included one on the stone pad at the refueling tanks. 1/22/07</p> <p>Concrete washout areas are in place along the ROW as needed and old washouts are being cleaned and removed as work continues along the ROW. 1/22/07</p> | <p>and inlets such as culverts and CBs. Monitor and maintain equipment. 1/22/07</p> <p>Monitor and maintain leaking equipment as soon as possible to prevent leaks around the site. Spill controls should always be used when equipment is leaking during refueling and equipment maintenance. 1/22/07</p> <p>Continue to use and maintain the designated washout areas. 1/22/07</p> | <p>Equipment needs attention (maintenance).</p> <p>NA</p> |

Small stains were noted around the contractor receiving yard including near a leaking forklift.

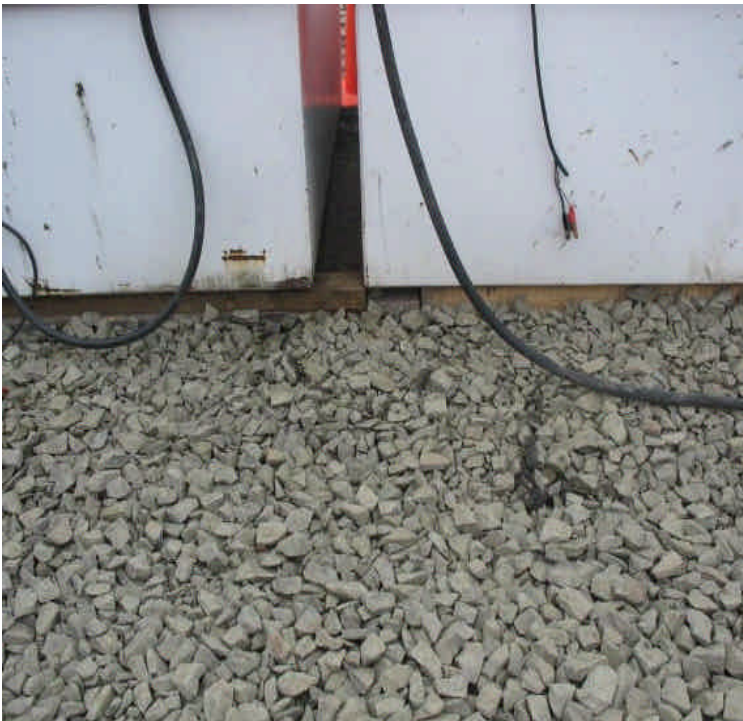
The fuel storage tanks remain in place on the new spill pad and nozzles are contained. A small drip stain was noted and is contained to the stone.

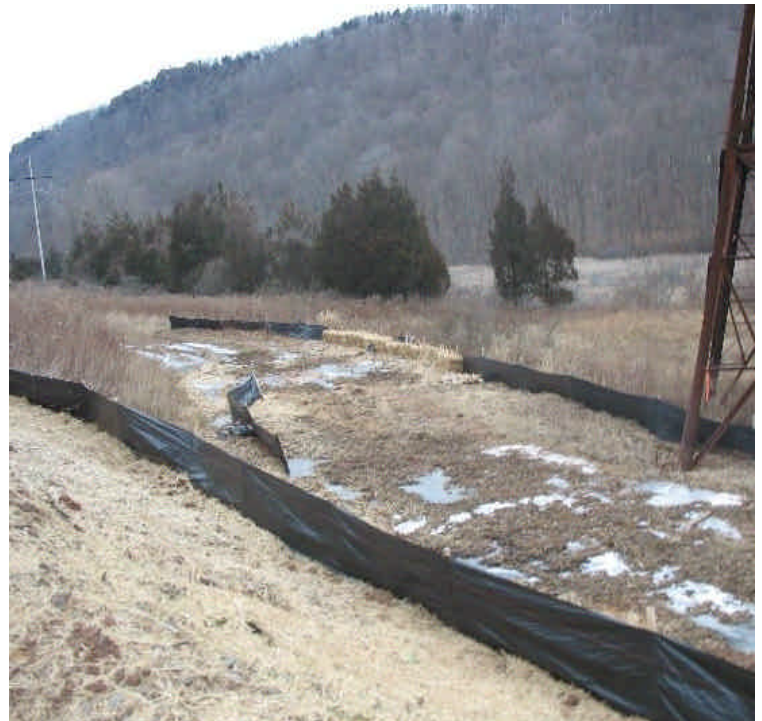
Silt fence and haybales are in place upgradient of wetlands at Black Pond.

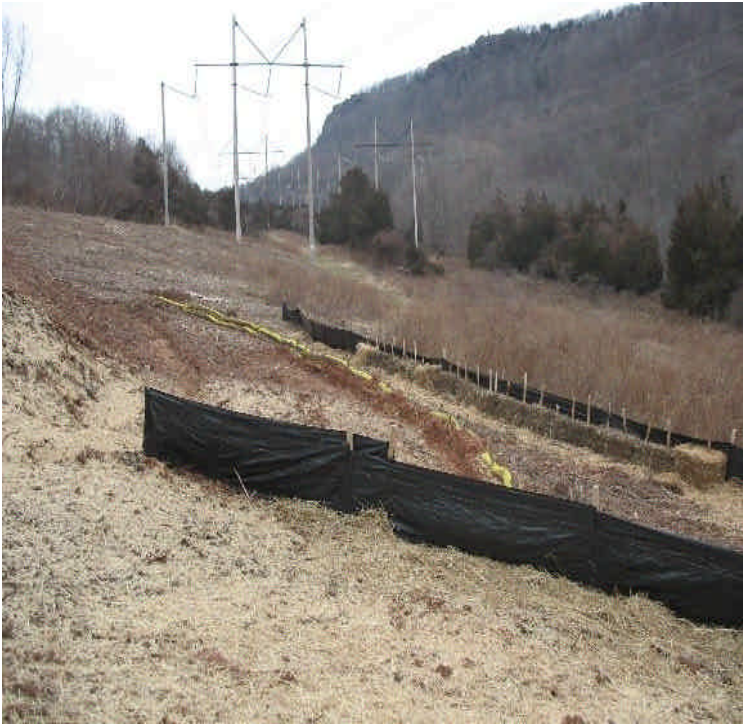
| Areas of Inspection | Observation | Recommended Action | Corrected Action |
|--|--|---|--|
| <p>Dewatering North of PAR Receiving Yard Along Rte. 17</p> <p>Black Pond</p> | <p>Ponded stormwater remains contained in the controls 1/22/07</p> <p>Dewatering controls in use at Black Pond include filter-socks, rows of silt fence, haybales, and mulch. Silt fence was extended and clean water was noted leaving the silt fence above the wetlands. 1/22/07</p> | <p>Mud should be removed or used onsite and exposed soils stabilized as soon as possible. 1/22/07</p> <p>Monitor controls; and continue to stabilize exposed surfaces, including the spread slurry, as needed. 1/22/07</p> | <p>NA</p> <p>NA</p> |

Overview of the haybales, silt fence, and filter socks at Black Pond. Mulch remains in place around the site for increased stabilization.

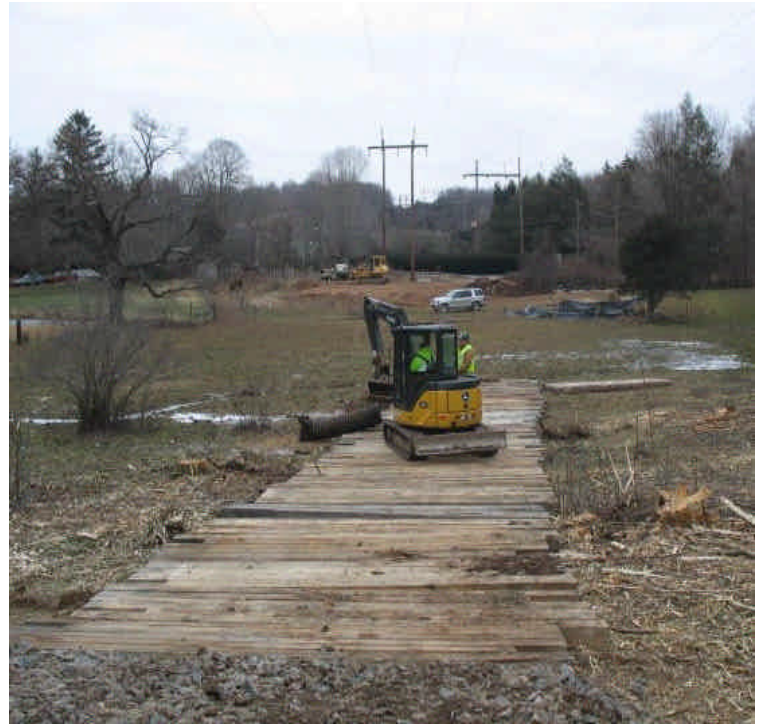
| Areas of Inspection | Observation | Recommended Action | Corrected Action |
|--|---|--|---|
| | Access road construction was underway, connecting Little Ln. to Rte. 17. Access includes timber mats and a culvert to cross a section of wetlands and small stream. 1/22/07 | Monitor activities and add controls, as needed, to prevent sediment from leaving the site. 1/22/07 | Wetlands were being crossing appropriately. |

ROW extension connecting Rt. 17 with Little Lane. Timber mats and a culvert are being used to cross the wetland and a stream.

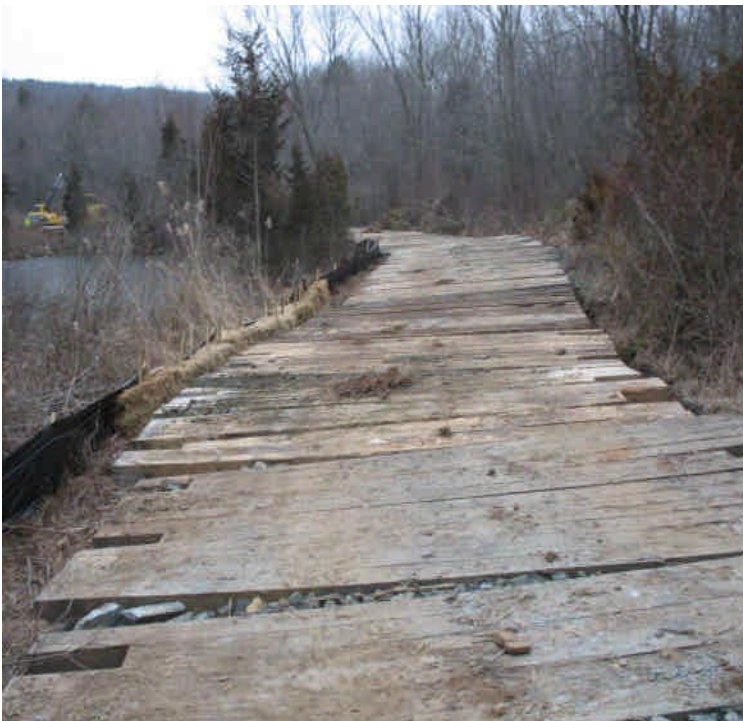
| Areas of Inspection | Observation | Recommended Action | Corrected Action |
|---|---|--|--|
| | <p>of Powder Hill Rd.; Timber mats are in place. Powder Hill Rd. was free of sediment. 1/22/07</p> <p>Timber mats were being added as access road construction is permitted to continue across the wetland. Supports were added to areas where timber mats were sinking. The stream will be crossed in the coming week. 1/22/07</p> | <p>Maintain/adjust controls at this low section as work continues in this area. 1/22/07</p> <p>Caution should be taken to minimize impacts to the stream. 1/22/07</p> | <p>Supports were added to the sinking section of timber mats.</p> |

View of a low, saturated spot at the timber mats crossing in the wetlands located west of Powder Hill Rd. Haybales are in place for further control and timber mats have added support. Minor sedimentation was noted leaving the site in this area.

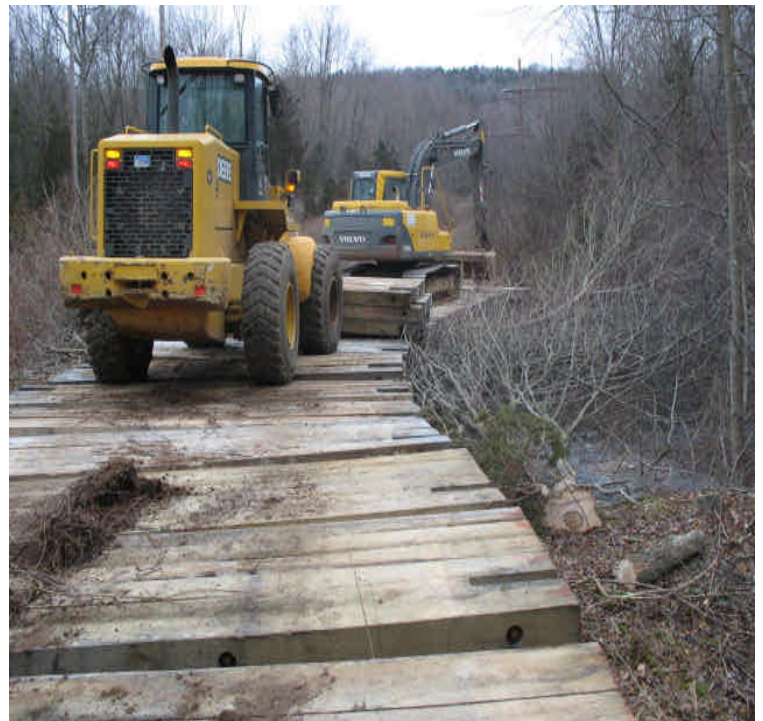
Wetland crossing construction continues west of Powder Hill Rd. The stream will be crossed later in week. Monitor for sedimentation and adjust controls as needed.
