Docket No. 272 – Development and Management Plan Inspection

Segment 1a Inspection

Date: January 29, 2007

Location: Segment 1a – Scovill Rock Switching Station to Chestnut Junction, Oxbow Junction to Beseck Switching Station (excluding Royal Oak Bypass), Black Pond Junction to Beseck Switching Station

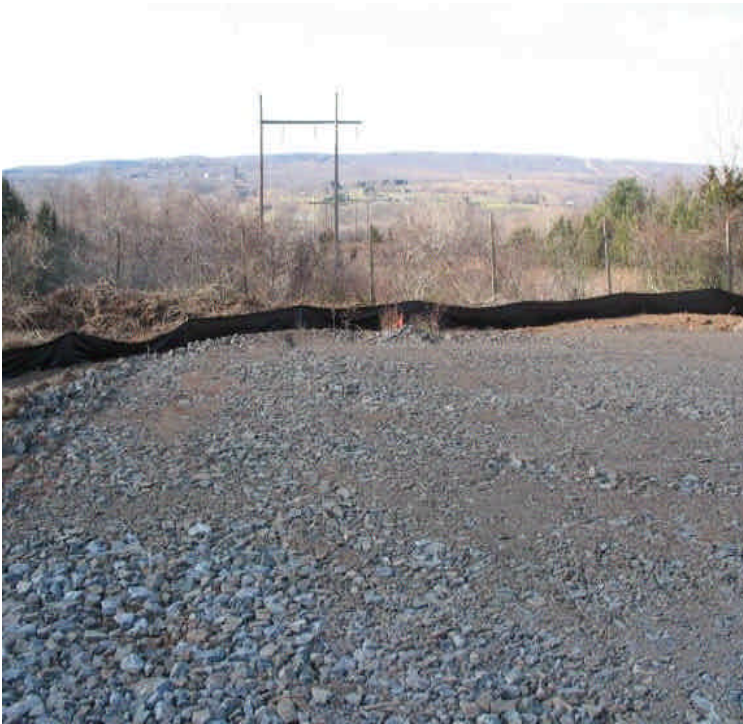
New silt fence installed and staging area in place along the ROW off Little Ln. (to the west).

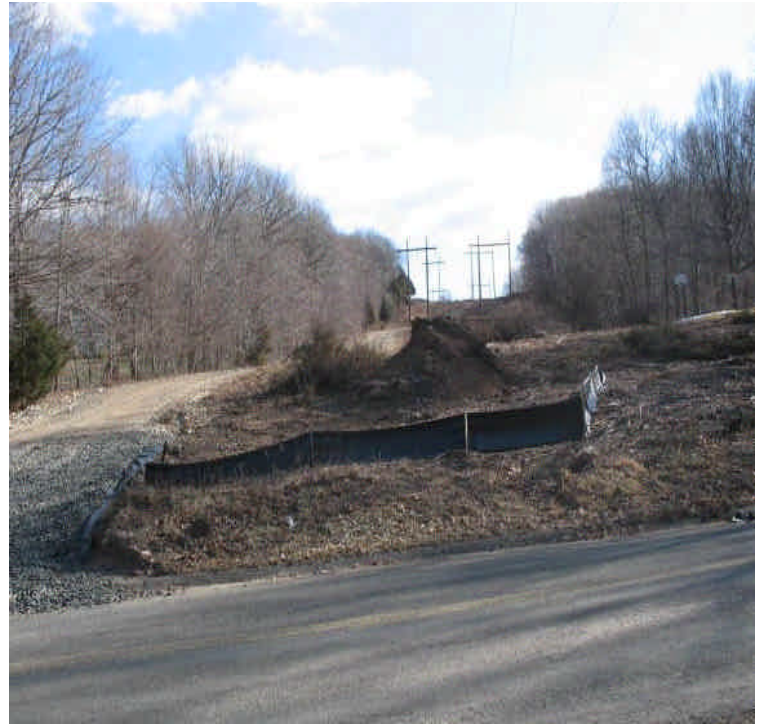
Access road and ROW off Arbutus Street. No run-off noted during the inspection.

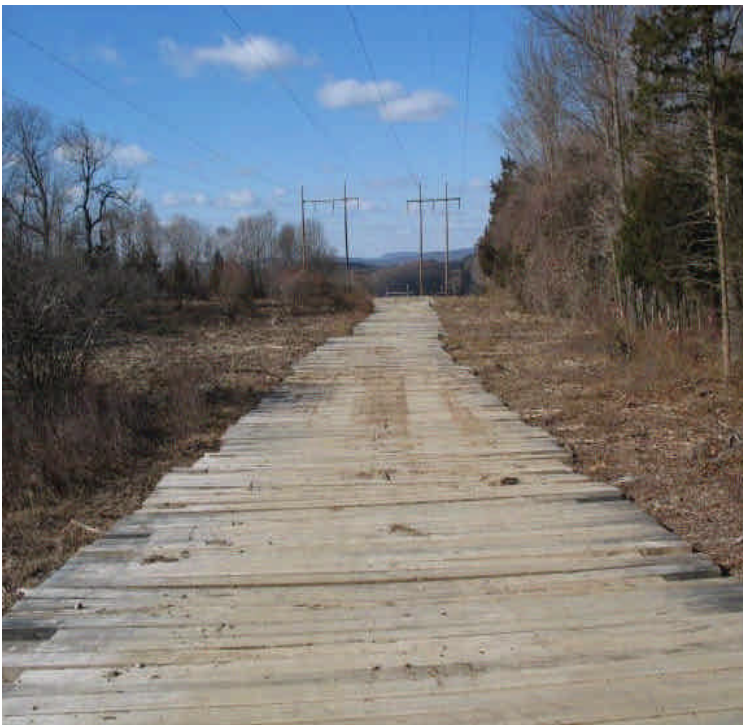
Access road (timber mats) in place off Haddam Quarter Rd.

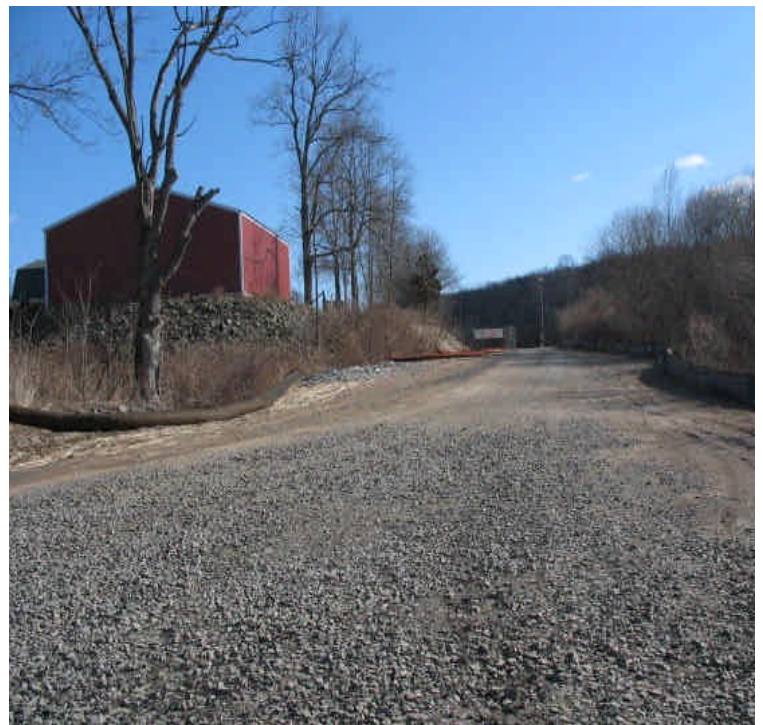
Silt fence, fiber rolls, and hay mulch have been added as a buffer around the perimeter of the contractor receiving yard.

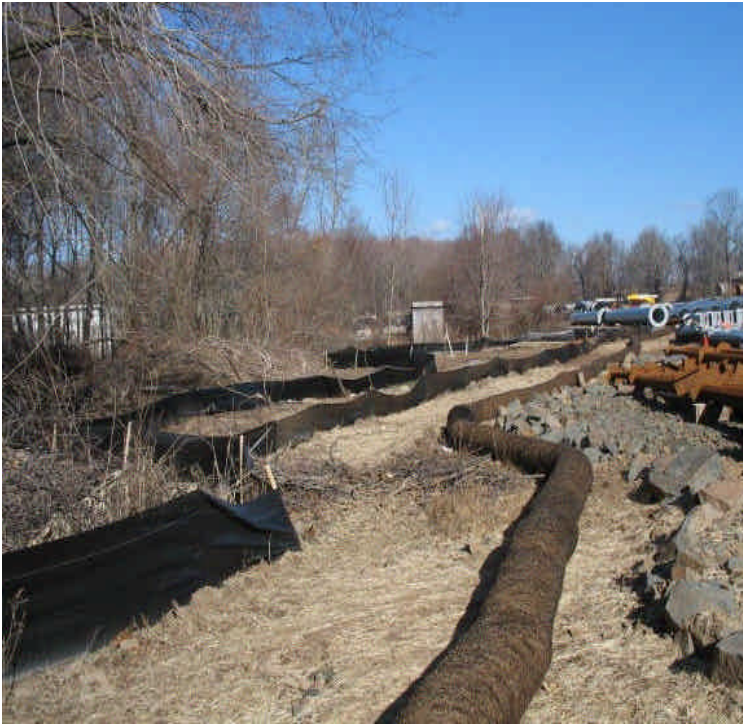
Additional controls remain in place adjacent to wetlands to filter/contain any turbid run-off leaving the site.

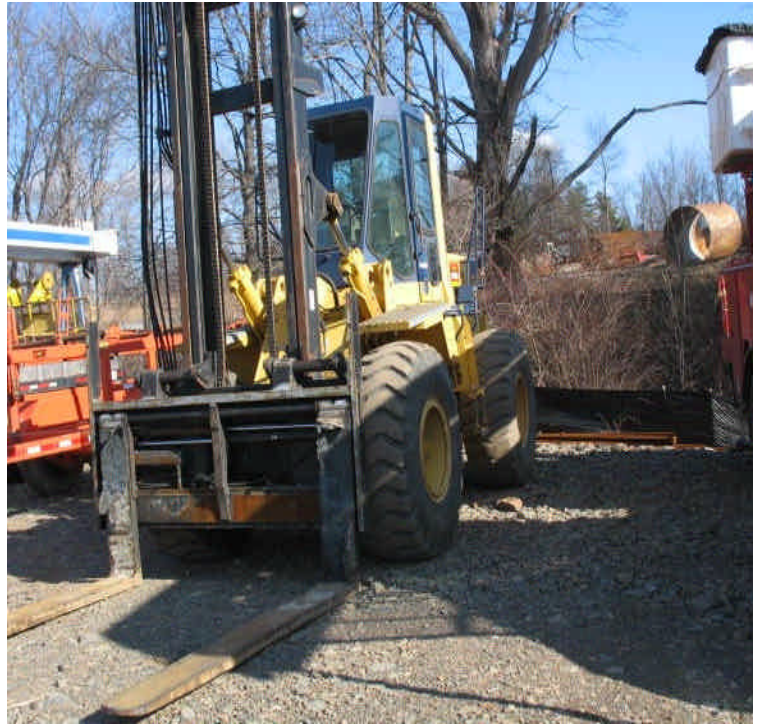
Small stains/drips were noted around the contractor receiving yard including under a leaking forklift.

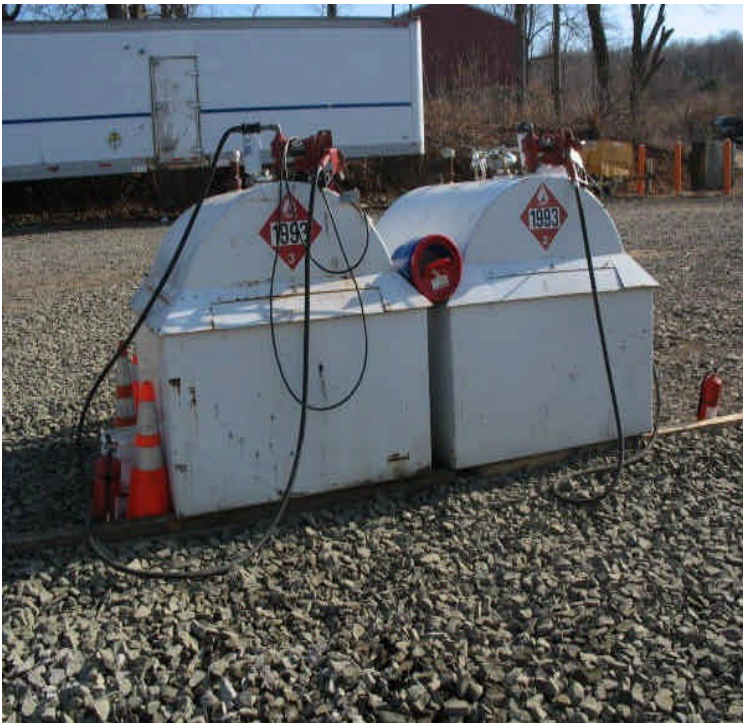
The fuel storage tanks remain in place on the new spill pad and nozzles are contained. Small drip stains were noted and are contained to the stone.

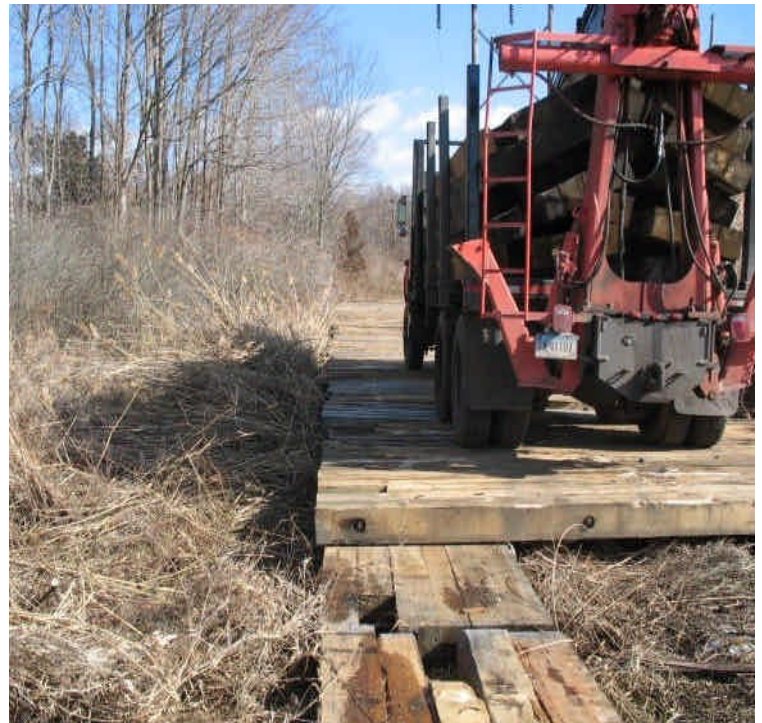
Timber mat installation off Durham Rd. Erosion controls may be needed.

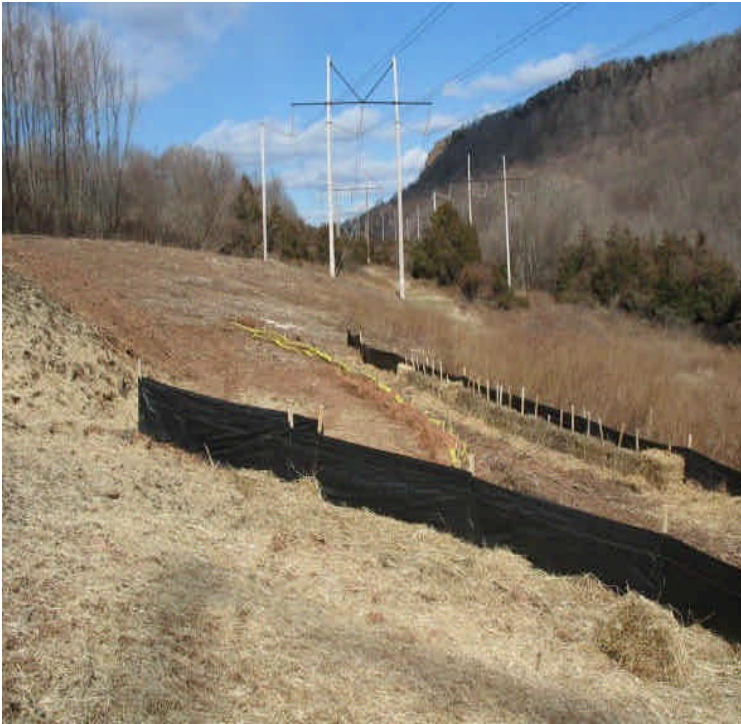
Overview of the haybales, silt fence, and filter socks at Black Pond. Mulch remains in place around the site for increased stabilization.

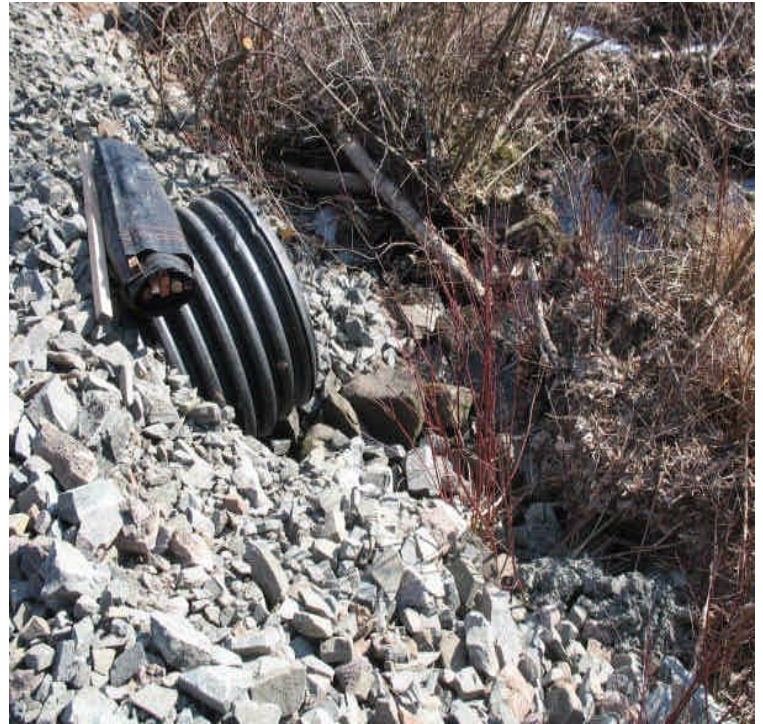
Stone and culvert used to cross a small stream off Powder Hill Rd. No sediment was observed leaving the site. Original conditions will need to be restored when work is complete.

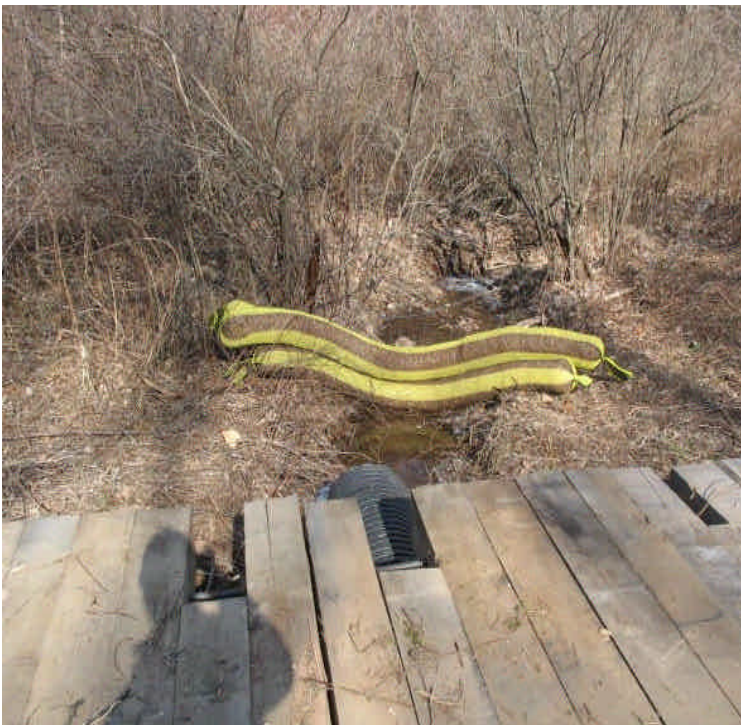
View of a timber mat crossing over a small stream in the wetlands located west of Powder Hill Rd. Filter socks were added for control of potentially turbid run-off. No sediment was noted leaving this area.

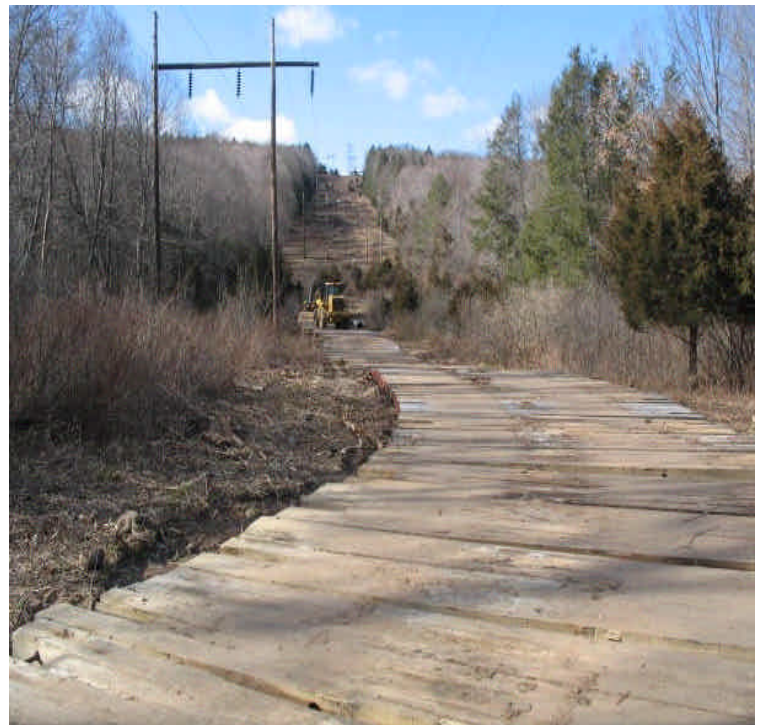
Timber mat installation for access west of Powder Hill Rd. The mats traverse wetlands, uplands, and small streams.
