**Docket No. 272 – Development and Management Plan Inspection**

**Segment 2a Inspection**

**Date:** January 3, 2007

**Location:** Segment 2a – Beseck Switching Station to Cheshire/Hamden Town Line

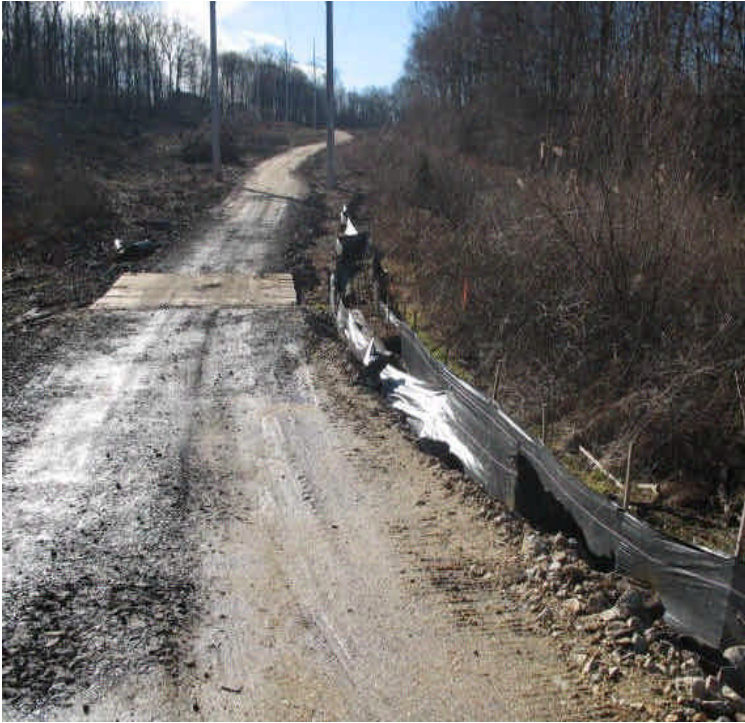
**Access road, timber mats, and erosion controls off High Hill Road at a non-federally jurisdictional wetland crossing**

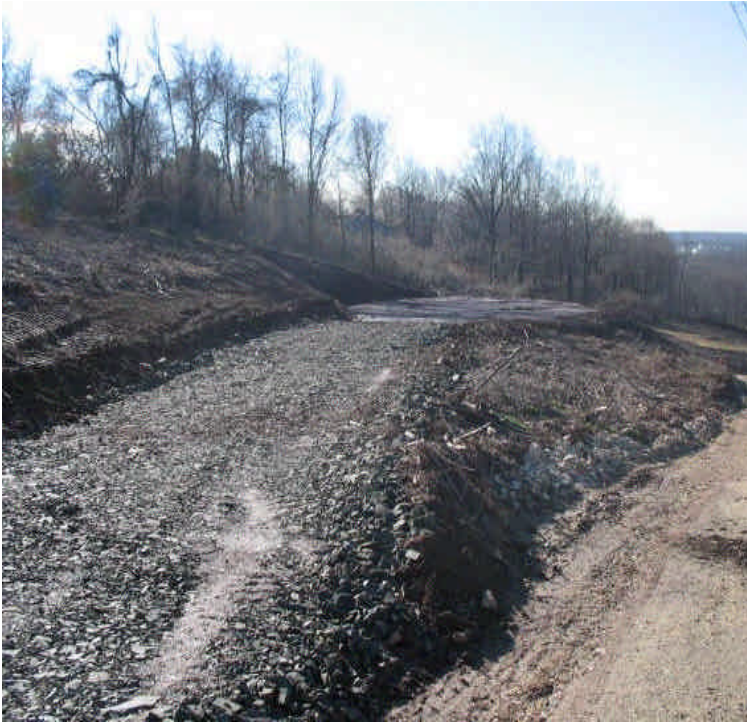
**New staging areas prepared for pole construction. Temporary stabilization measures (mulch) are in place.**

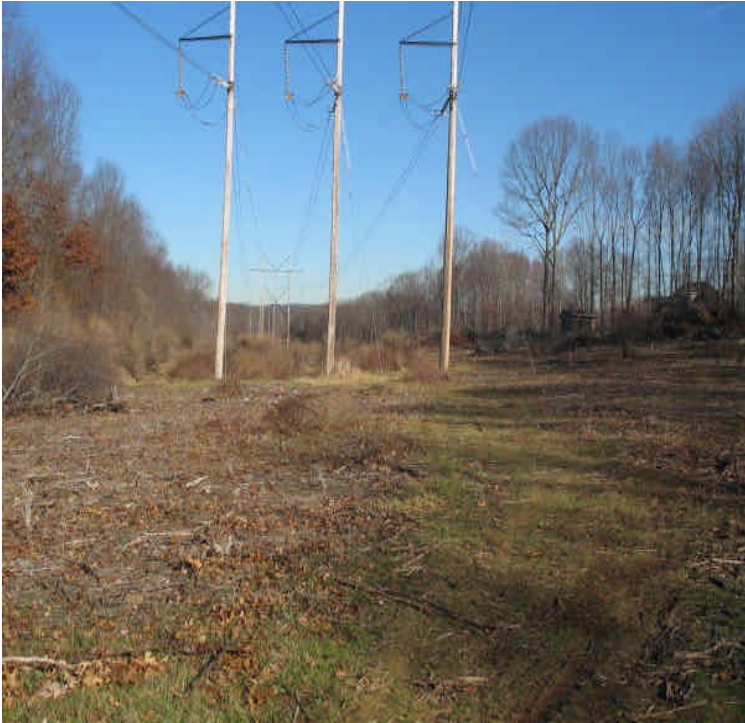
Additional Observations	Some non-project related debris dumping was noted at a few access points, including off Stony Brook Rd. 11/27/06-1/3/07	None. Noted for the record. 1/3/07	NA

**ROW off Stony Brook Rd. Non-project related debris had been dumped near this area.**

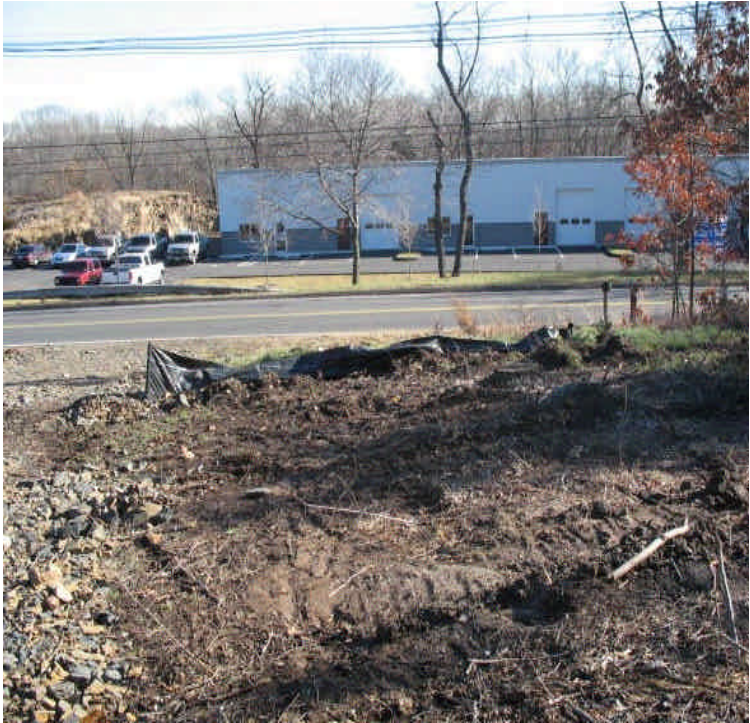
**Section of silt fence is in slight disrepair along South Turnpike. Continue to monitor slope for erosion.**

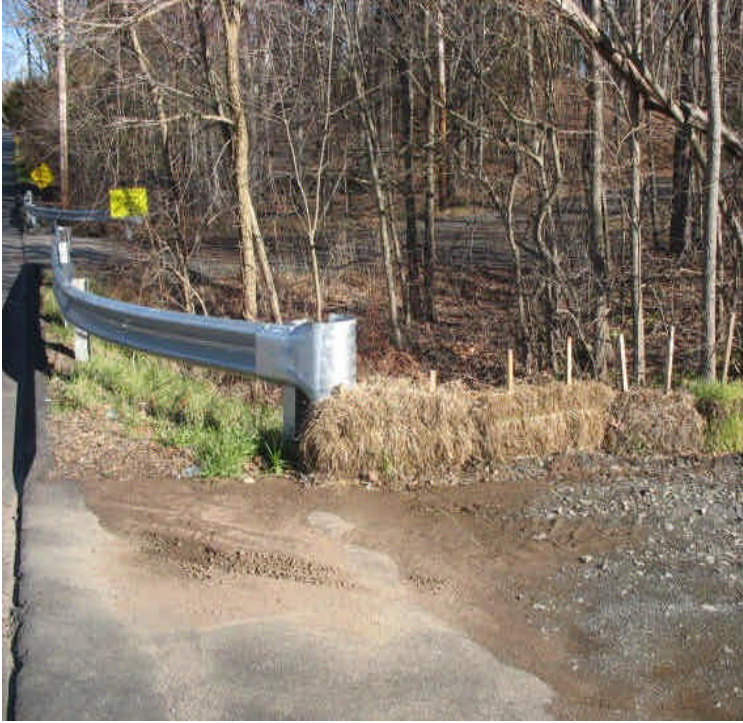
**Sediment accumulation should be removed from the haybales at the ROW entrance off Mansion Rd.**

S. Turnpike + Merritt Parkway Area	No sediment tracking noted on S. Turnpike. 1/3/07	Continue to monitor the entrance and sweep as needed. Also, continue to monitor the slope for additional wash-out or run-off issues. 1/3/07	NA
Mansion Rd	No sediment tracking noted on Mansion Rd. Some sediment build-up was noted at the entrance to Mansion Rd. This	Continue to monitor and sweep entrance as needed. Sediment should be removed before it reaches the roadway.	Needs attention when feasible.

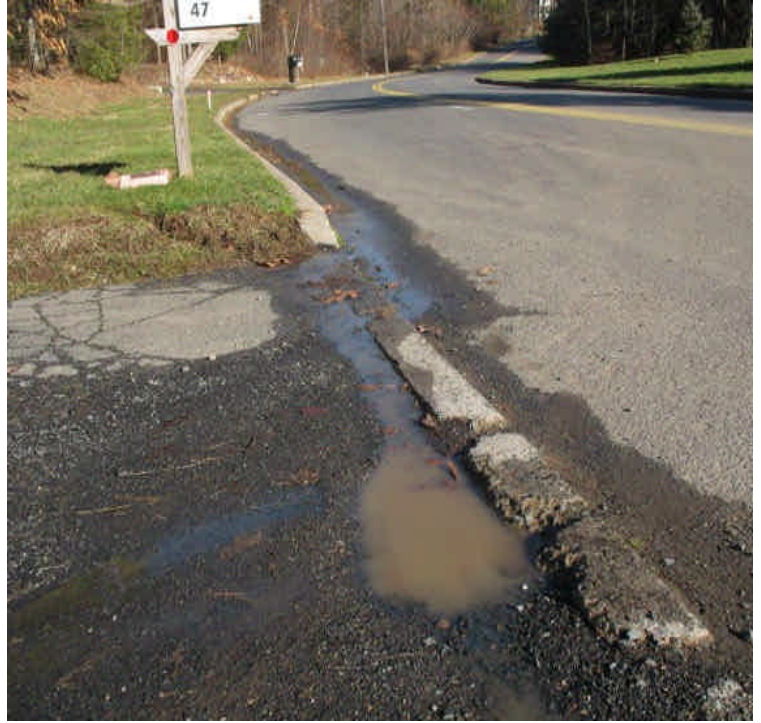
**Continue to monitor run-off seeping from non-federally jurisdictional wetland crossing off Old Farms Rd. Some turbid water has been observed reaching the roadways.**

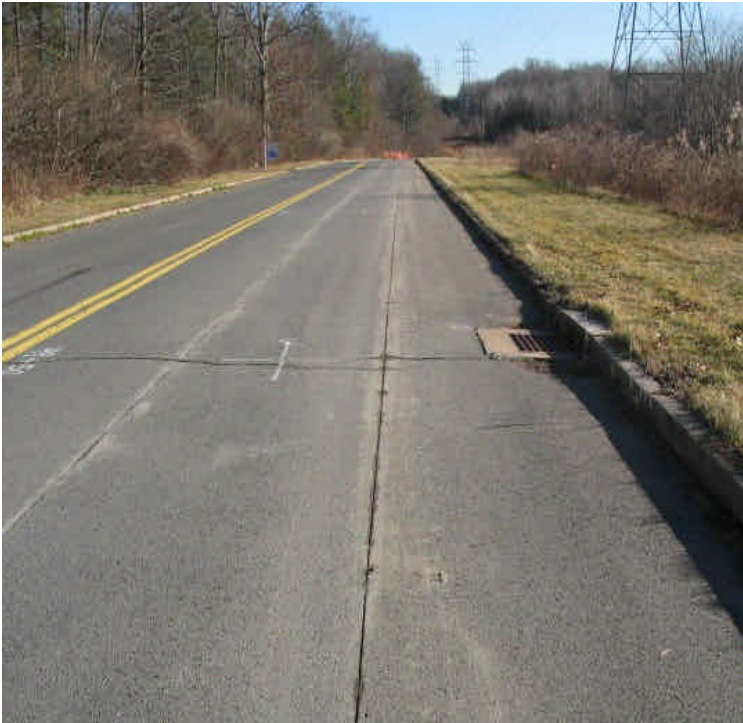
**Old Farms Road sawcut in preparation for underground work. One catch basin still needs protection. Adjacent wetlands showed no signs of sedimentation. Continue to sweep roadway as needed, especially as soon as sawcut slurry is created.**

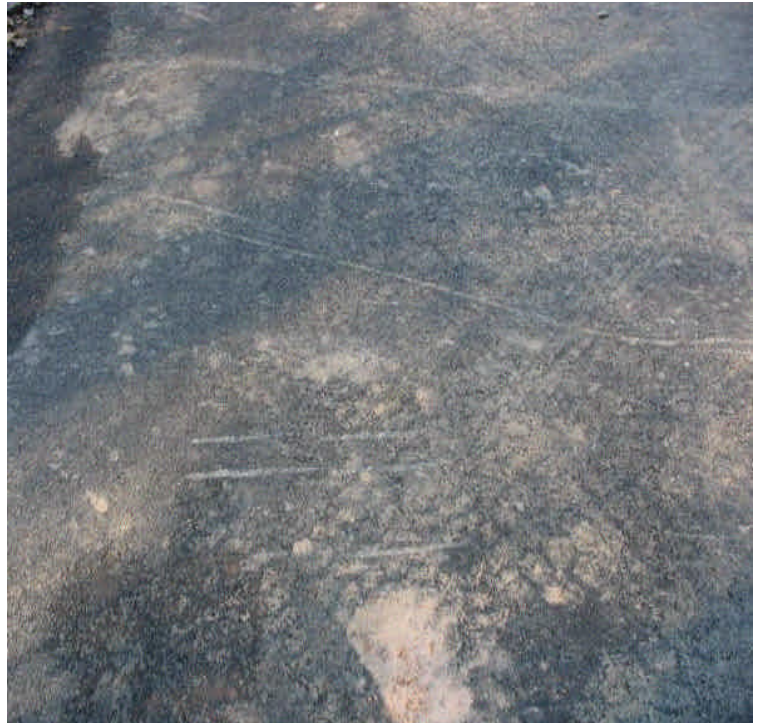
**Plywood was used to protect driveways from equipment crossing on the ROW off Old Farms Rd. Only minor tracks were noted on a few driveways.**
