Docket No. 272 – Development and Management Plan Inspection

Segment 2a Inspection

Date: January 9, 2007

Location: Segment 2a – Beseck Switching Station to Cheshire/Hamden Town Line

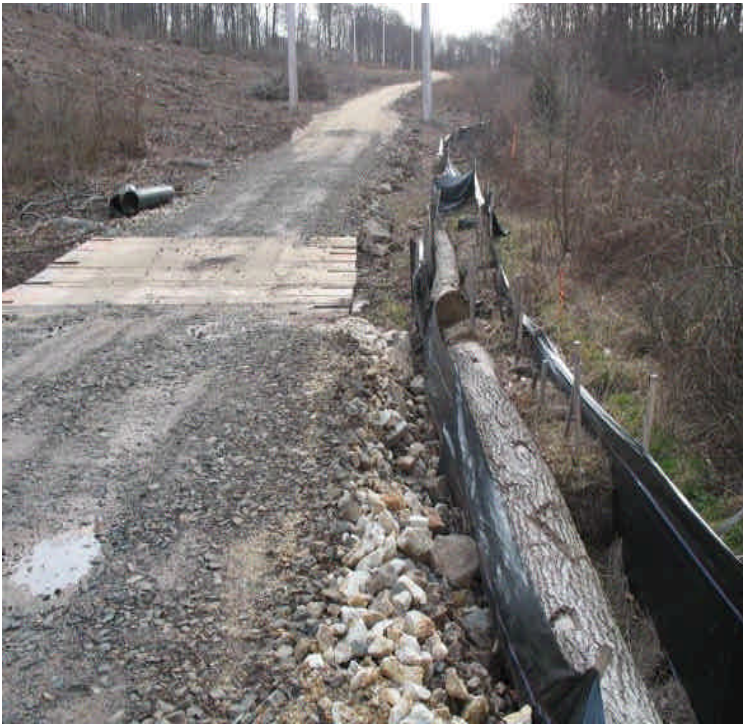
Access road, timber mats, and erosion controls off High Hill Road at a non-federally jurisdictional wetland crossing

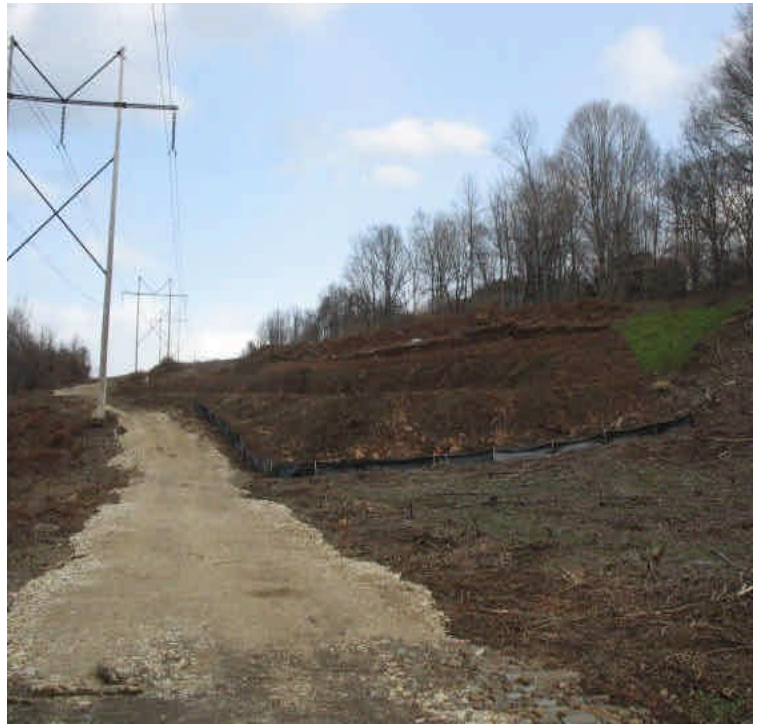
New staging areas prepared for pole construction. Temporary stabilization measures (mulch) are in place. Grading was performed to repair washouts.

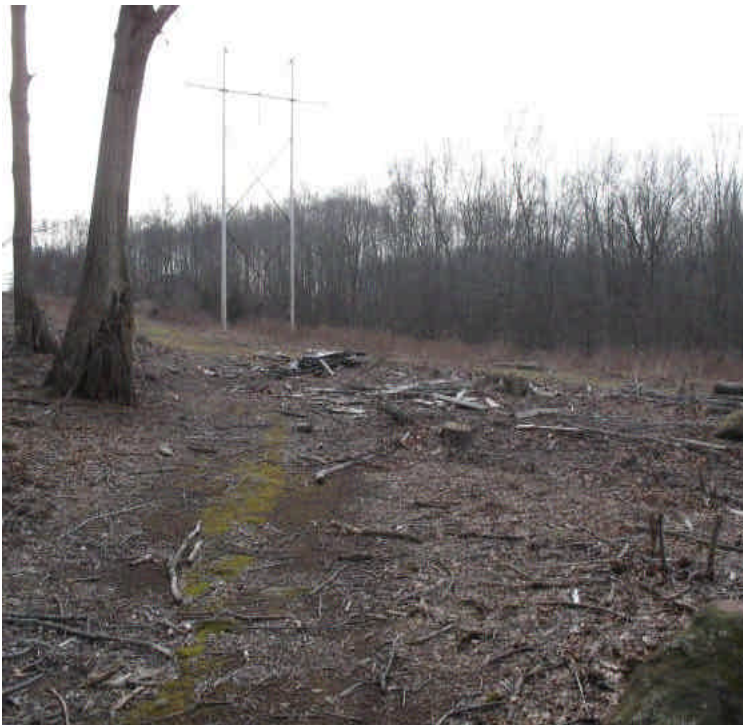
ROW off Stony Brook Rd. Non-project related debris had been dumped near this area.

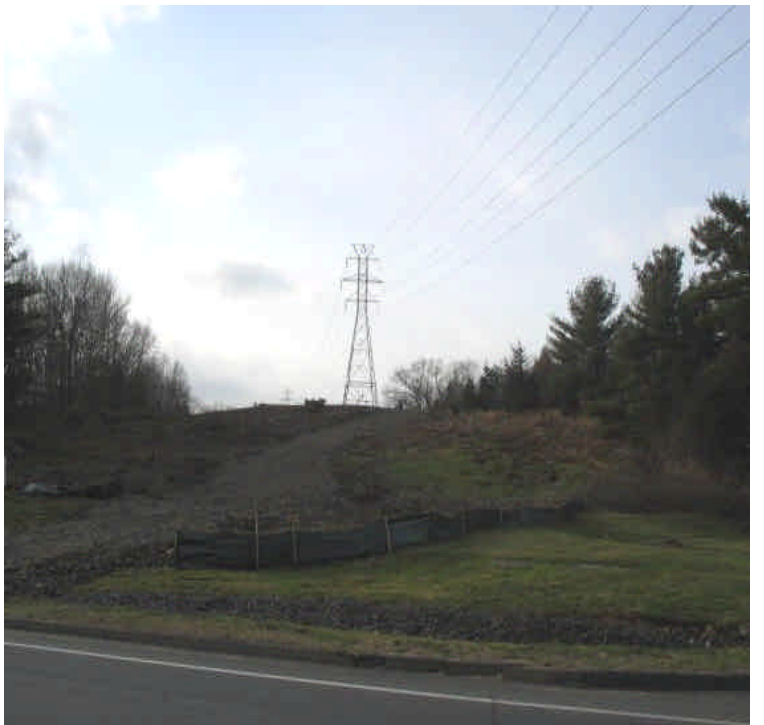
Section of silt fence is in slight disrepair along South Turnpike, however no immediate issues were noted. Continue to monitor slope for erosion.

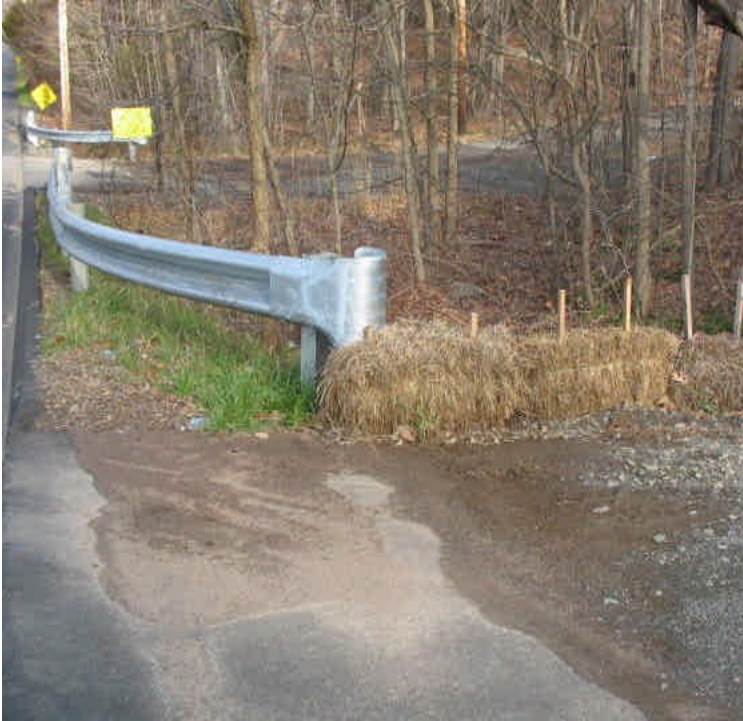
Sediment accumulation should be removed from the haybales at the ROW entrance off Mansion Rd when feasible although no immediate issues were noted.

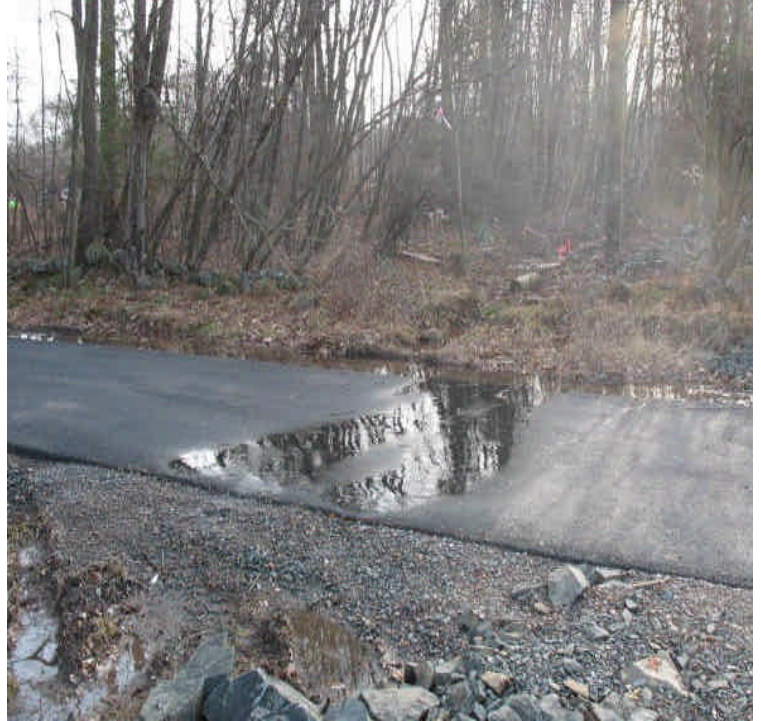
Continue to monitor run-off and sheet flow seeping from non-federally jurisdictional wetland crossings off Old Farms Rd. Some turbid water has been observed reaching the roadway. Also, evaluate past and current hydrology here as water was pooling across some driveways.

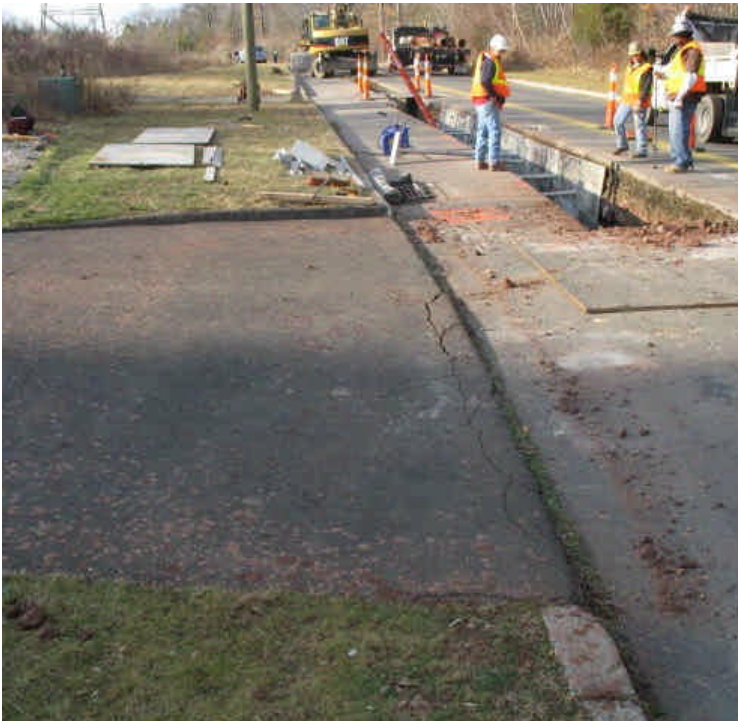
View of trenching on Old Farms Road for underground work. Minor sediment was noted on adjacent driveway. Adjacent wetlands showed signs of sedimentation. Continue to sweep roadway or driveways as needed, especially as soon as sawcut slurry is created.

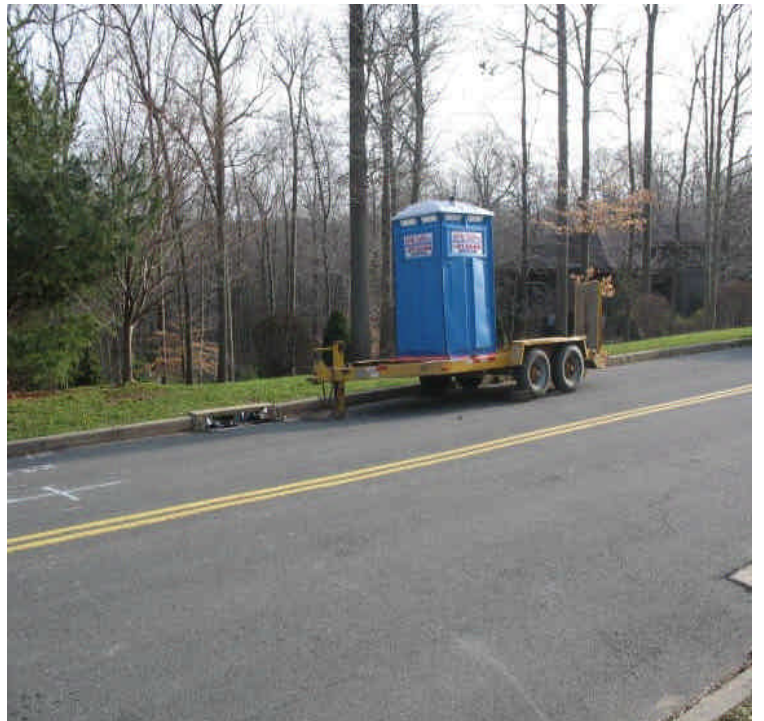
Portable sanitary facilities should be moved away from wetlands and catch basins to reduce the potential for impacts.
