Docket No. 272 - Development and Management Plan Inspection

Segment 2b Inspection

Date: January 5, 2007

Location: Segment 2b - Cheshire/Hamden Town Line to East Devon Substation

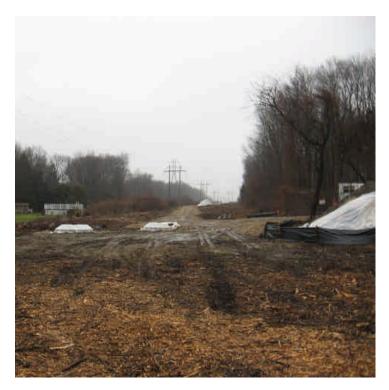
View of the foundation work and spoil piles in the ROW off Russell Ave.

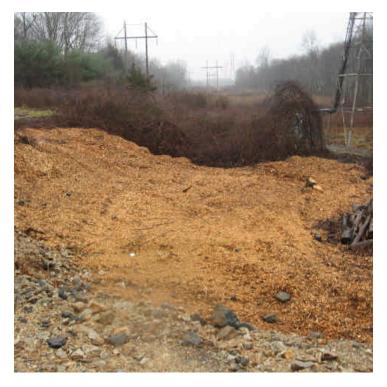
View of the wood chips pile within the ROW off Hunting Hill Place. Wood chips are currently at a depth greater than 3" and should be spread in upland areas or removed.

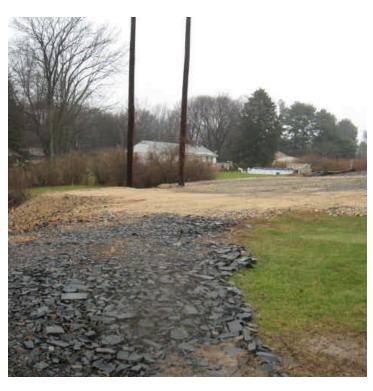
Overall view of the work area within the ROW located off Hunting Hill Place.

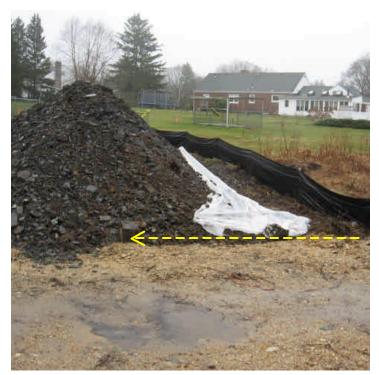
Silt fence was installed between the stockpile and wetland within the ROW off Sunset Ave. The silt fence may need to be extended toward the road here.

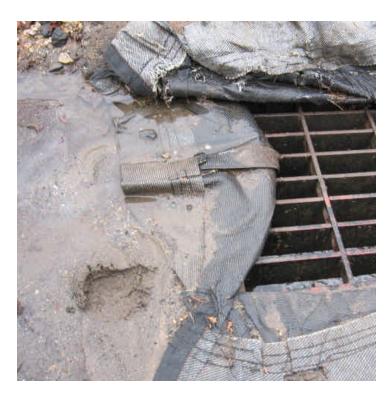
Sediment has built up around the catch basin on Sunset Dr. The Silt-Sak still appears to be functioning properly here. Clear as necessary.

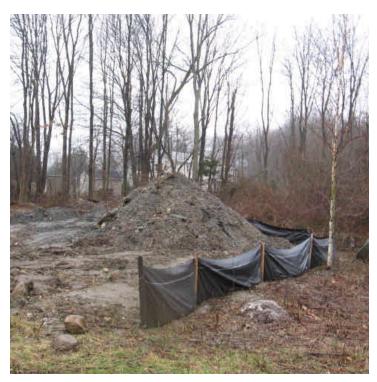
Silt fence was installed at the spoil pile located near the wetland off Overland Drive (west).

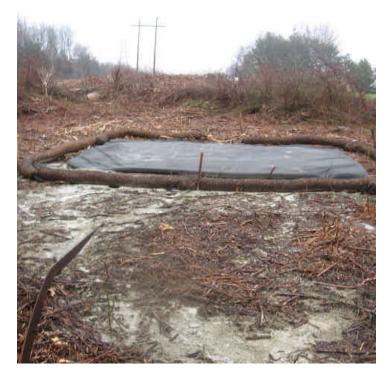
Sediment/slurry remains outside of the controls within the ROW Off Overland Drive (west). It is unlikely that sediment will affect the wetland located downgradient but this should be avoided.

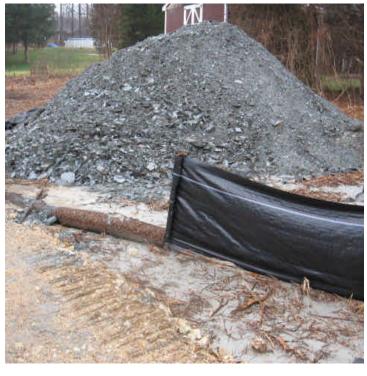
Some sediment/slurry has breached the dewatering controls off Overland Drive (east).

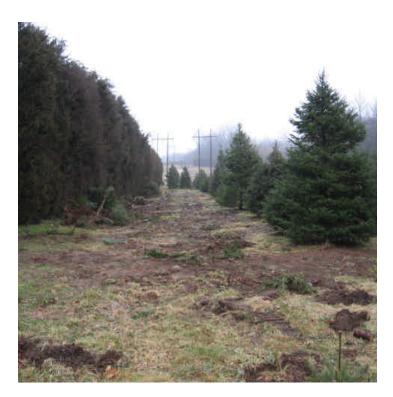
View of the clearing at the tree farm located within the ROW off Overland Drive (east).

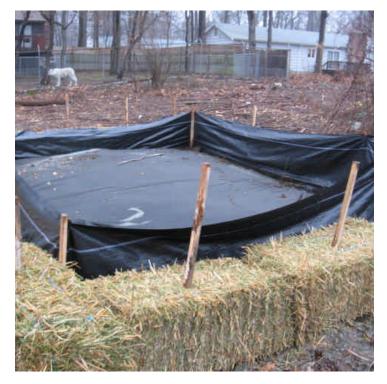
View of one of the many dewatering basins located within the ROW off Route 152 (west).

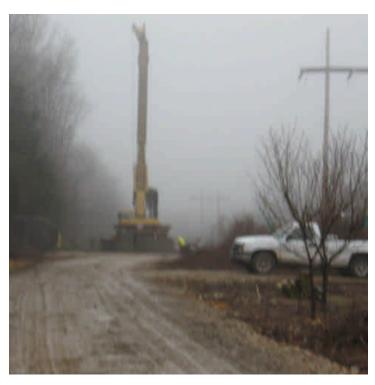
View of the foundation drilling within the ROW located off Route 152 (west).

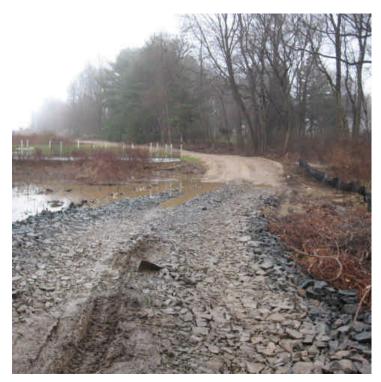
View of the water pooling at the access road located across from the wetland area off Route 152 (west). Additional stone may be needed in the access road here to reduce turbidity.

Areas of Inspection	Observation	Recommended Action	Corrected Action
(west)	access road located across from the wetland area off Orange Center Drive (west). Silt fence remains intact here. 1/5/07.	be placed at this spot in the access road to reduce turbidity and allow for additional filtration before this water reaches the wetland. 1/5/07	feasible.
Pine Tree Drive and Dogwood Rd	Evidence of past clearing was noted within the wetlands located in the ROW off Pine Tree Dr (east & west) and near the wetland located off Dogwood Rd (east). 1/5/07.	Continue to monitor. Maintain erosion controls as necessary. 1/5/07.	NA
	Some wetland flags were missing at the wetland off Dogwood Rd, but it appears a small portion of wetland may have been cleared for proposed structure installation. Many shrubs and some herbaceous vegetation remain in place along the edges. 12/7-1/5/07.	Silt fence is not necessary at this time. Continue to monitor. Confirm that this wetland is not under federal jurisdiction. 12/7-1/5/07.	Needs evaluation

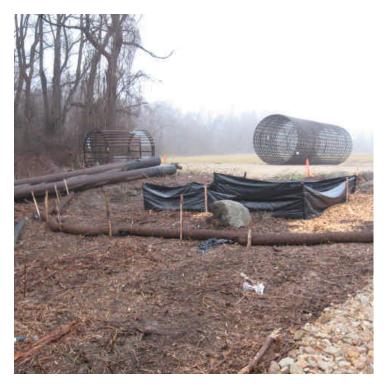
View of a dewatering basin and filter sock check dam within the ROW off Route 152 (east). Continue to ensure controls are adequate to contain slurry.

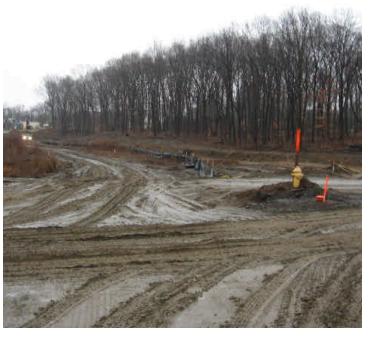
Activities associated with the relocation of Shelland Street continue in Milford.

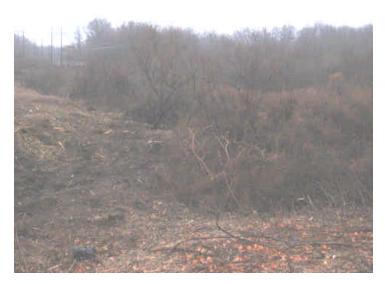
View of the clearing within the ROW located off Lexington Lane (east) in Milford. Continue to retain shrubs whenever feasible.

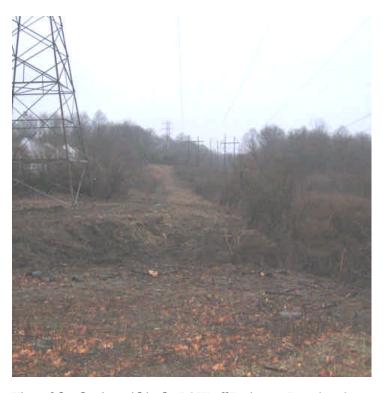
View of the clearing within the ROW off Lexington Lane (west).
