## Docket No. 272 - Development and Management Plan Inspection

## **Segment 2b Inspection**

**Date: January 11, 2007**

Location: Segment 2b - Cheshire/Hamden Town Line to East Devon Substation

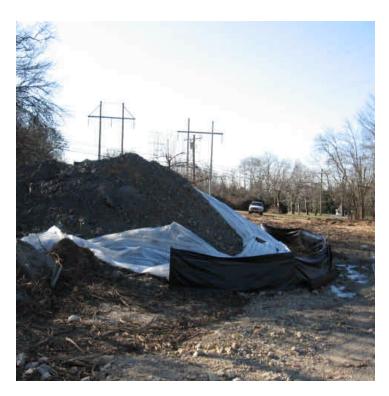
Plastic has slipped from some of the spoil piles off Russell Ave but silt fence remains intact where necessary.

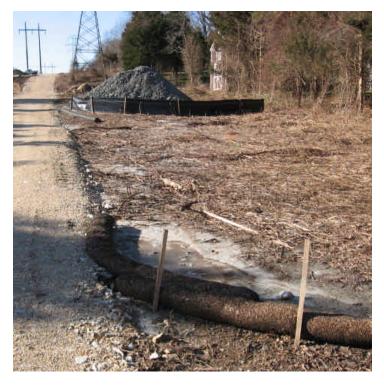
View of the sediment that had breached the controls off Overland Dr. (east). Filter sock check dams have prevented the sediment from migrating further downgradient.

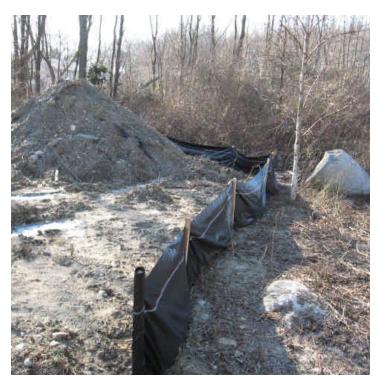
Silt fence remains intact around the spoil pile near the wetland off Overland Drive (west).

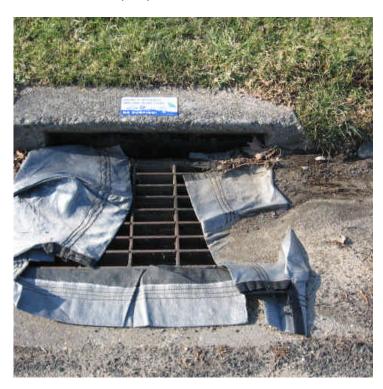
Accumulated sediment was noted around the catch basin on the western side of Overland Dr. Sweep the gutter and roadway as needed.

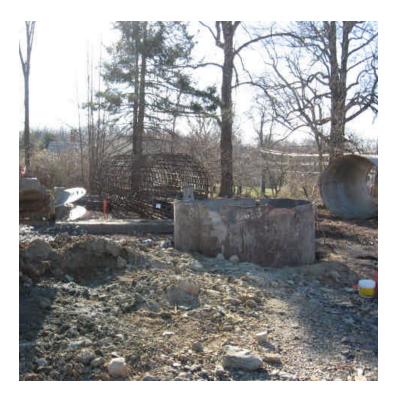
View of the foundation work within the ROW off Dogwood Rd.

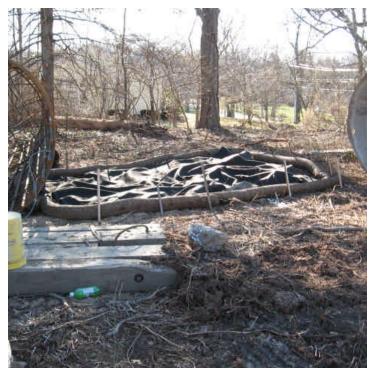
Dewatering controls were installed proactively off Dogwood Rd.

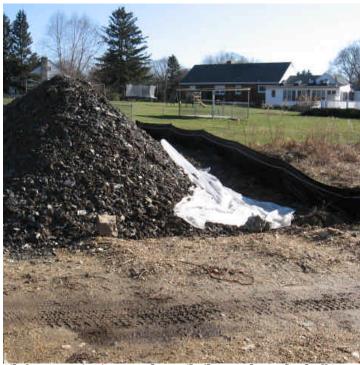
Silt fence remains intact at the spoil pile near the wetland off Sunset Dr. The pile appears contained, but silt fence may need to be extended toward the road.

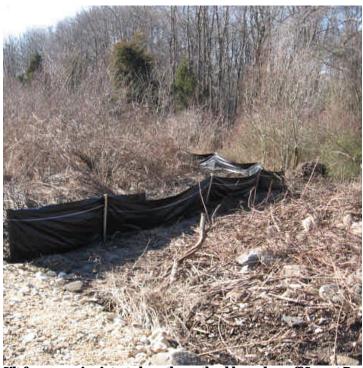
Silt fence remains intact along the wetland boundary off Sunset Dr.

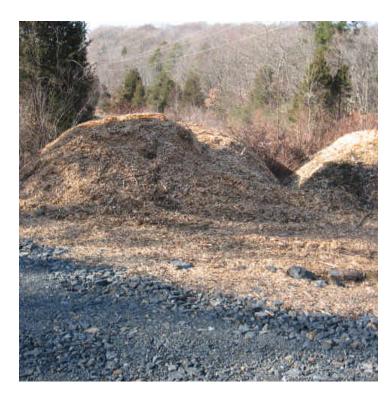
View of the wood chip piles stored within the ROW off Lambert Rd. Piles will need to be removed or spread appropriately in upland ROW areas to a depth of 3-inches or less.

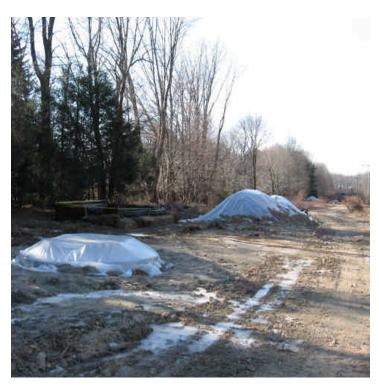
Overall view of the work within the ROW off Route 152 (west).

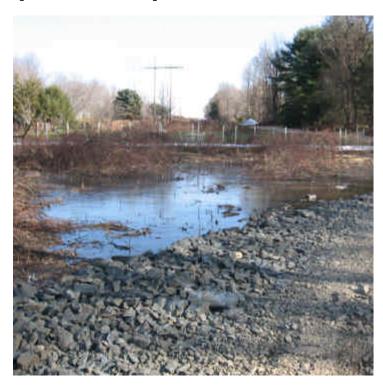
View of the water pooling at the access road located across from the wetland area off Route 152 (west). Additional stone could be placed in the access road here to reduce vehicle tracking/turbidity.

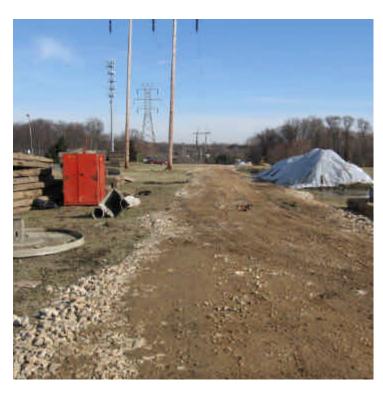
Overall view of the work within the ROW off Route 152 (east).

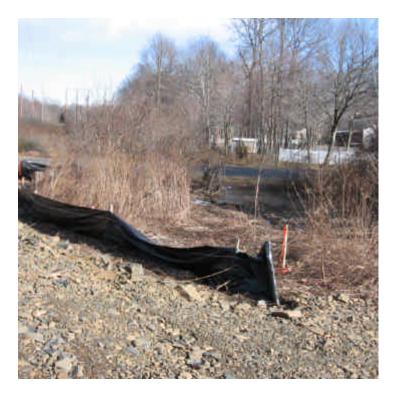
Silt fence remains intact at the small wetland pocket within the ROW off Pine Tree Dr (west).

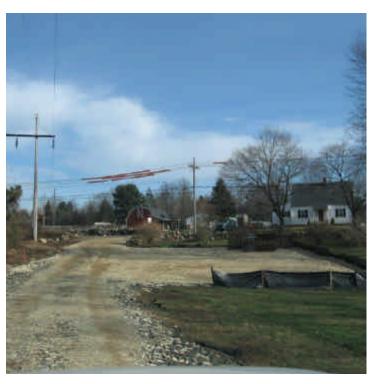
Silt fence remains intact along work areas off Rolling Ridge Rd.

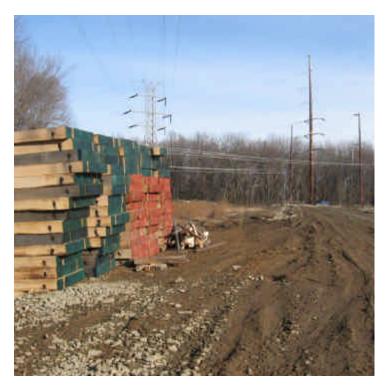
View of the access road within the ROW off Pease Rd in Woodbridge. Timber mats are being stored here for future access.

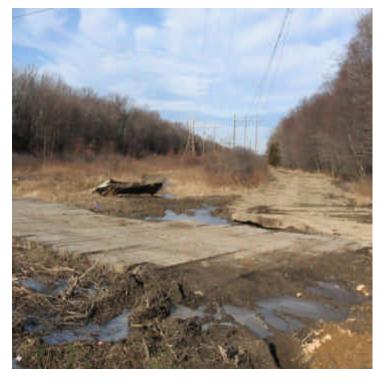
Additional mats were placed along the access road here (Pease Rd).
