Docket No. 272 – Development and Management Plan Inspection

Segment 3 Underground Line

Date: January 9, 2007

Location: East Devon Substation to the Housatonic River Crossing

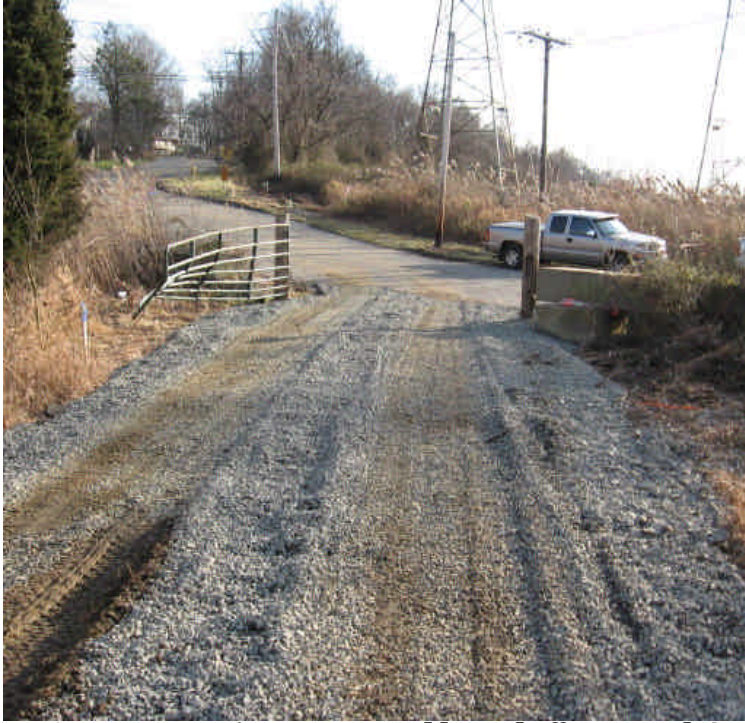
Stone construction entrance pad located off Naugatuck Ave. to access station 1050 to 1058.

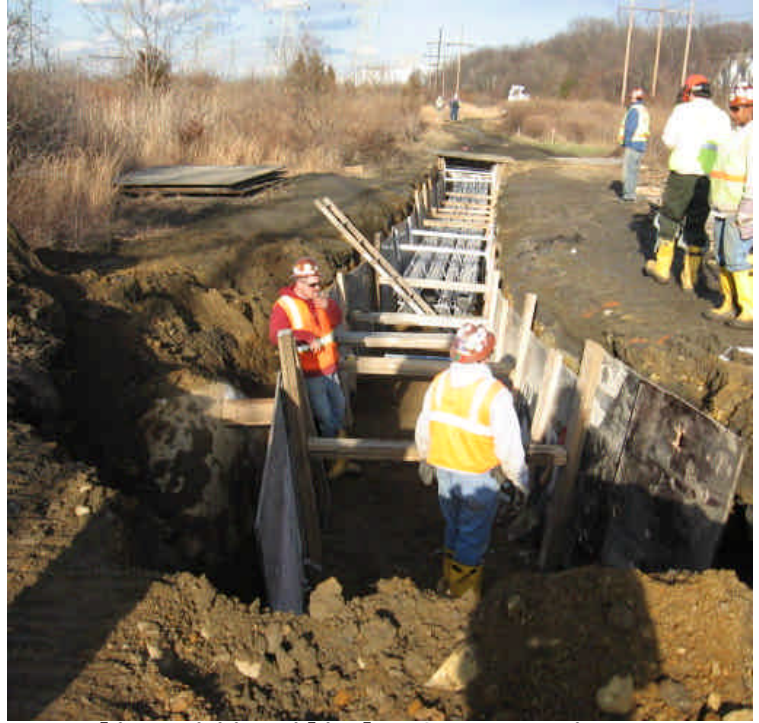
Trenching activities within the ROW near station 1053.

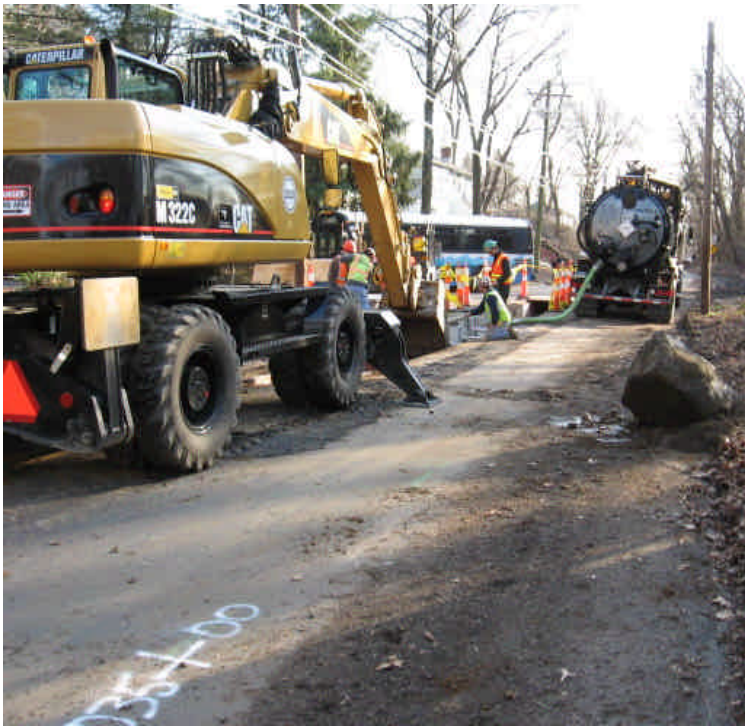
Trenching activities from station 1033 to 1037. Vac truck is dewatering groundwater from trench. Roadway should be swept of sediment at the close of the workday and as sawcut slurry is created.

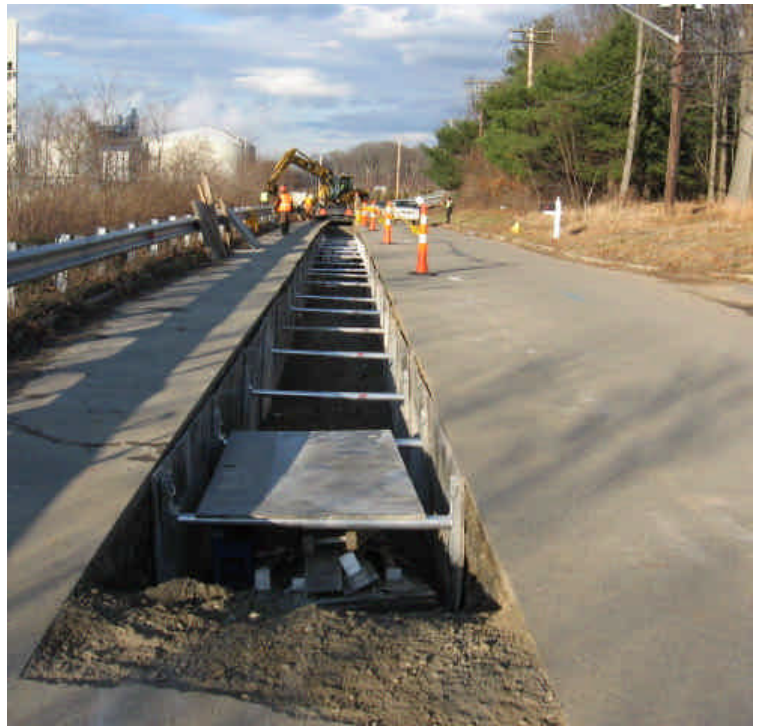
Trenching activities from station 1089 to 1097. All catch basins near construction activities are protected.

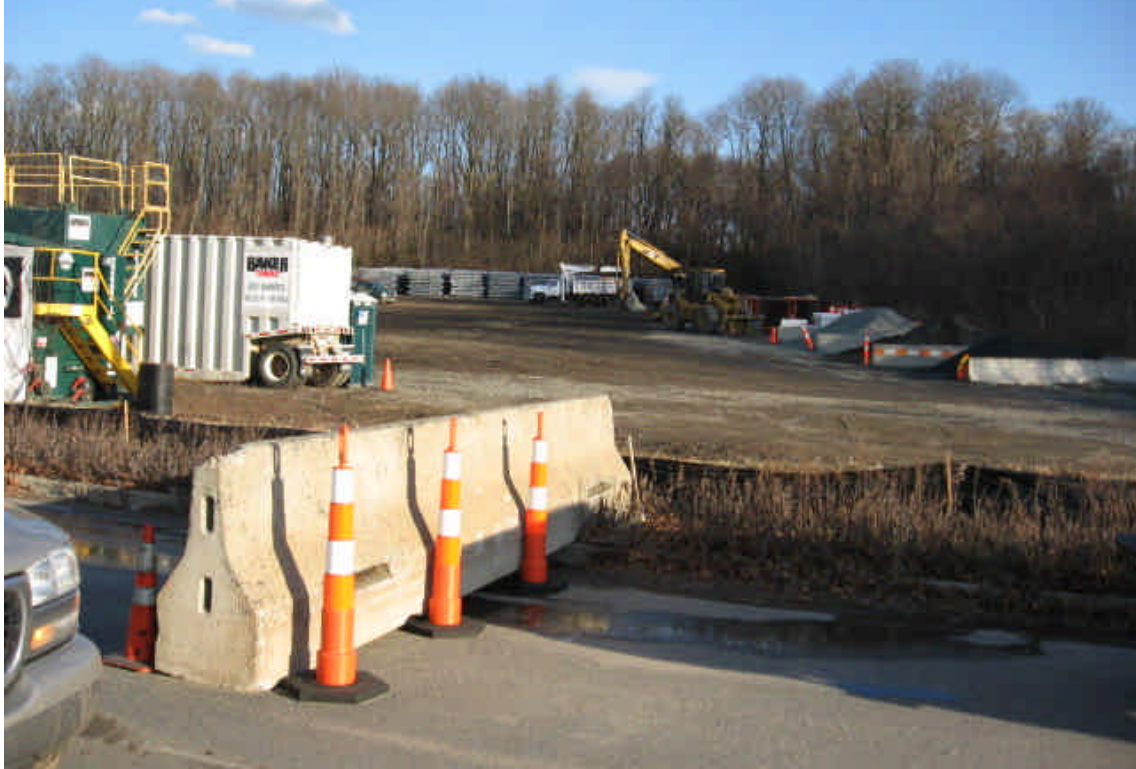
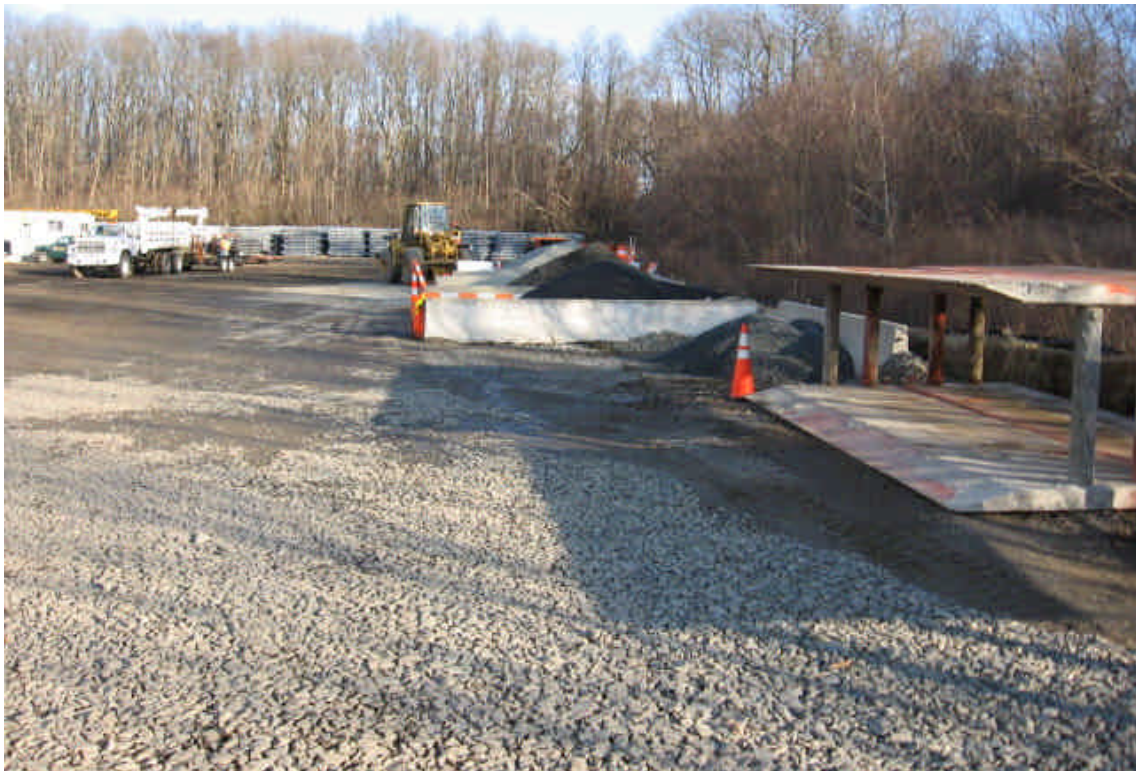
Both photos show the contractor lay-down yard in Milford. Erosion controls surround the entire perimeter of the yard, all loose fill materials are being stored within jersey barriers. The access to the yard has a stone construction entrance to prevent sediment tracking. No issues were noted at the time of inspection.
