Docket No. 272 – Development and Management Plan Inspection

Segment 3 Underground Line

Date: January 16, 2007

Location: East Devon Substation to the Housatonic River Crossing

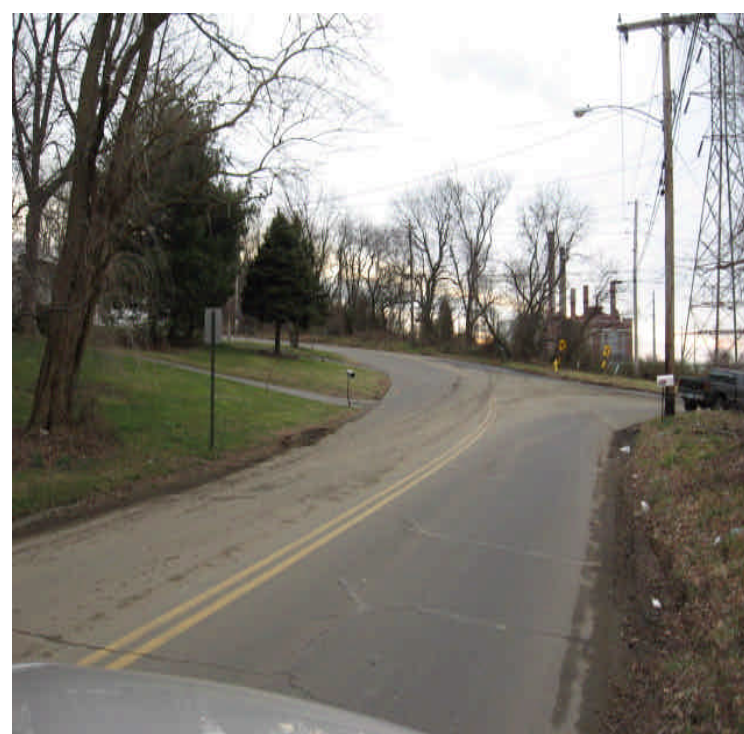
Sediment is being tracked onto Nungateck Ave. from the cross-country roads. Sweep roadway as necessary, and prevent further tracking as feasible.

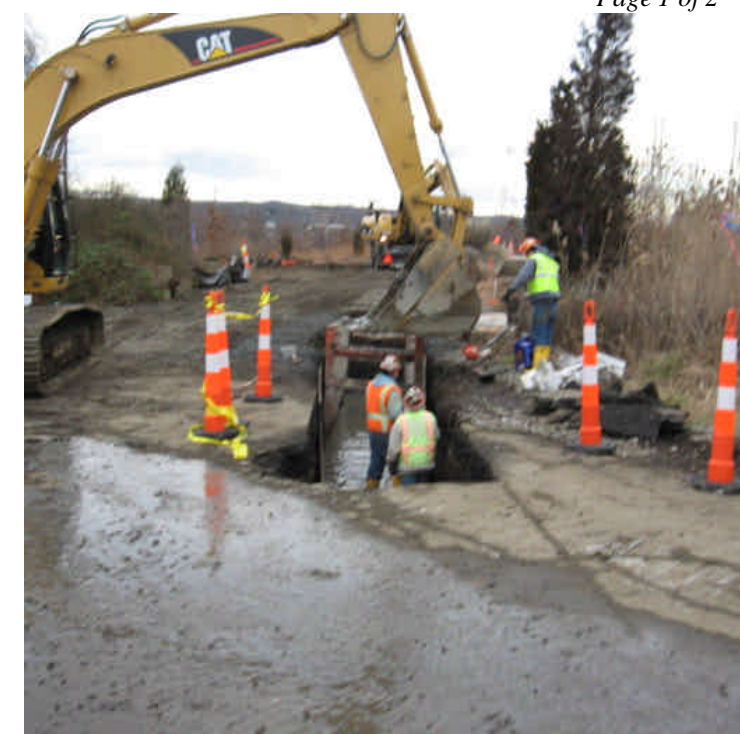
Photograph of trenching activities at station #1055. Water in the trench is not being pumped at this time.

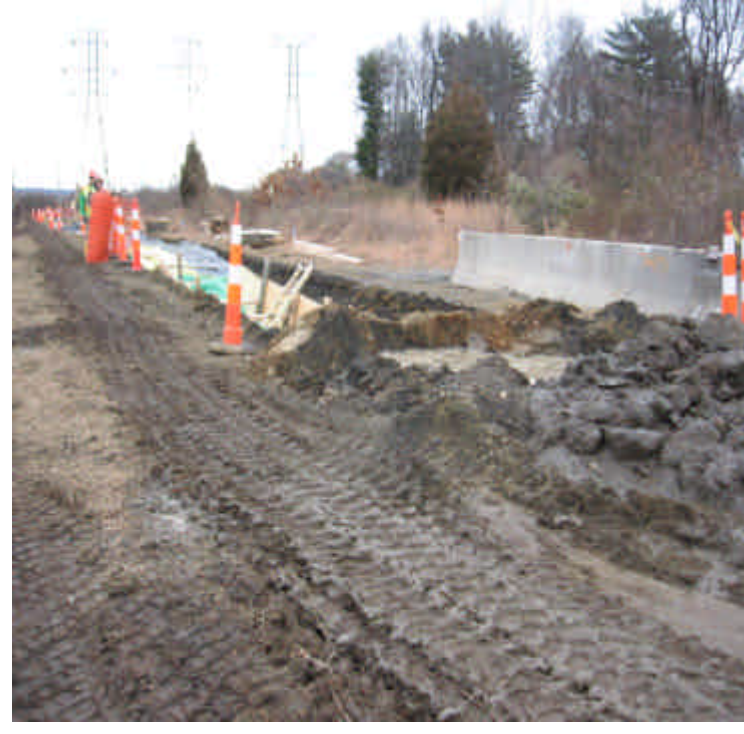
Photograph of trenching activities from station # 1054 to 1050. A basin has been constructed to receive/contain concrete washout.

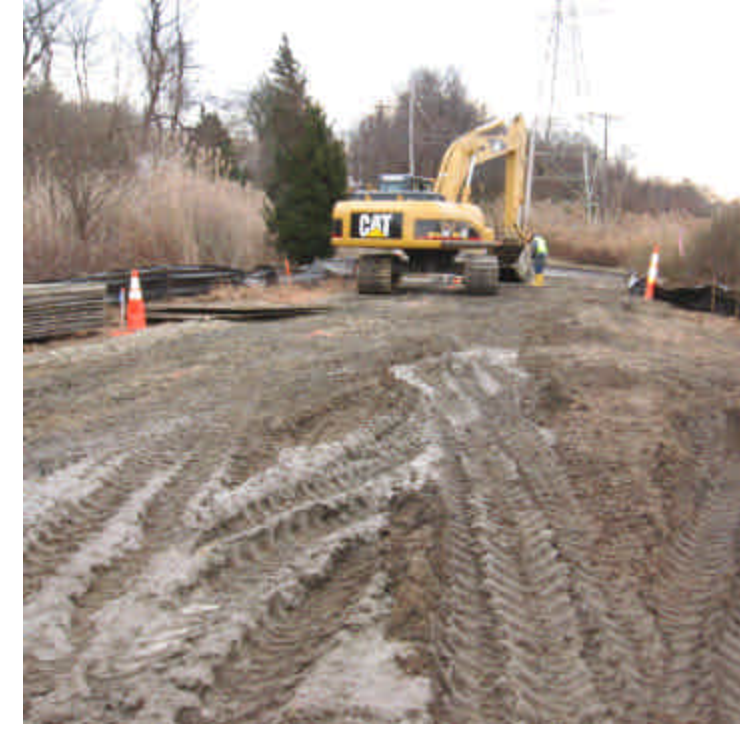
Erosion controls (silt fence) have been installed to protect wetland areas on either side of access road.

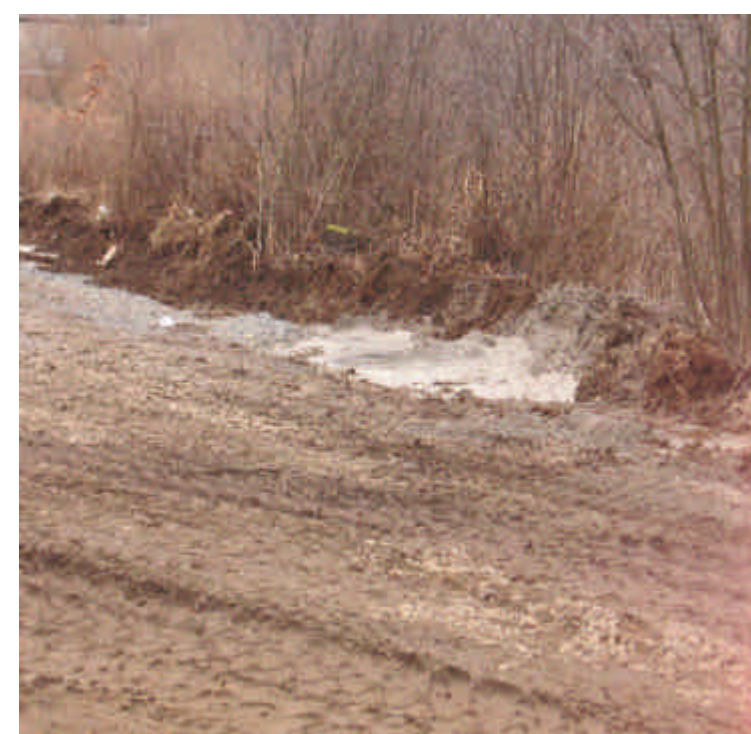
An uncontained concrete washout was noted along the ROW. This concrete should be removed and properly disposed of. Rental drivers to continue using designated, contained area.

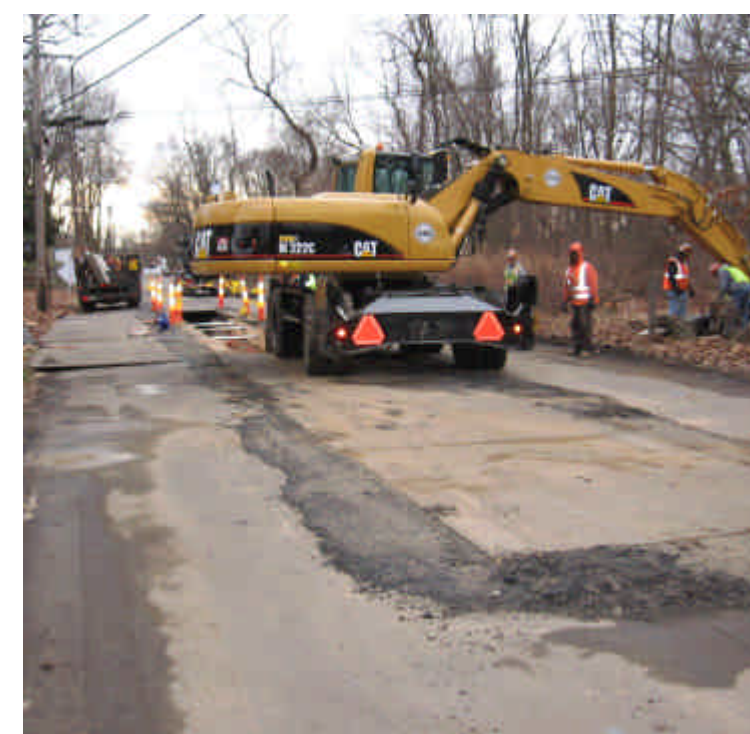
Photograph of trenching activities from station #1033 to 1039. No issues were noted at the time of inspection.

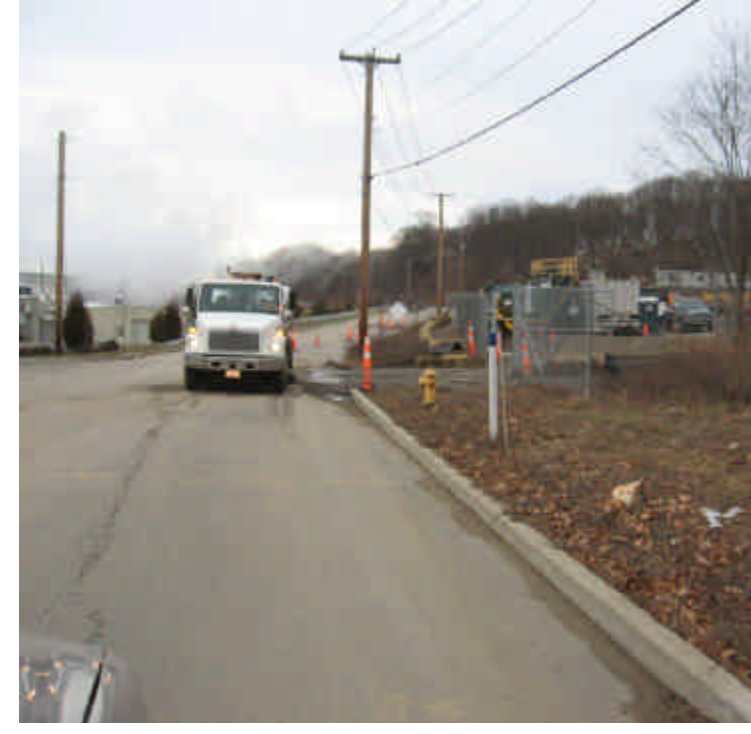
Photo of street sweeping at the entrance to the Millfield lay-down yard. Minor sediment had been tracked onto the roadway.

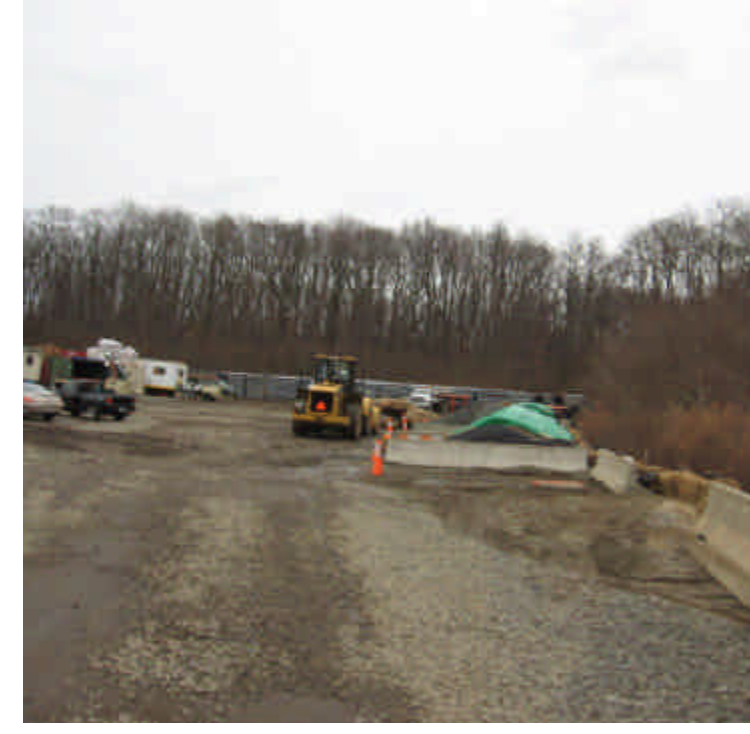
Overview photo of the Millfield lay-down yard. No issues were noted at the time of inspection. Erosion controls remain at the perimeter of the yard.
